## Service Bulletins

BULLETIN NO : SBMA200311  
BULLETIN TO : ALL MARINE DEALERS  
ATTENTION : SERVICE MANAGER AND ALL RELEVANT STAFF  
DATE : March 2003  
SUBJECT : BF 75/ 90 A Oil leak from oil pump

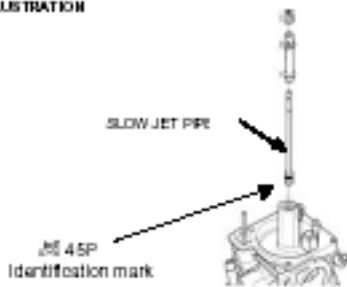
ILLUSTRATION

The height of the air bleed hole in the slow jet pipe was incorrect; the air-fuel mixture would lean-out when accelerating between 2000- 3000 rpm. This causes the engine to hesitate or stall.

**NOTE; Don't forget to balance the carburetors after the upgrade.**

**Replacement SLOW JET PIPE** part number – 16150-ZW4-H02, order 3 pieces per outboard.  
Note; new manifold gaskets may be required.

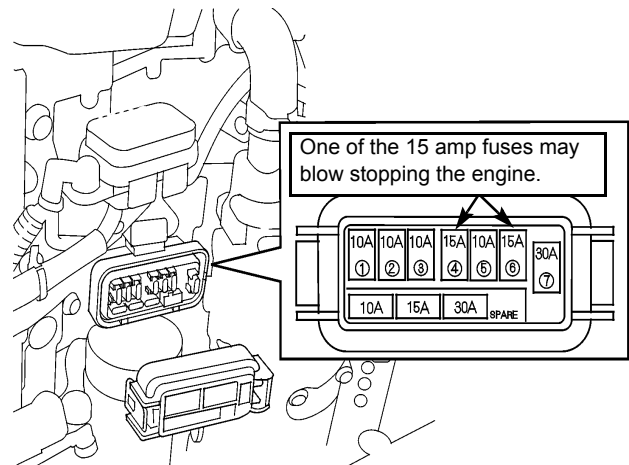
The routing of the engine wiring harness may allow contact with the throttle body under normal running conditions. Eventually, the repeated contact may wear through the wire's insulation and cause a short circuit. This may cause a blown fuse (15A) and the engine will stop, or the short may cause the throttle cable to overheat and become difficult to move or, in the worst case, the throttle could become stuck.

The throttle arm will not operate because the throttle cable inner liner has melted and cooled around the cable.

All affected units must be inspected for possible main harness damage. If no damage has occurred, install the protective cover after completing the inspection. If the main engine harness has been damaged, install a new main engine harness. In addition, the throttle cables must be replaced if the main engine wire harness has been damaged.

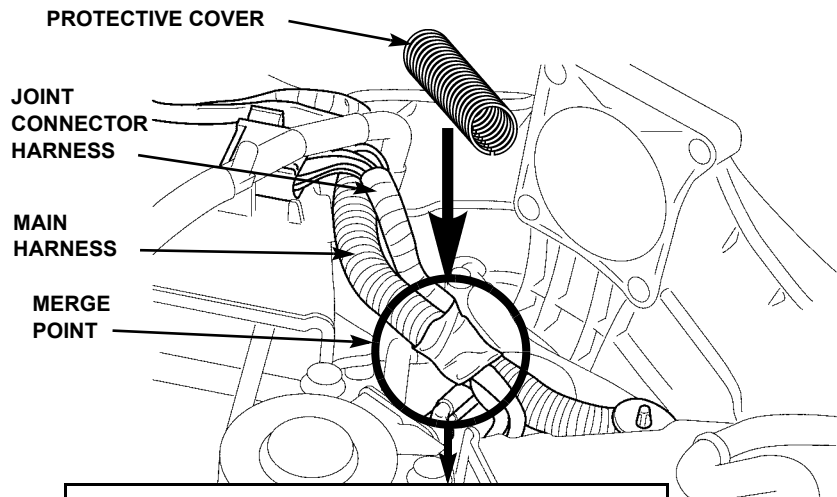
11. Inspect the taped area where the joint connector harness merges with the main harness. If any of the tape is rubbed or broken where any of the wires are visible, proceed to *Main Engine Harness Replacement* (page 6). If no damage is visible, continue on and install the protective cover.

12. Install the protective cover over the main harness where the joint connector harness merges with the main harness.

Replace the main engine harness if the tape is rubbed, torn or damaged exposing any of the wires.

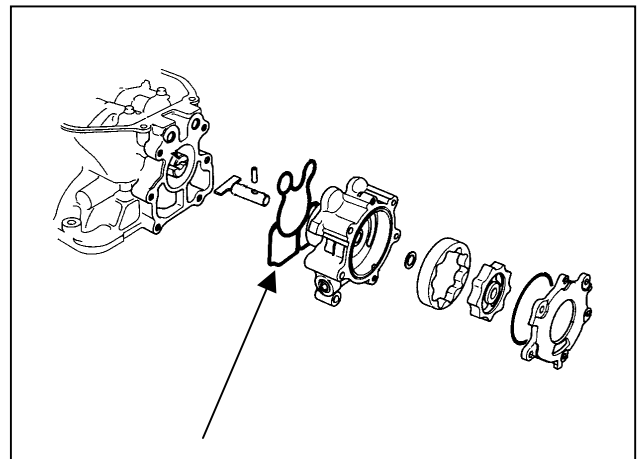
An engine oil may leak may occur from between the engine and mount case area.

During manufacturing a human error may have been made and the o ring may have been damaged.

The O ring may have been damaged on assembly.

Replace parts as per list below. Use the workshop manual for the correct assembly and disassemble procedure.

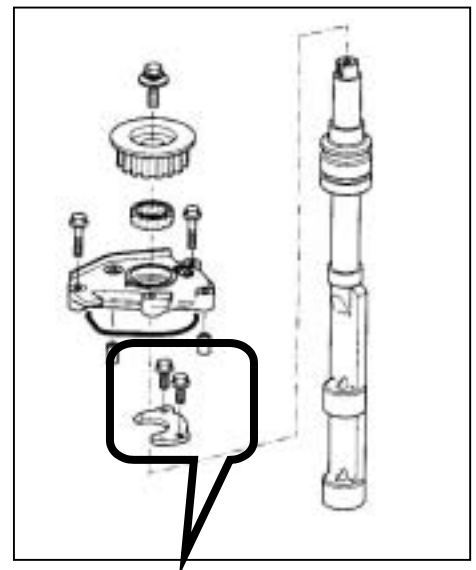
Oil may leak from the balancer shaft on the exhaust side of the cover.

Parts maybe missing.

Replace parts as per list.

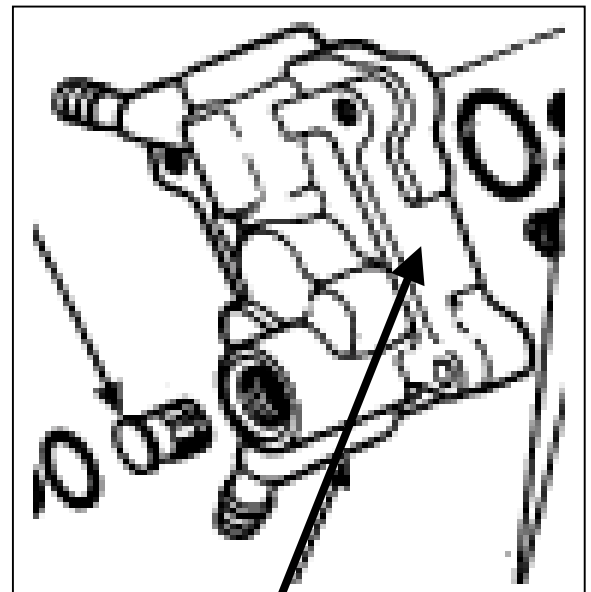
Z mark

Aeration of the fuel is caused by cracks in the diaphragm. The aeration then enters into the fuel pump, which causes a vapor lock.

Fit new fuel pump and cam shaft assembly.  
(use service manual for installation instructions)  
The letter Z is marked on the new style fuel pump.

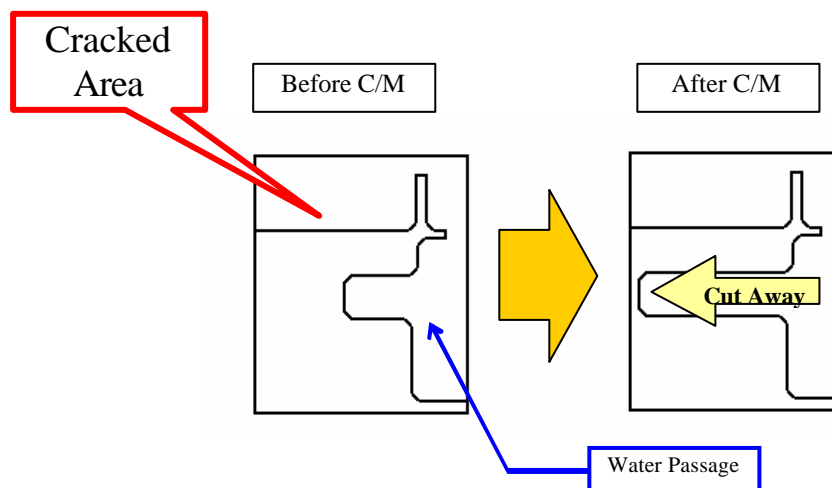
## Illustration

Due to internal stress from the rapid swelling of the exhaust port during acceleration small cracks may occur in the coolant water passage behind the exhaust port.

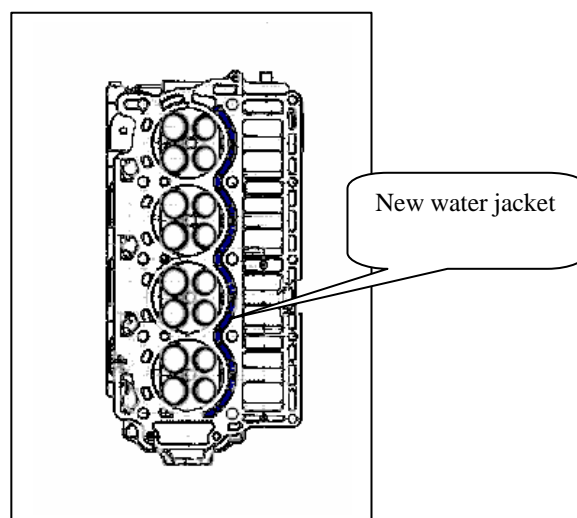
After C/M

Engine idle is unstable and water can be found in the combustion chamber.

A crack develops between the number 2 and number 3 cylinders allowing water to enter into the combustion chamber.

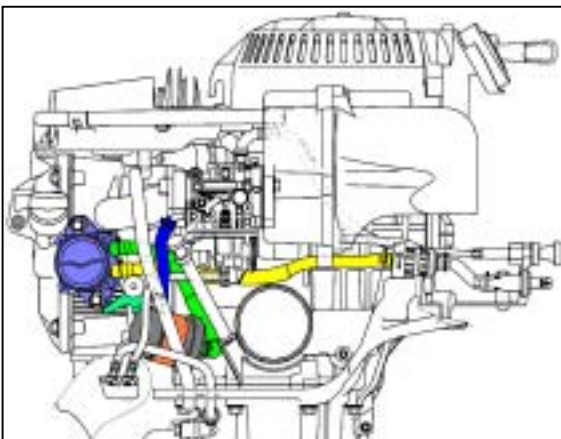
**Before replacement**

Due to vaporized petrol in the fuel pump, the internal pressure of the fuel pump can rise, allowing liquid petrol in the fuel chamber to flow into the carburetor. The petrol that flows into the carburetor can then leak out of the carburetor through the main nozzle.

1. The installation direction of the fuel pump has been changed 180 degrees to prevent fuel from flowing out even if it vaporizes.
2. The installation direction of the fuel chamber has been changed so that the liquid fuel will not drain into the carburetor, but let fuel vapor flow into the chamber.
3. As the installation direction of the two above components have been changed, the length and shape of the fuel hoses have also been changed.
4. If required order the special kit using the form on page 2.

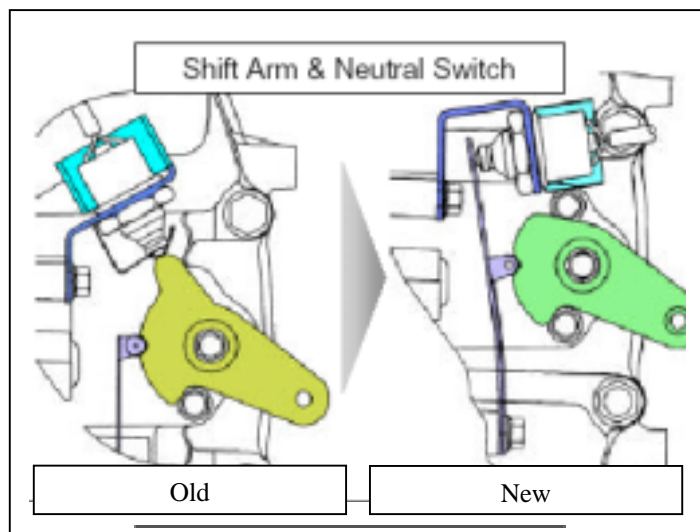
1. The operation generally requires plenty of force.
2. The operator cannot feel the neutral position easily.
3. When the gear position is changed from "Forward" to "Neutral" or from "Reverse" to "Neutral" the gear shift becomes difficult.

1. As the neutral switch plate may not be in the correct position, the neutral point is not found easily.
2. The control cables have too much lost motion and friction.
3. Some propellers can keep the dog clutch engaged firmly when the gear is shifted to the "neutral" position, because the propeller shaft speed synchronizes with the engine speed. This requires greater disengaging load.

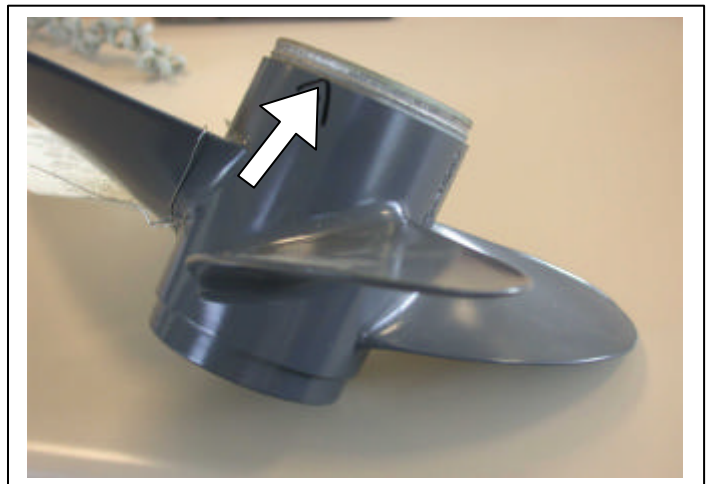
The customer may notice the propeller ring is damaged after only a few hours of use.

Propeller bush not pressed correctly causing propeller ring to fall off.

Replace the propeller.
