# SHOP MANUAL

## GUIDANCE FOR REUSABLE PARTS

# ENGINE

CYLINDER LINERS, PISTONS  
AND PISTON RINGS

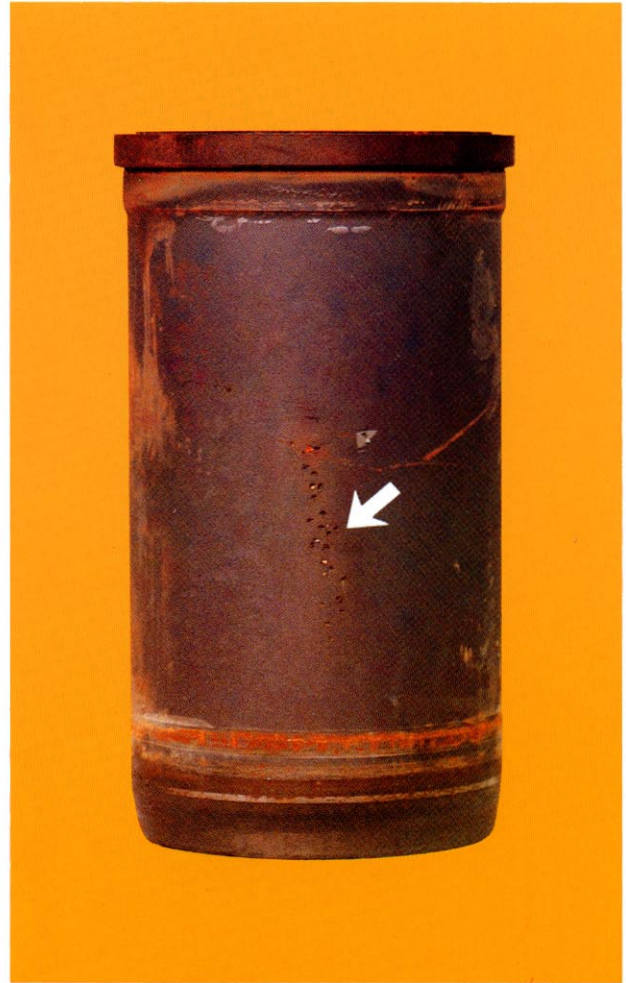
**USE AGAIN**

- Pitting caused by cavitation erosion is seen in the middle part of the cylinder liner, but damage is slight.

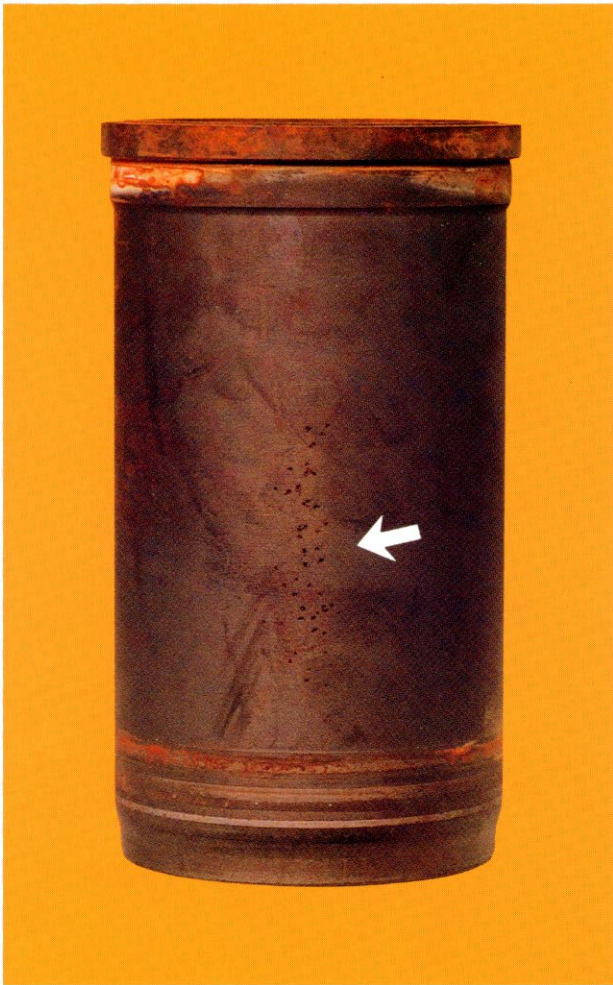
**USE AGAIN**

- Pitting is observed on the middle part of the cylinder liner's outside surface, however the damage is light since the depth of the pits is less than 30% of the wall's thickness.

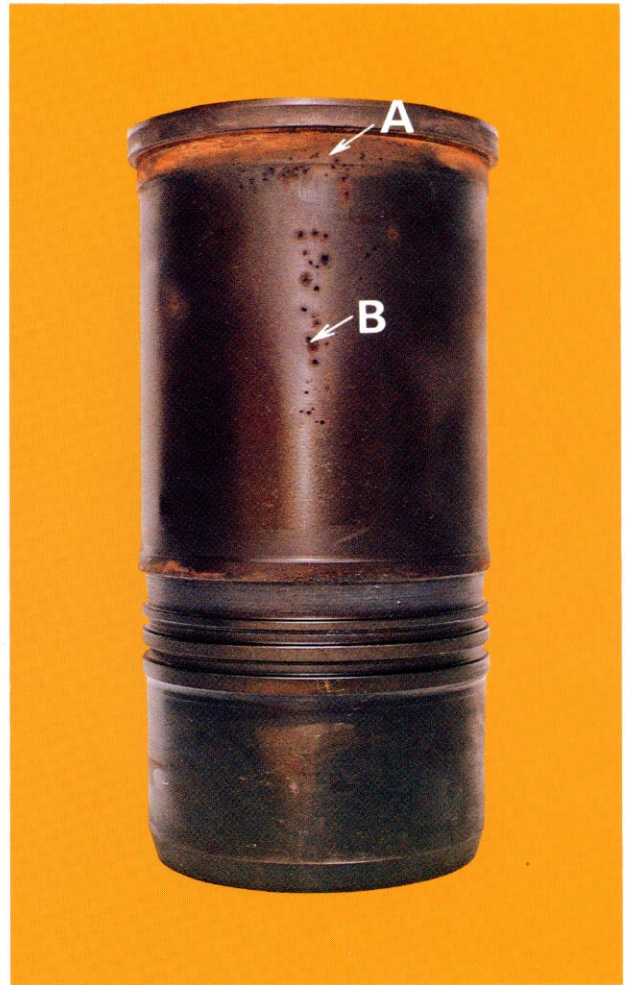
**USE AGAIN**

- Pitting is observed on the top (A) and middle (B) portion of the cylinder liner, however the pits are all only slight.

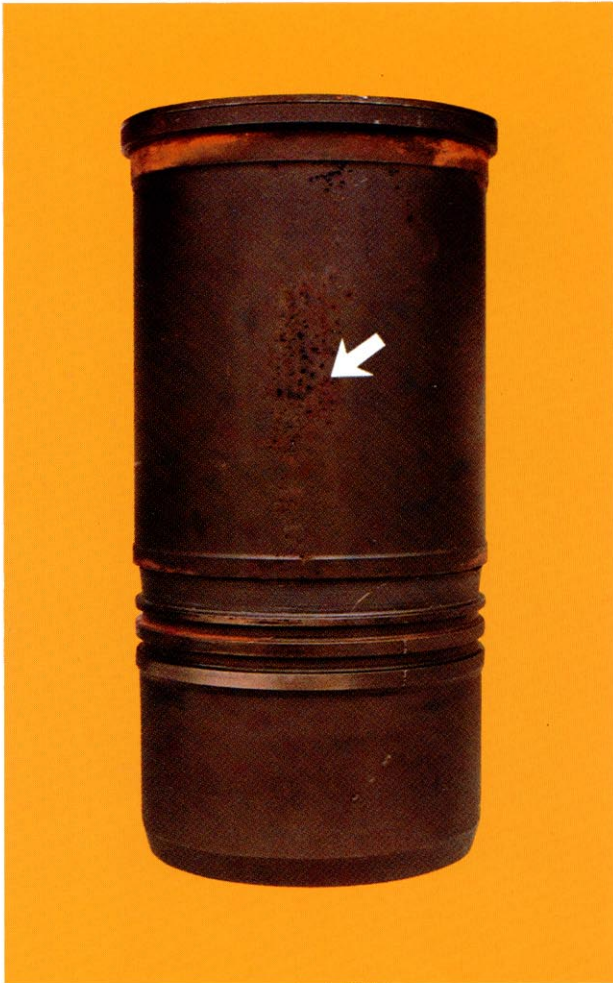
**USE AFTER RECONDITIONING**

- Quantity of cooling water is insufficient.
- Maintenance of corrosion resistor is improper.

- Refill pits with chemical agent.
- Rotate cylinder liner by 90° and install it again.

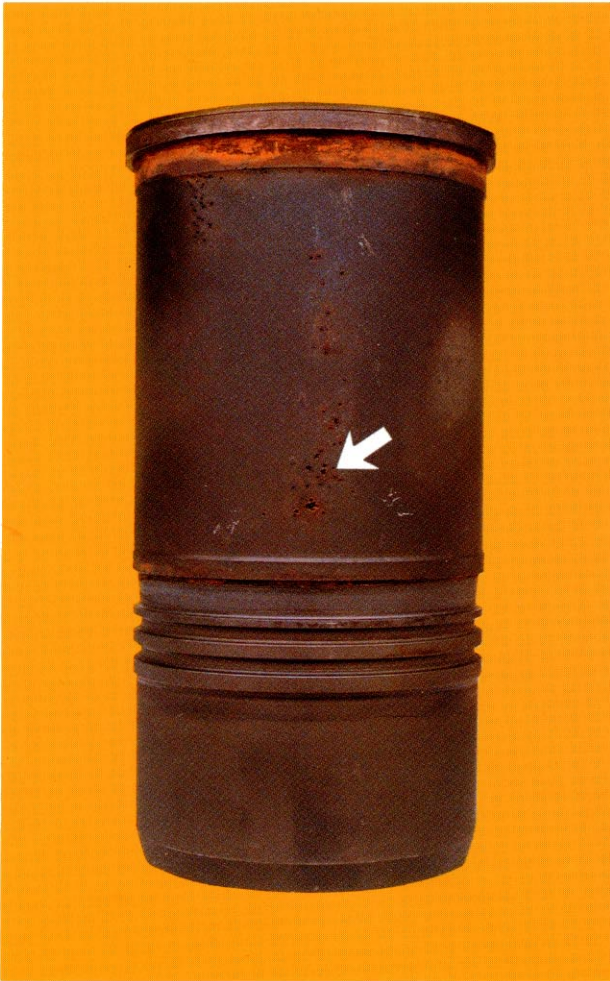
**USE AFTER RECONDITIONING**

- Pitting in middle part caused mainly by cavitation erosion.
- Depth of the pits reach 30% of the wall thickness.

- Quantity of cooling water is insufficient.
- Maintenance of corrosion resistor is improper.

- Refill pits with chemical agent.
- Rotate cylinder liner by 90° and install it again.

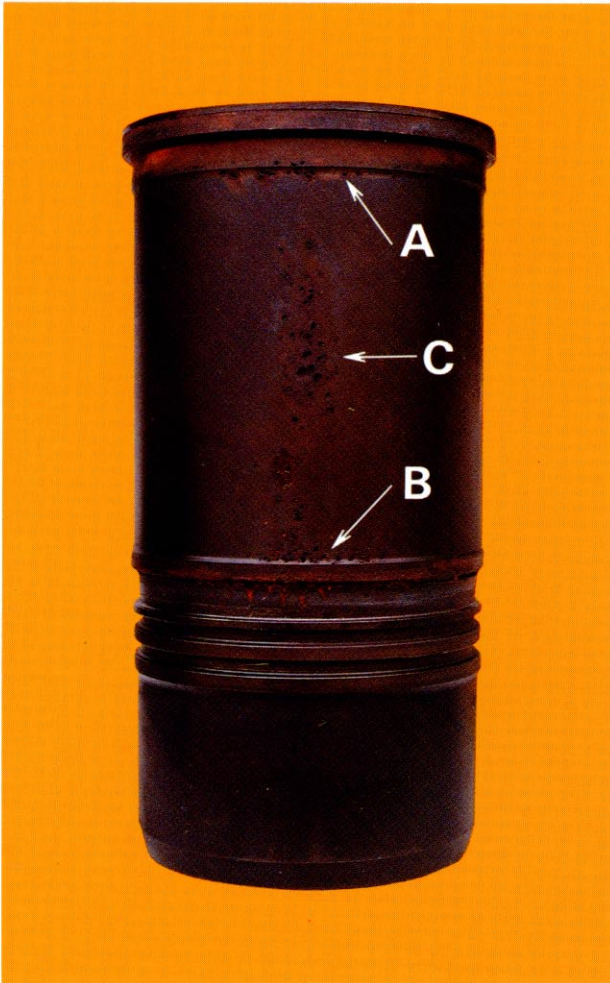
**DO NOT USE AGAIN**

- Corrosion in the upper (A) and lower part (B) of cylinder liner.
- Cavitation erosion of the middle part (C) is the main cause, and fairly large pits can be seen.
- Corrosion at the seal groove exceeds 20% of the groove width.

- Quality of the cooling water is not suitable.
- Quantity of cooling water is insufficient.
- Maintenance of corrosion resistor is improper.

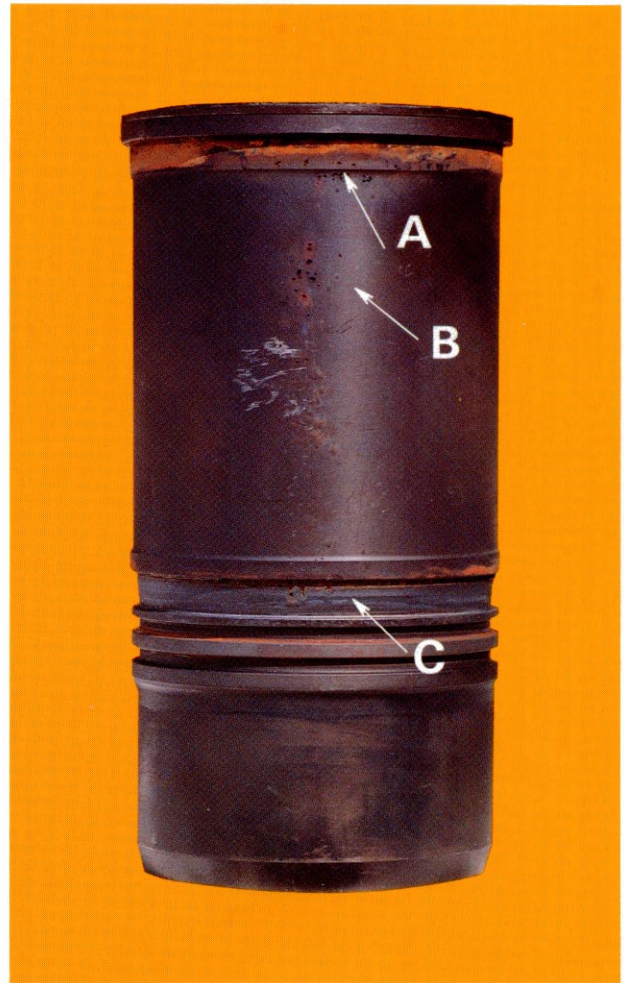
**DO NOT USE AGAIN**

- Corrosion can be seen in the upper (A), and middle part (B) of the cylinder liner and in the crevice seal groove (C).
- Deep pits can be seen, in particular, in the crevice seal groove.

- Quality of the cooling water is not suitable.
- Maintenance of corrosion resistor is improper.
- Maintenance of anti-freeze is improper.

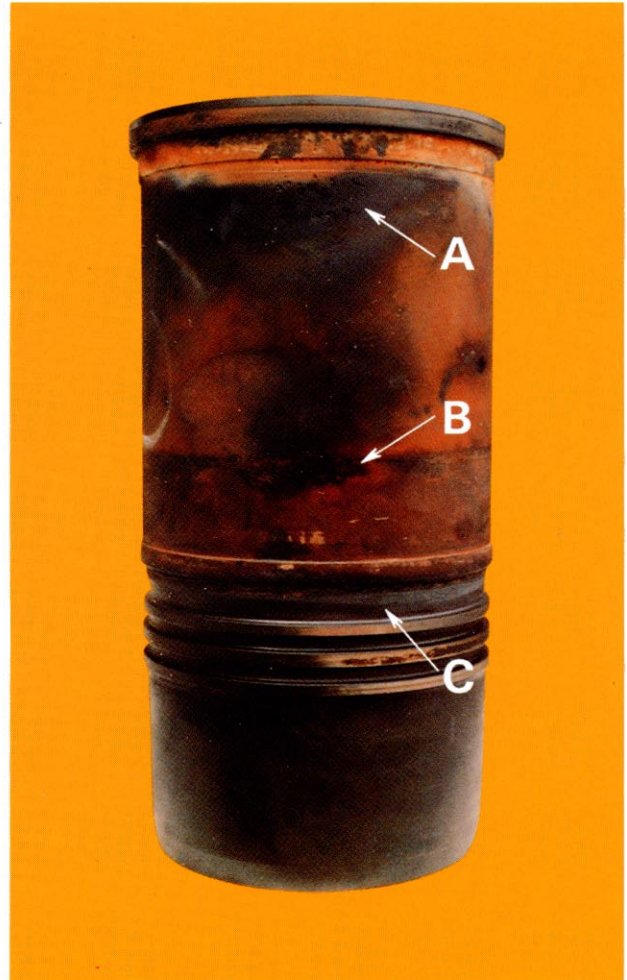
**DO NOT USE AGAIN**

**Causes**

- Quality of cooling water is not suitable.
- Maintenance of corrosion resistor is improper.
- Maintenance of anti-freeze is improper.

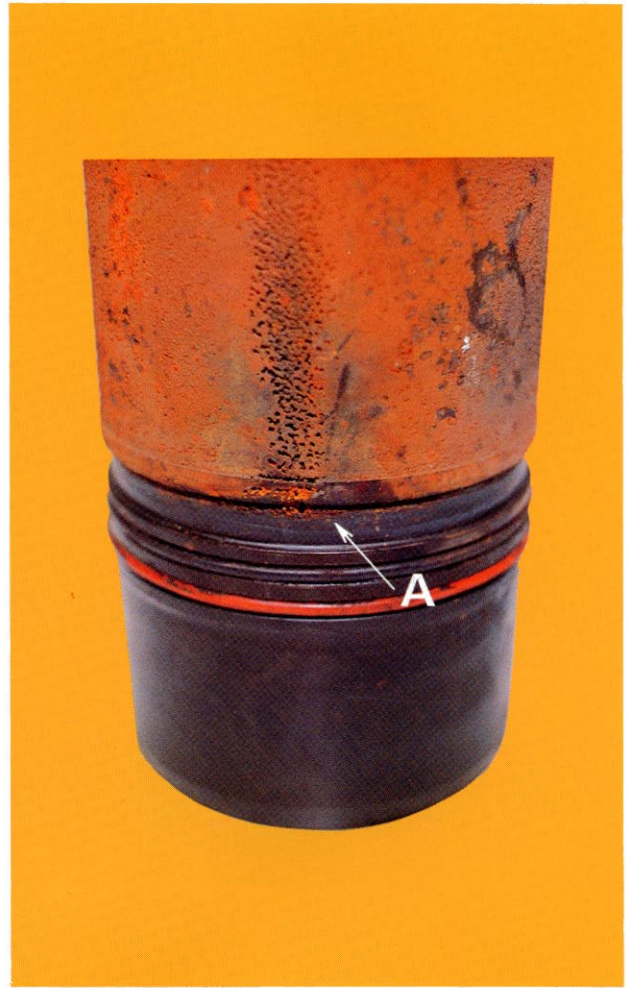
**DO NOT USE AGAIN**

- Numerous, relatively small pits can be seen, and because rust development is considerable, the cause can be attributed to the combined effect of both corrosion and erosion.
- Corrosion can be seen, and deep corrosion in particular in the grooved part (A).

- Quality of cooling water is not suitable.
- Quantity of cooling water is insufficient.
- Maintenance of corrosion resistor is improper.
- Maintenance of anti-freeze is improper.

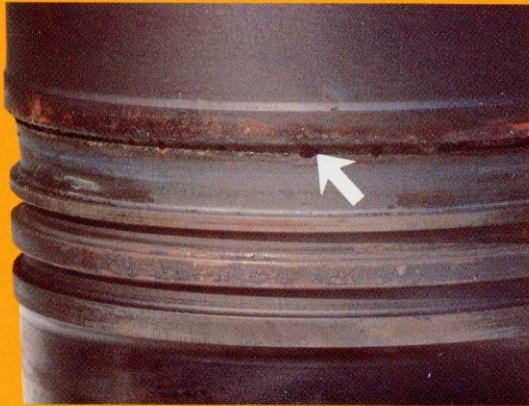
**DO NOT USE AGAIN**

**Causes**

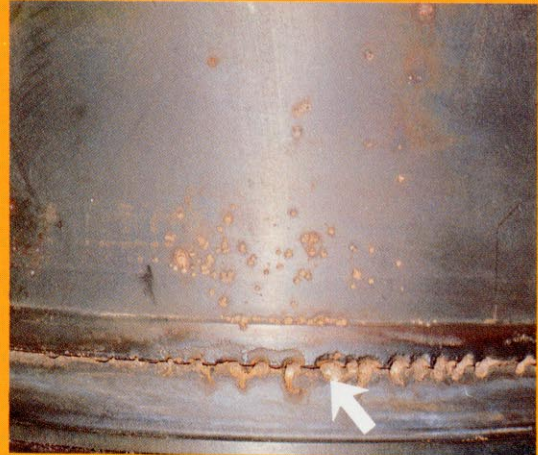
**DO NOT USE AGAIN**

**Causes**

- Quality of cooling water is not suitable.
- Maintenance of corrosion resistor is improper.

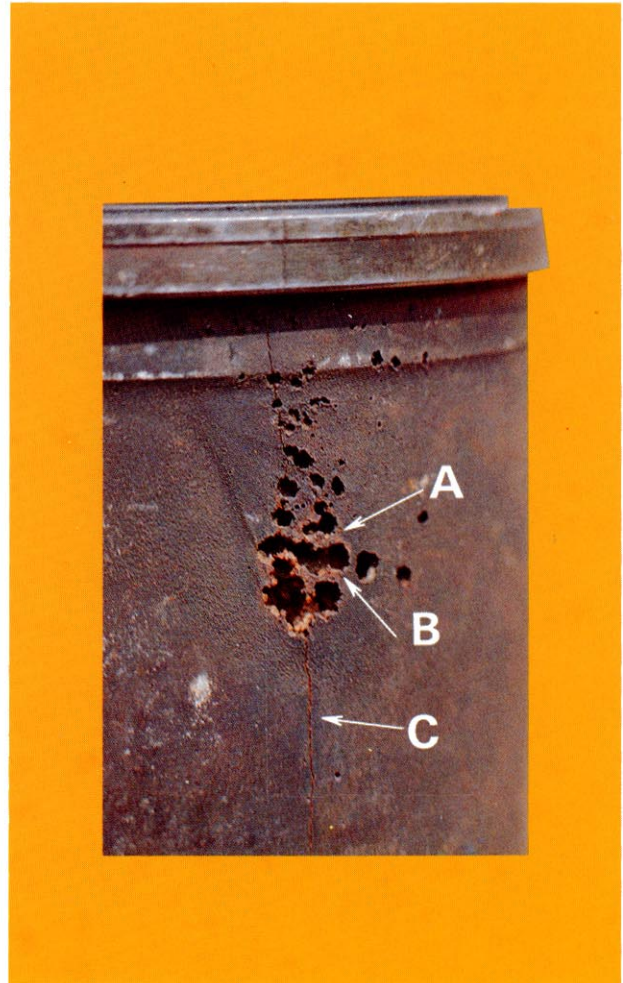
**DO NOT USE AGAIN**

- The pits are relatively large (A) and are caused mainly by cavitation erosion.
- The red coloring (B) around the pits' walls is caused by copper precipitated from the copper ions dissolved in the cooling water, this phenomenon speeds up eroding of the cylinder liner material.
- Cracks (C) have developed because of the deep pitting.

- Quality of cooling water is not suitable.
- Maintenance of corrosion resistor is improper.
- Maintenance of anti-freeze is improper.

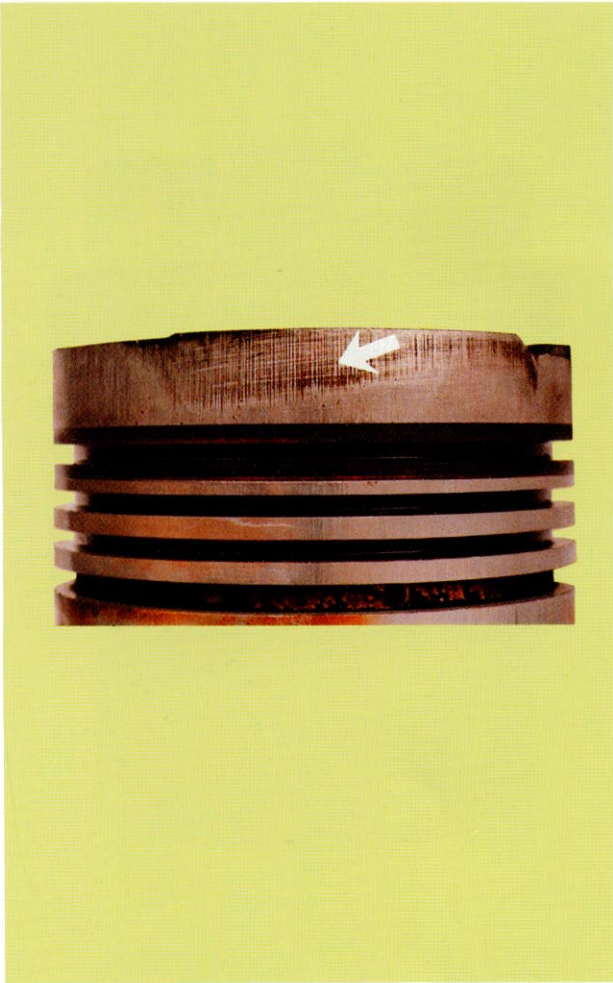
### USE AFTER RECONDITIONING

- Scratches on the piston top ring land area caused by carbon sticking to the top part of the cylinder liner.

- Presumably due to long hours of running under high-load condition.

- Refinish the piston with a fine oil-stone and reassemble.

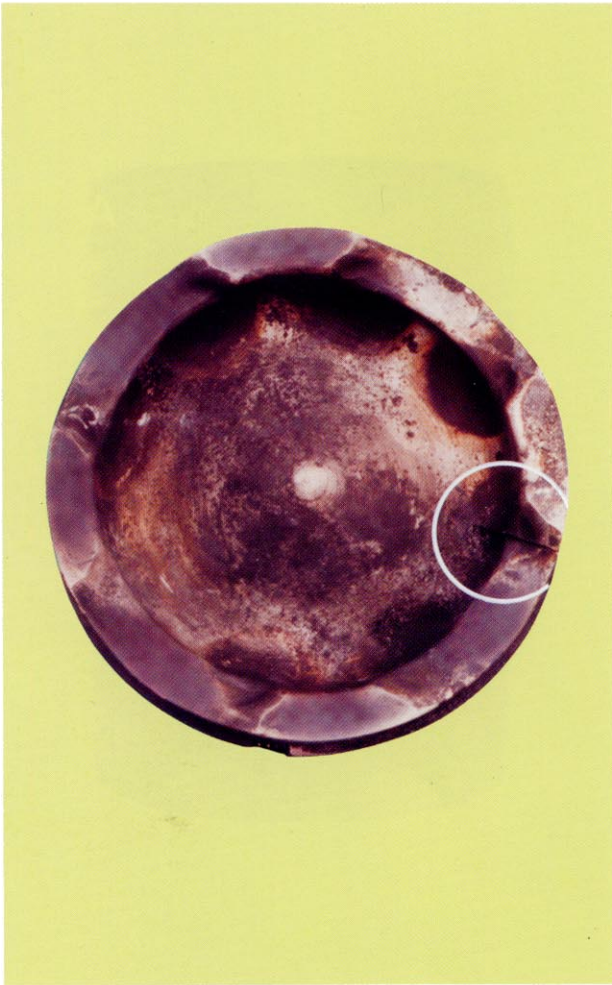
**DO NOT USE AGAIN**

- Cracks have developed in the rim area of the piston top.

- Overfueling.
- Incorrect fuel injection timing.
- Clogged piston cooling nozzle.

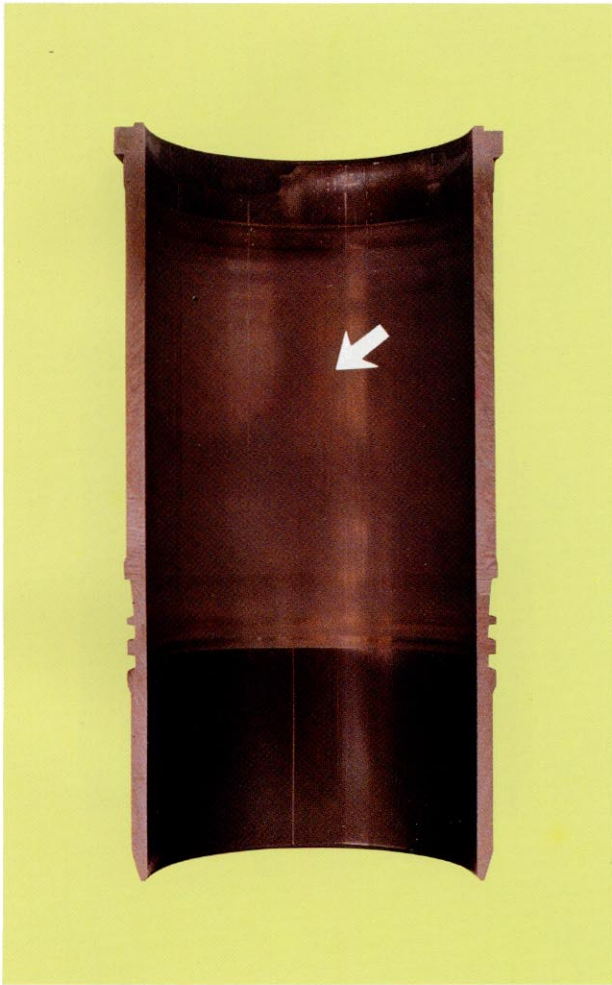
**USE AGAIN**

- Very slight lengthwise scratches can be seen on the inner surface of the cylinder liner, however, the cross-hatch finishing marks still remain over the entire inner surface, and its condition is generally good.

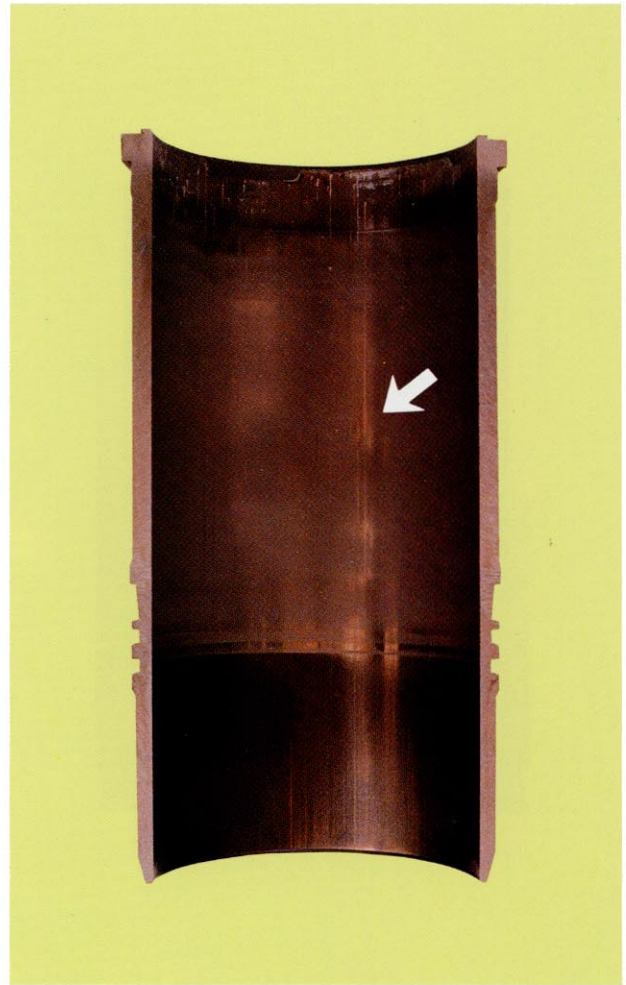
**USE AFTER RECONDITIONING**

**Failure Signs**

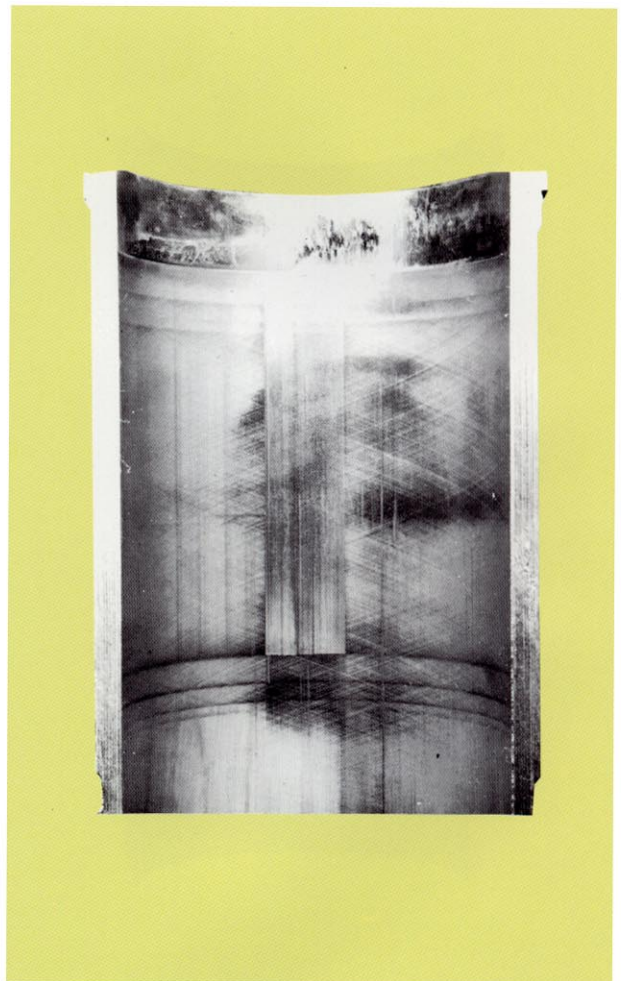
### DO NOT USE AGAIN

#### Failure Signs

- The longitudinal scratches in the cylinder liner's inner surface have deepened and spread to erase the cross-hatch marks.

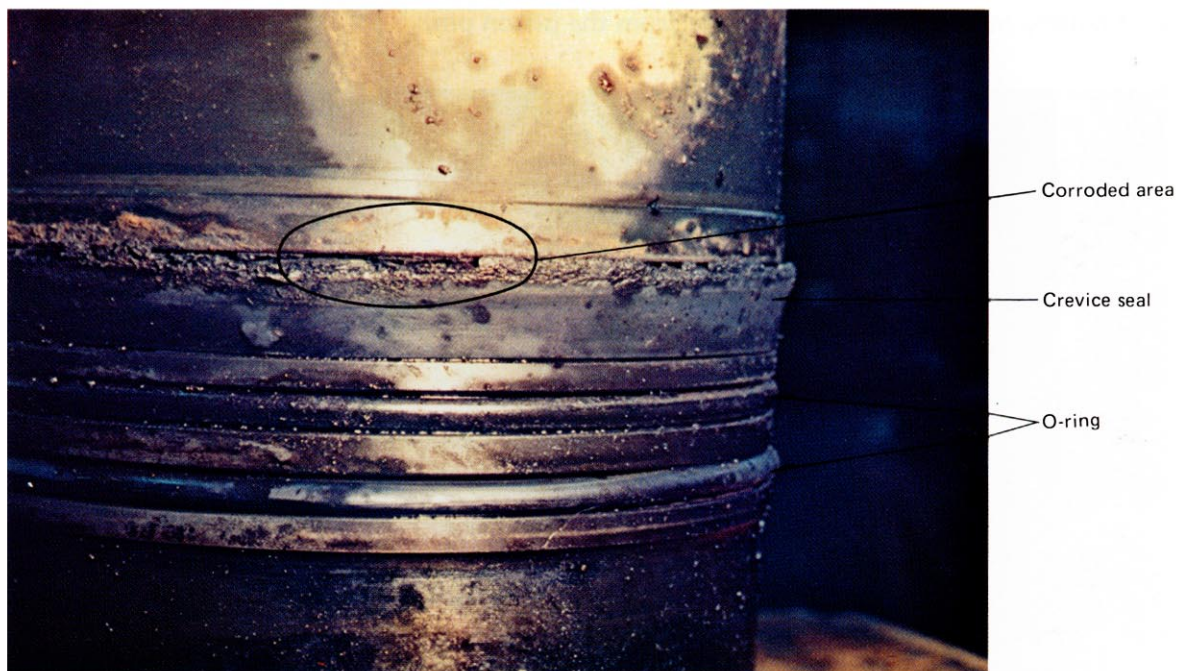
More specifically, the erosion develops where flow of the cooling water is retarded, as circular or streaked corrosion areas, mainly at the lower part of the cylinder liner or the cylinder liner seal parts.

Sludge produced by the erosion, scum, water fur, etc. tend to retard the water flow and this in turn accelerates the cavitation erosion.

- Abnormal vibration of the cylinder liner.
- Use of unsuitable cooling water.
- Mixing of air (aeration) due to insufficient cooling water.
- Ineffective corrosion resistor.

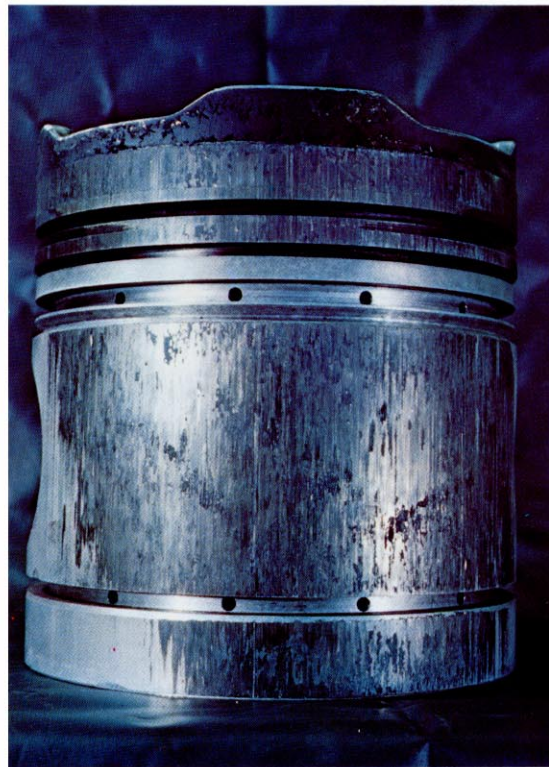
The piston is in direct contact with the combustion gases and expands with the heat produced, but contracts when it is cooled by the engine oil, through the piston rings. When running, the piston continuously expands and contracts, so that if the clearance between the piston and the cylinder liner is too large or small, the oil film will be destroyed and the piston will make metal-to-metal contact with the cylinder liner, thereby producing seizure and scuffing. Symptoms appear as lengthwise seizure streaks in a part of the piston, particularly in the areas at right angles from the piston pin.

### Causes

- Excessive expansion of the piston due to overheating.
- Sudden running under heavy load conditions and abrupt stopping.
- Use of unsuitable engine oil.
- Engine oil is insufficient, and pressure is low.
- Abnormal rise in engine oil temperature.
- Improper piston clearance.
- Entry of dust and foreign matter through the air intake system.

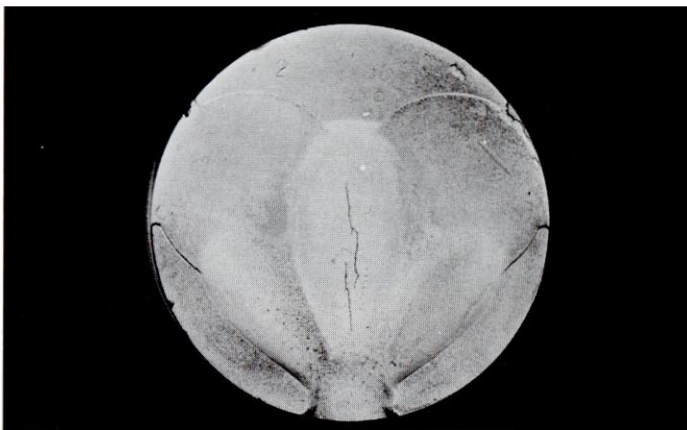
A crack developed in the radial direction from the combustion chamber's edge towards the piston body's periphery caused by the temperature difference in the radial direction.

Cracks developed as a result of the heat stresses and combustion pressure stresses caused by the temperature difference in the piston top in the thickness direction.

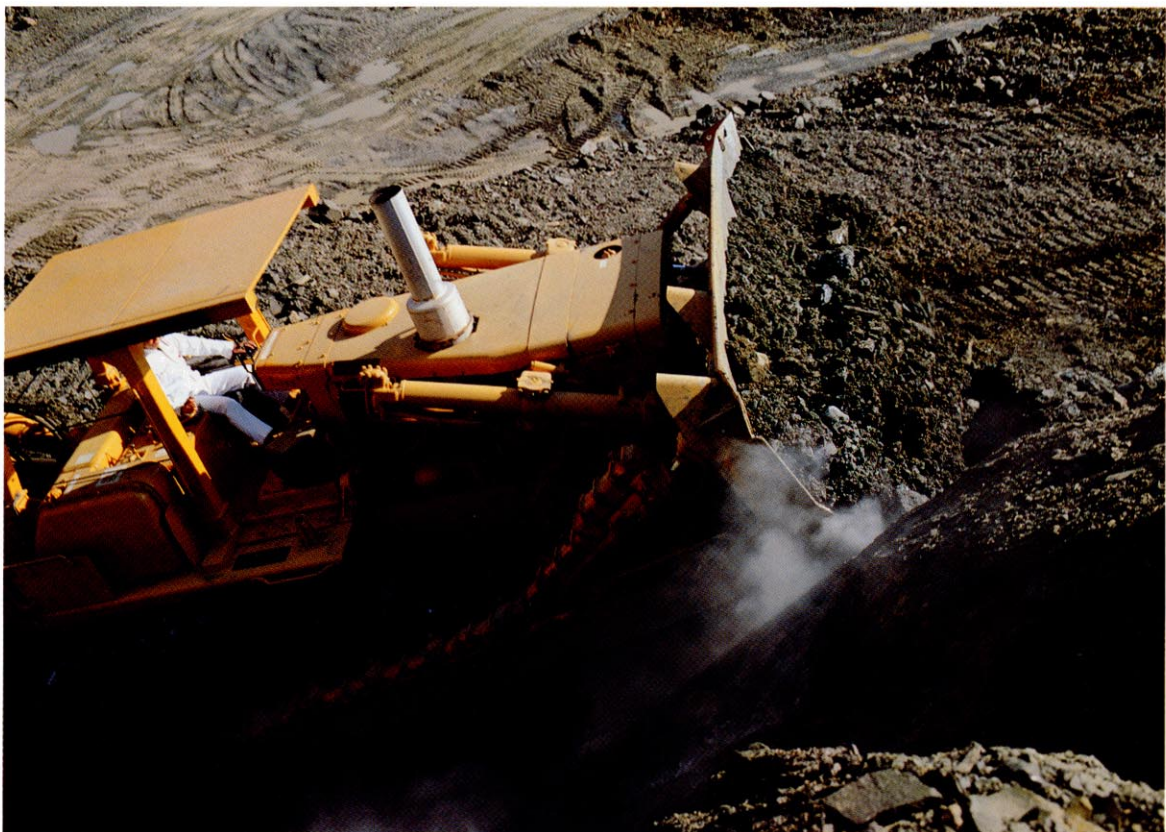
The below-listed measuring instruments are available for correct failure determination.

Measuring instruments	Part Number	Measuring items
Blow-by checker	790-201-1502	To measure blow-by
Hydraulic tester	790-301-1103	Hydraulic oil pressure
Thermistor kit	790-500-1300	Water and oil temperature
Engine oil checker	799-201-6000	Water and fuel oil mixed in engine oil
Water tester	799-202-7000	Quality of water used for cooling
Smoke tester	Available on the market	Color of exhaust gas
