SHOP MANUAL

GUIDANCE FOR REUSABLE PARTS

RUBBER HYDRAULIC HOSES

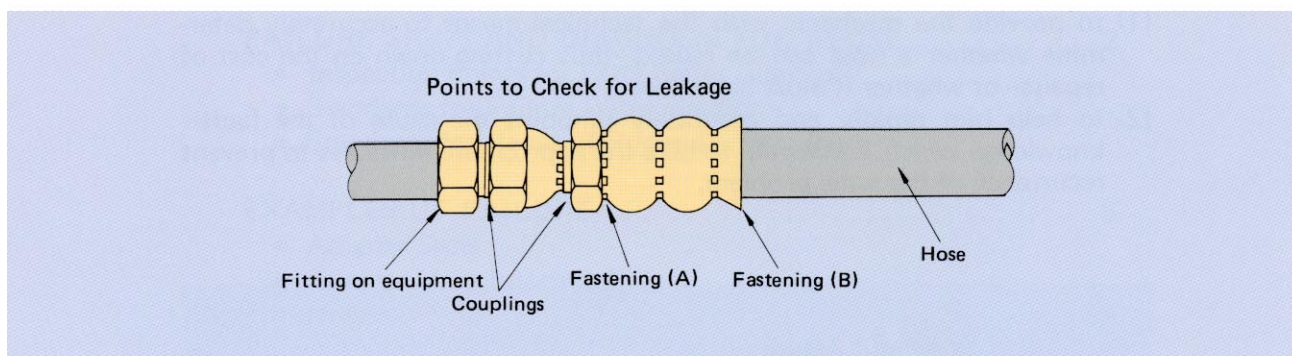
The first step in accurately judging whether or not to reuse a rubber hydraulic hose is to determine both the location and the extent of leakage. Pay special attention to the points in the accompanying diagram.

- * Better results are obtained if the hose is pressurized by running the engine for a while before the inspection.
- * Also check movement of the links.
 - 1) Is the hose under tension?
 - 2) Is the hose twisted?
 - 3) Is the hose crimped at any point?
 - 4) Is the hose crimped or under tension in the vicinity of the adapter?
 - 5) Does the hose come into contact with another hose, piping, or the frame? Is it likely to do so?
 - 6) Is the hose in a position where it can be constricted or compressed?
 - 7) Is the hose or adapter subject to external forces?
 - 8) Does the machine operate normally?
 - 9) Is the hydraulic fluid at a suitable temperature?
 - 10) Is the line pressure normal?

- 1) Is there a bend, twisting tendency, or flattened portion in the hose?
- 2) Are there any cuts, wear spots, or dents in the hose?
- 3) Is any part of the reinforcement layers exposed?
- 4) Is there any damage, dent, or deformation evident in the adapter?
- 5) Is there damage or uneven wear on the adapter's internal seat faces?
- 6) Is the adapter deformed? Are its threads intact?
- 7) Are the O-rings and their grooves free of damage?
- 8) Is any dirt or other foreign matter wedged into the mating parts?

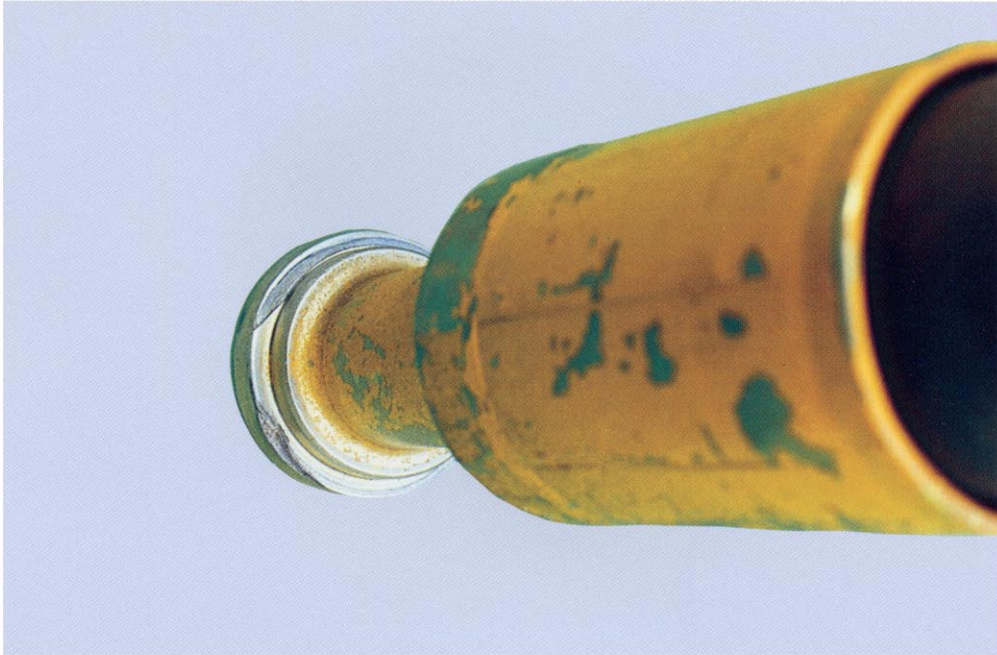
1

DO NOT USE AGAIN

- Crushing or deformation on rear surface of flange.

- Faulty alignment during installation has produced uneven tightening.

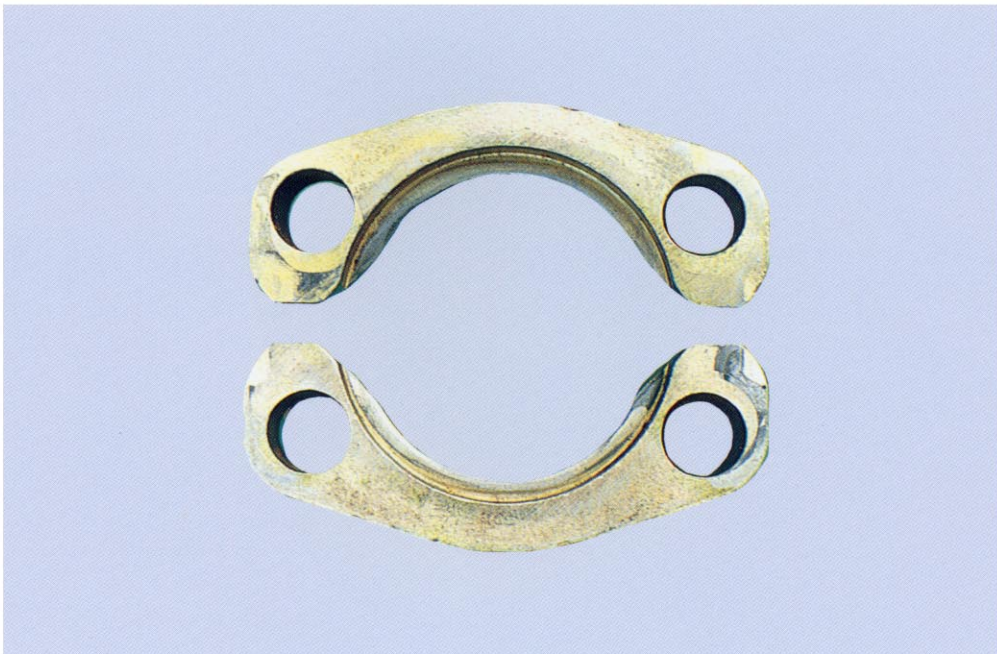
2

DO NOT USE AGAIN

- Split flange crushed.

- Faulty alignment during installation has produced uneven tightening. Note that the O-ring has also been damaged so must be replaced.

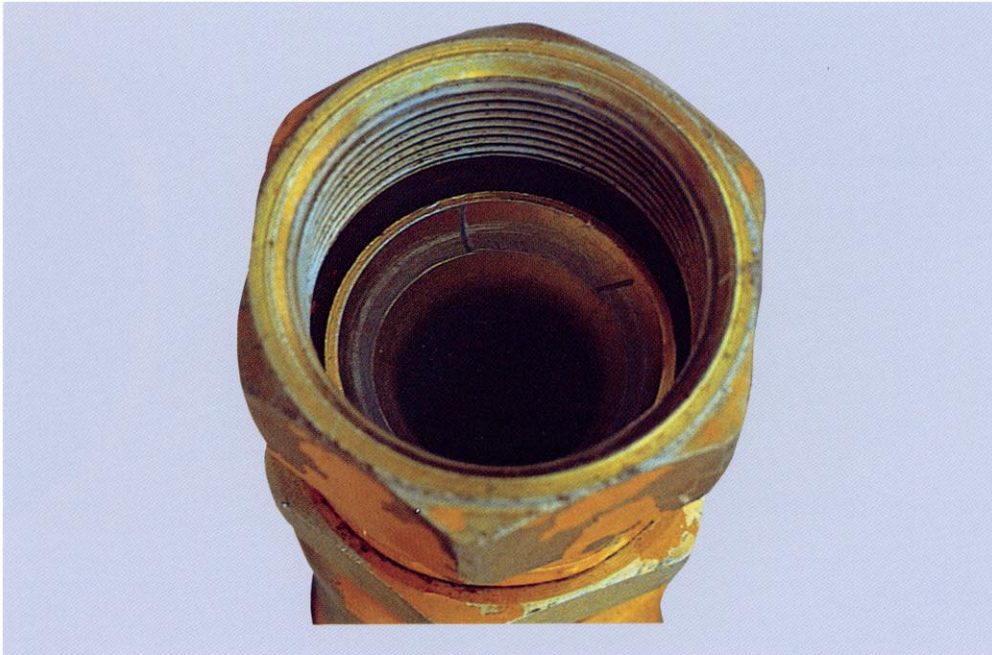
3

DO NOT USE AGAIN

(Unless longitudinal marks are confined to an extremely limited area)

- Longitudinal marks extend over almost the entire length.

- Foreign matter wedged inside.

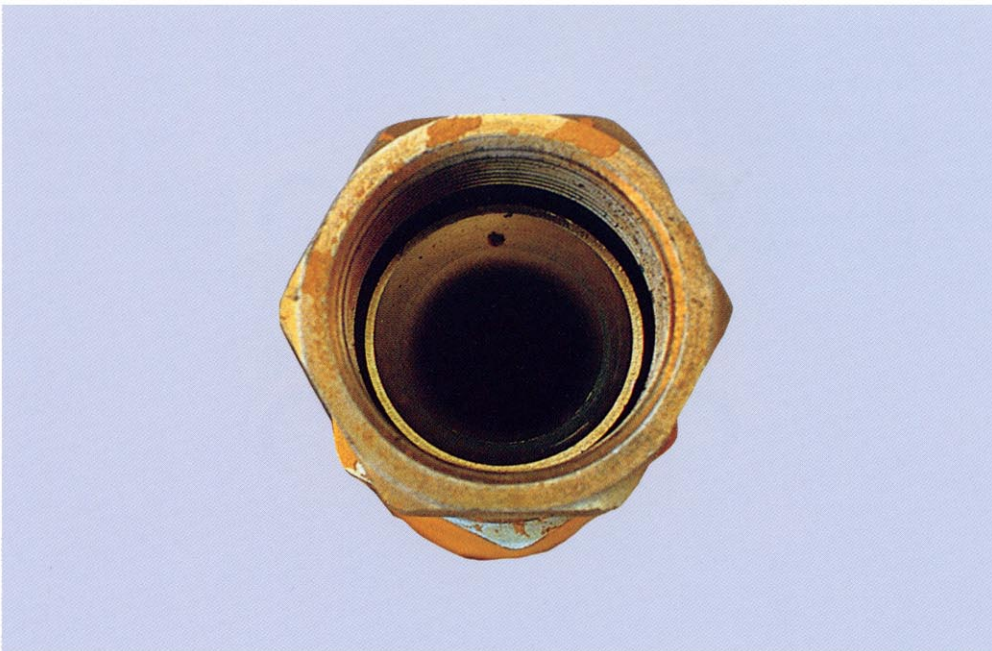
4

USE AGAIN

(but remove foreign matter)

- Foreign matter adhering to seat surfaces, contact of the seat is not strong enough.
- Foreign matter wedged inside.

If there is leakage from an adapter seal, disconnect the hose, wipe all hydraulic fluid off the male and female mating parts and the seat, and reconnect the hose with the specified tightening torque. Except in extreme cases (large or deep marks), this procedure should stop the leakage.

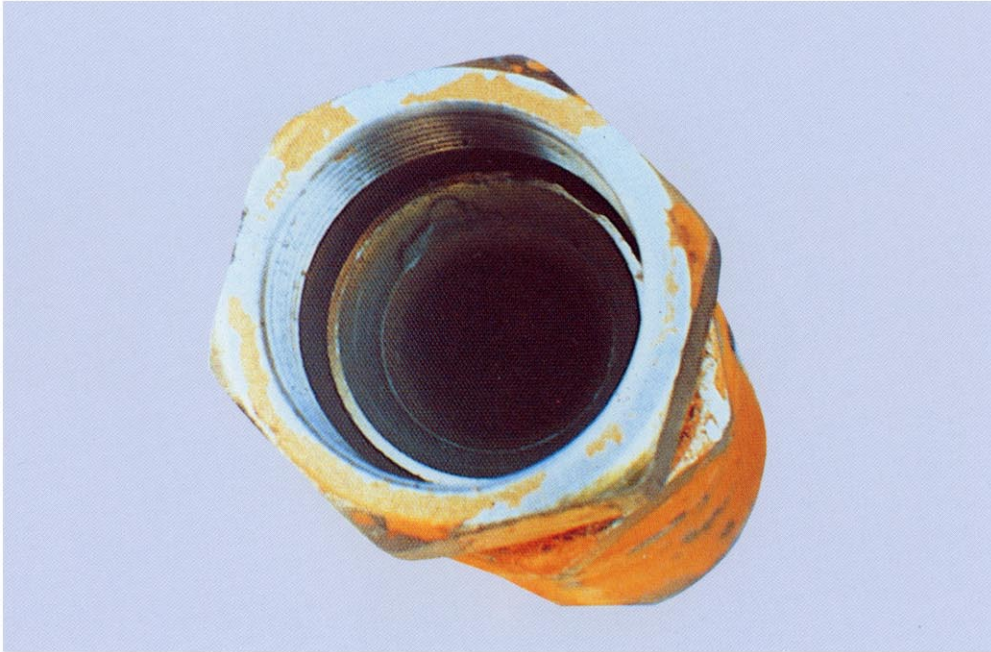
5

DO NOT USE AGAIN

(unless the damage is confined to an extremely limited area of the seat)

- Sludge and scratch marks on seat surface.

- Abrasion by foreign matter.

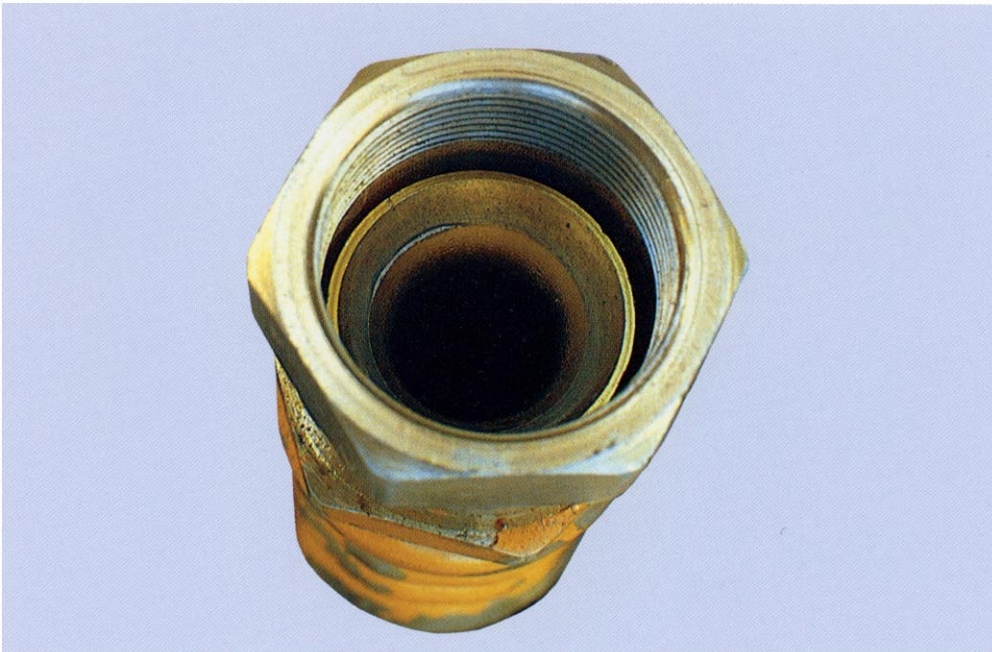
6

DO NOT USE AGAIN

- Large, deep scuffing marks around the circumference of the tip near the seat surface.

- Abnormalities in the shape (for example, dents) of the matching nipple.

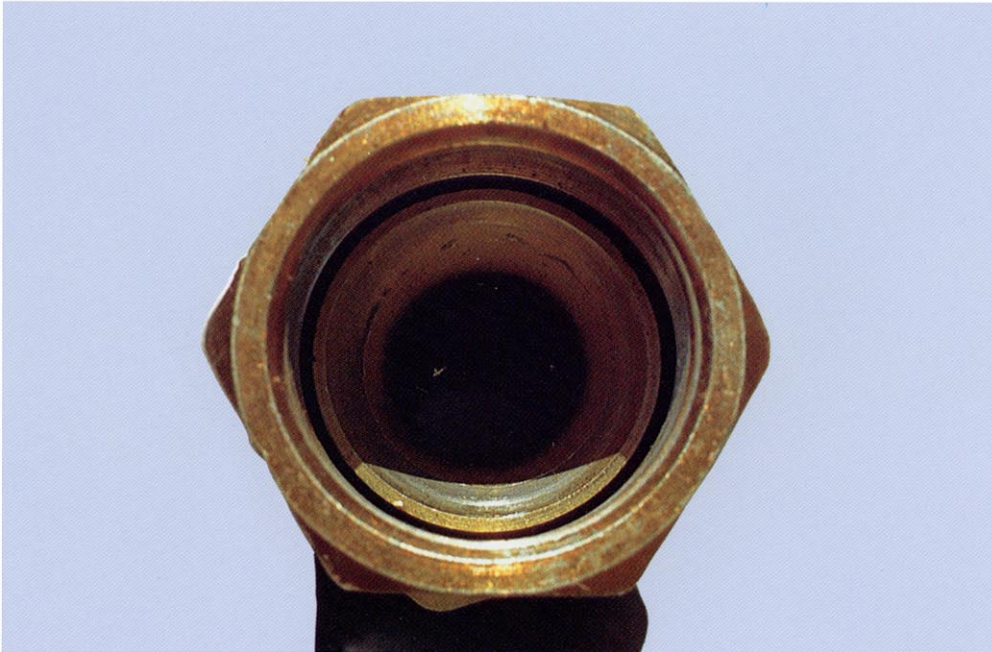
7

USE AGAIN

- Slight scuffing marks around the circumference of the tip near the seat surface.

- Abnormalities in the shape (for example, dents or flash) or the matching nipple.

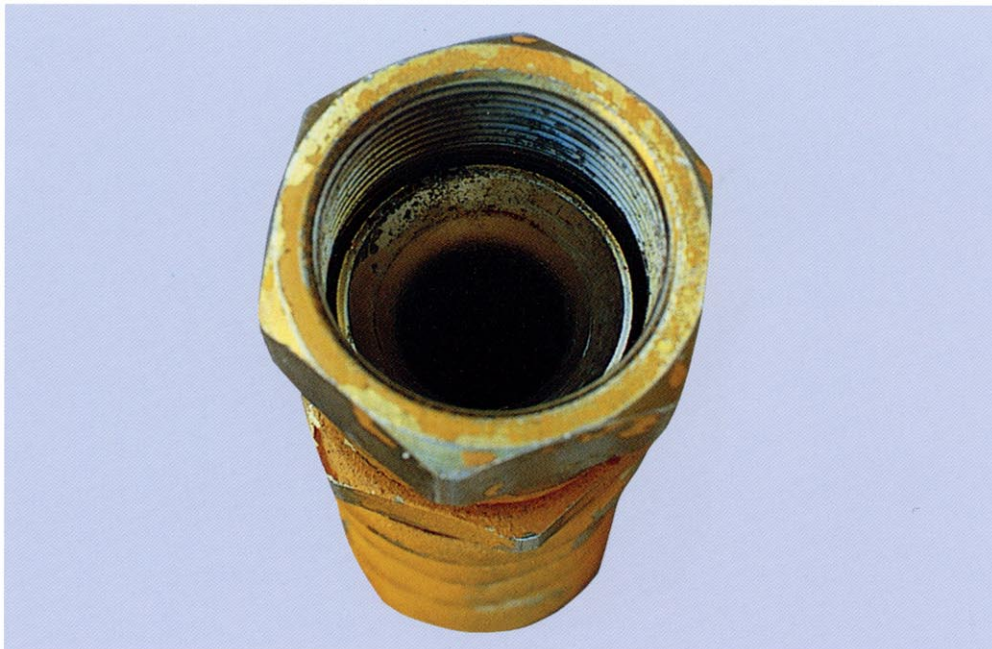
8

USE AGAIN

(but remove all rust from mating parts)

- Lots of rust on the contact surfaces, but only slight contact marks.

- Abnormality on the matching nipple (rust).

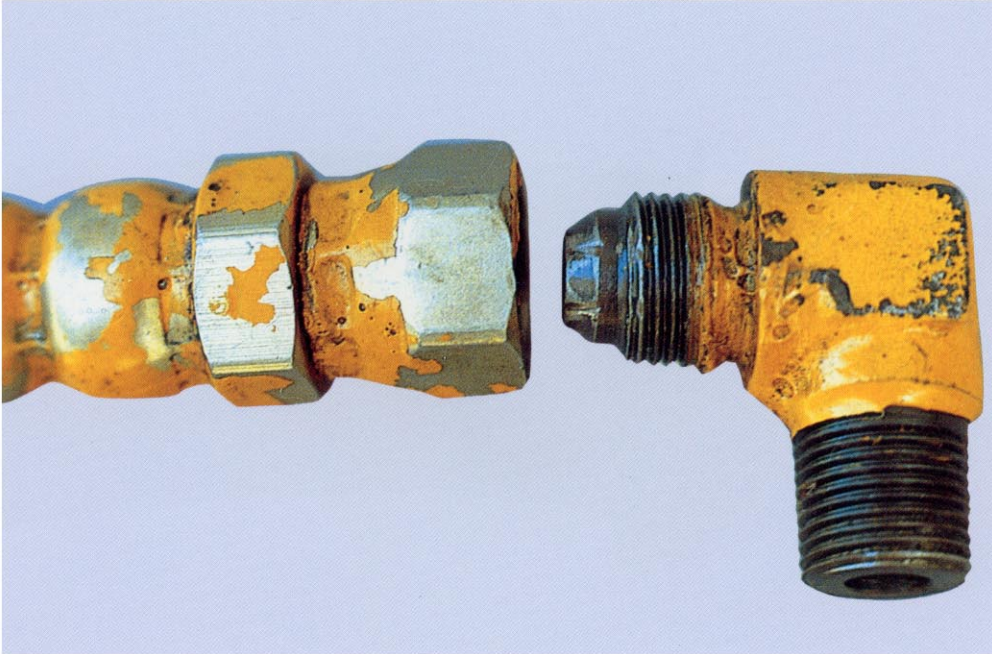
9

Example of dents on matching nipple and seat surface.

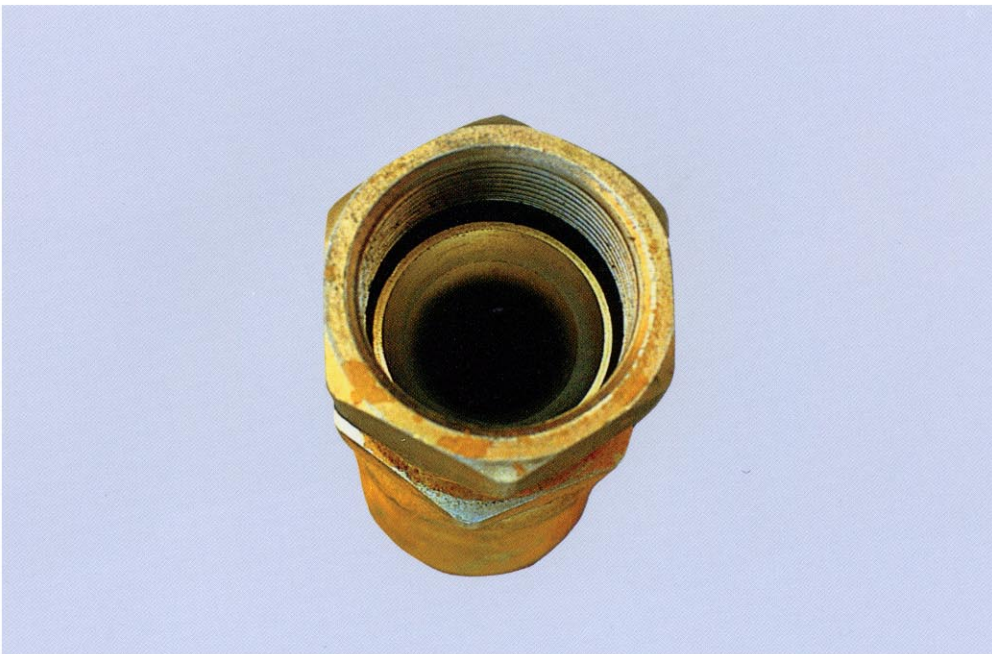
10

USE AGAIN

- Slight elliptical contact mark.

- Installation off-center.

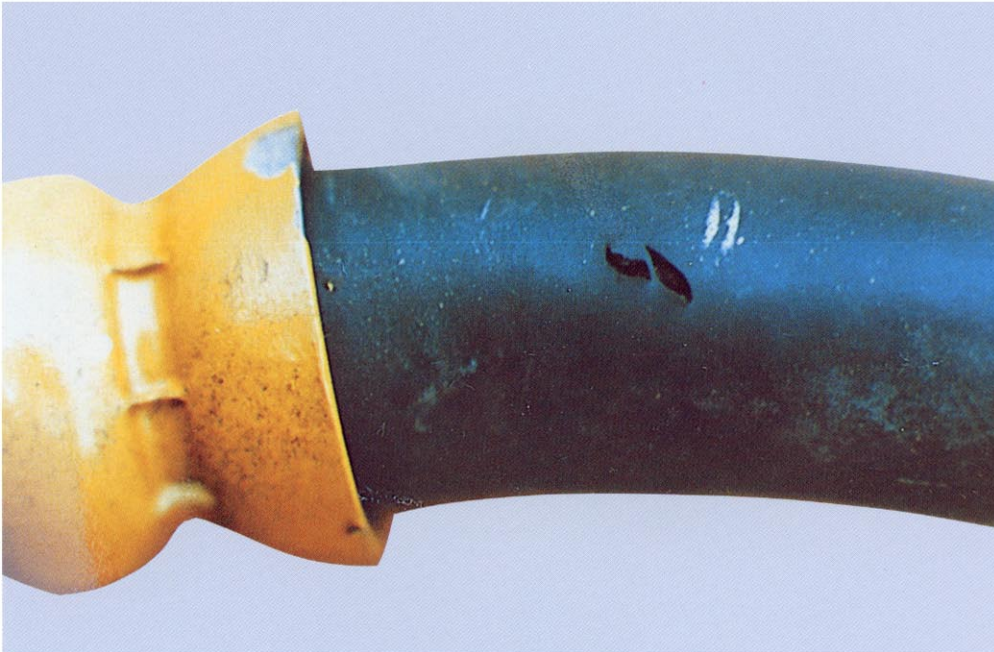
11

DO NOT USE AGAIN

- Collapsed hose or damaged rubber cover near fastening.

- Hose bent near fastening.

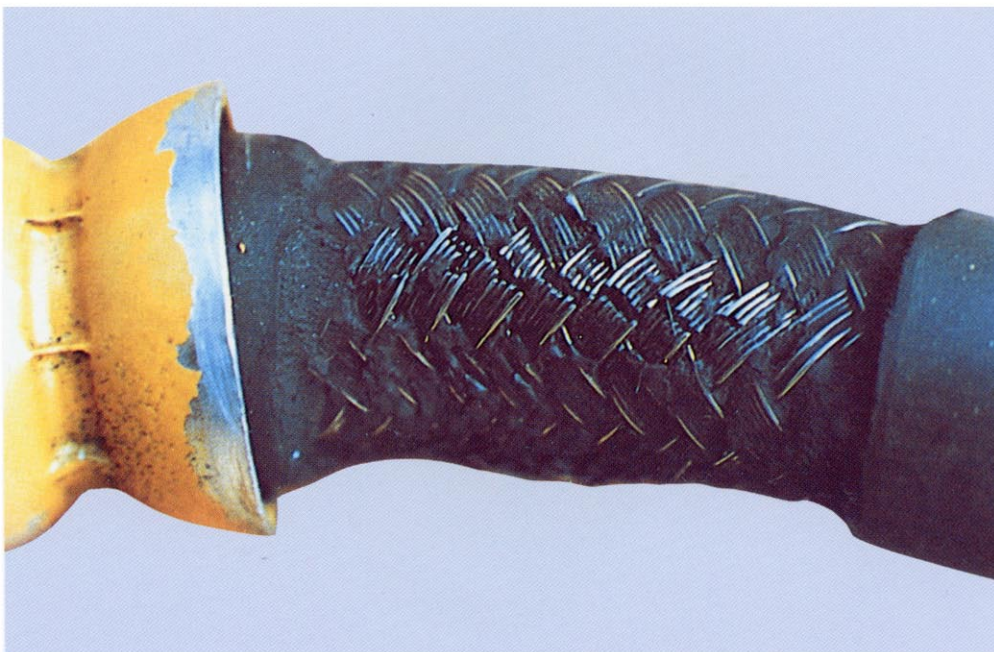
12

Disassembled view.

A crushed hose will, to a certain extent, revert to its original form so as not to be visible to the naked eye. Measure the diameter with calipers at several points around the circumference.

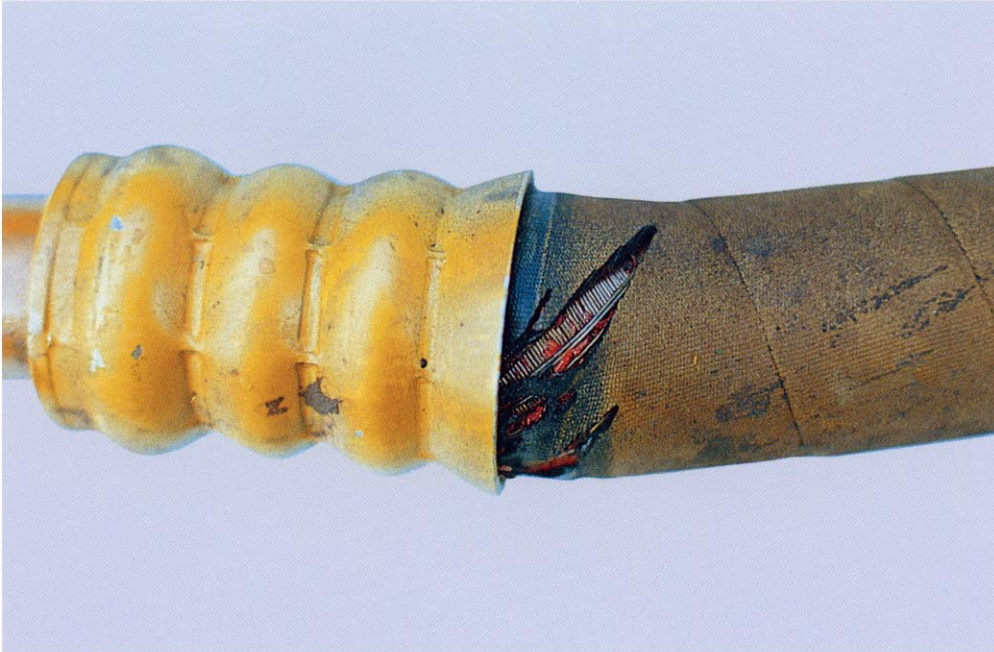
13

DO NOT USE AGAIN

- The adapter is bent at the tip so it is beginning to slip off.

- Hose was installed in twisted condition; sudden sharp increase in pressure while a wire rope is being used has produced crumpling.

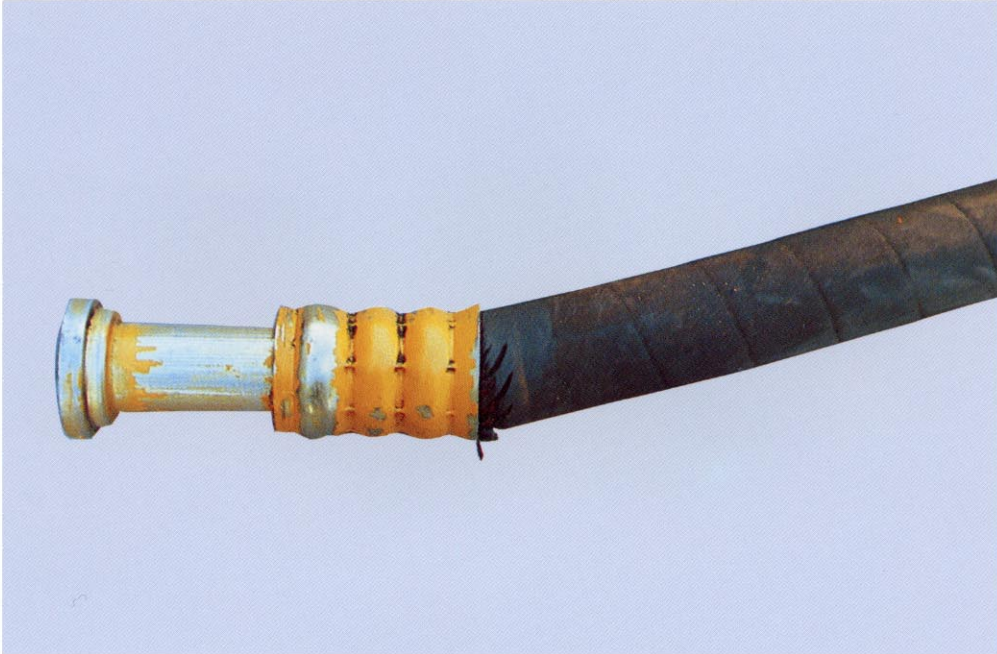
15

DO NOT USE AGAIN

- The adapter is slightly bent at the junction with the hose and the rubber cover is broken.

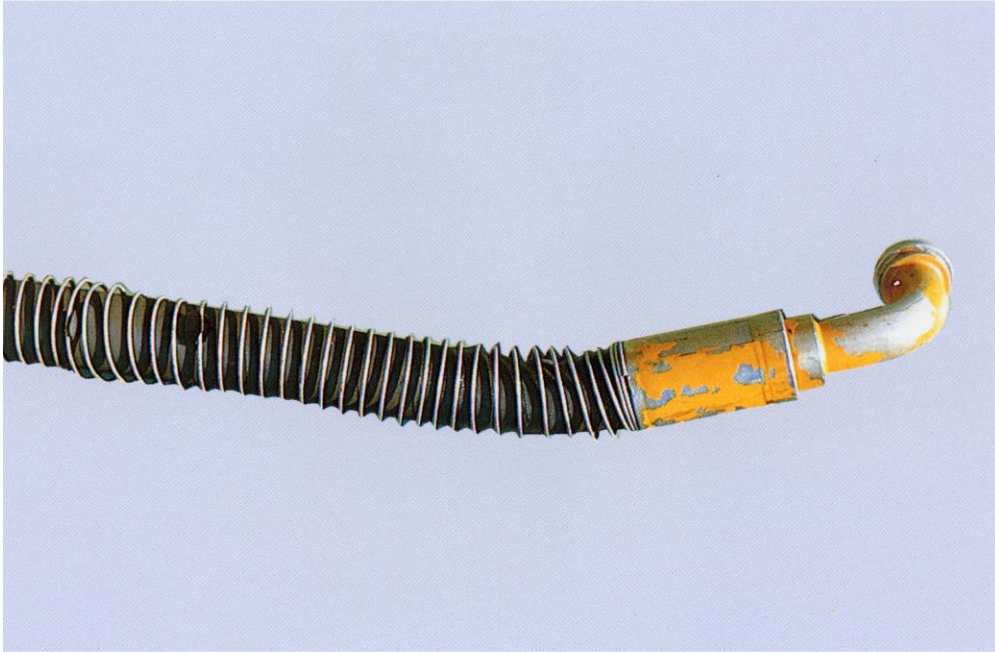
17

DO NOT USE AGAIN

- Protective spring crushed or deformed with the rubber cover broken.

- An external force has twisted and crushed the hose and disrupted the reinforcement wire layer.

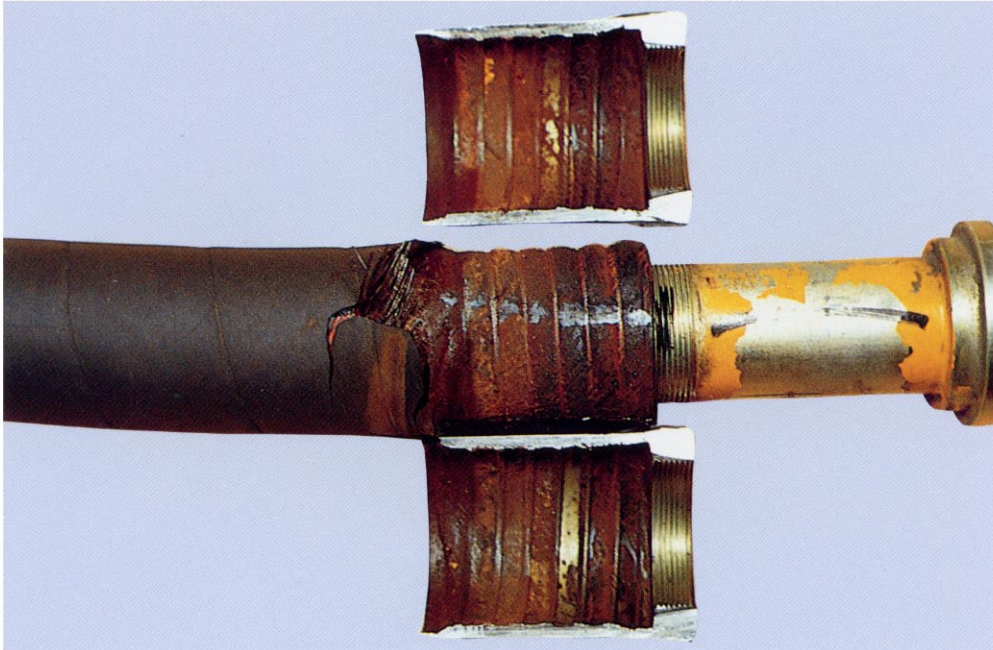
19

DO NOT USE AGAIN

- Hose broken at the fastening with reinforcing wires broken and sticking out.

- Rust in the reinforcing wires has led them to break under the pressure.

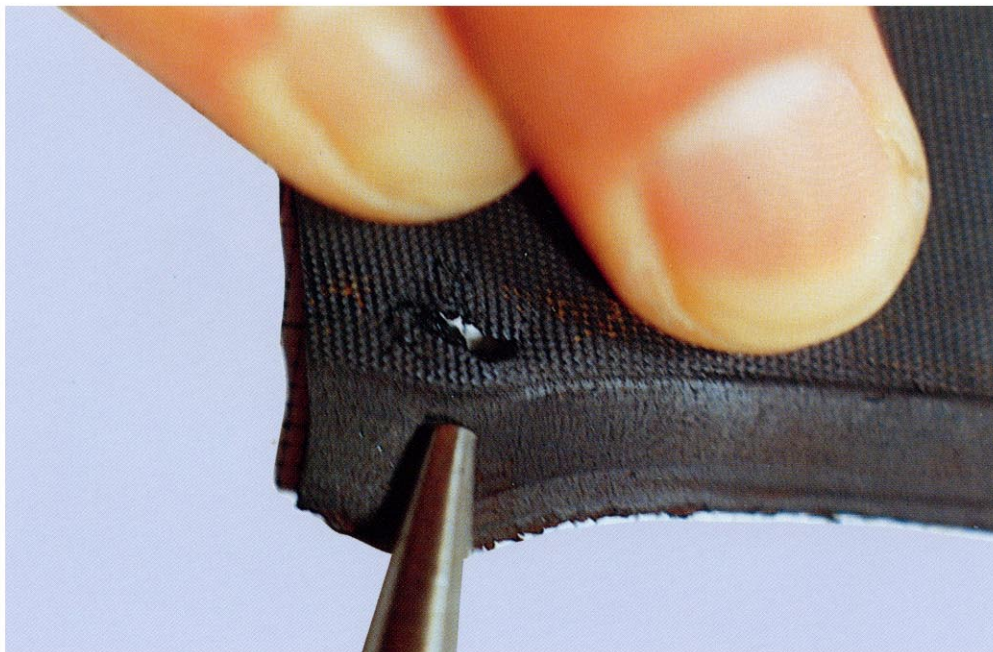
20

Disassembled view.

Puncture holes visible in the rubber cover near the site of damage and the fastening.

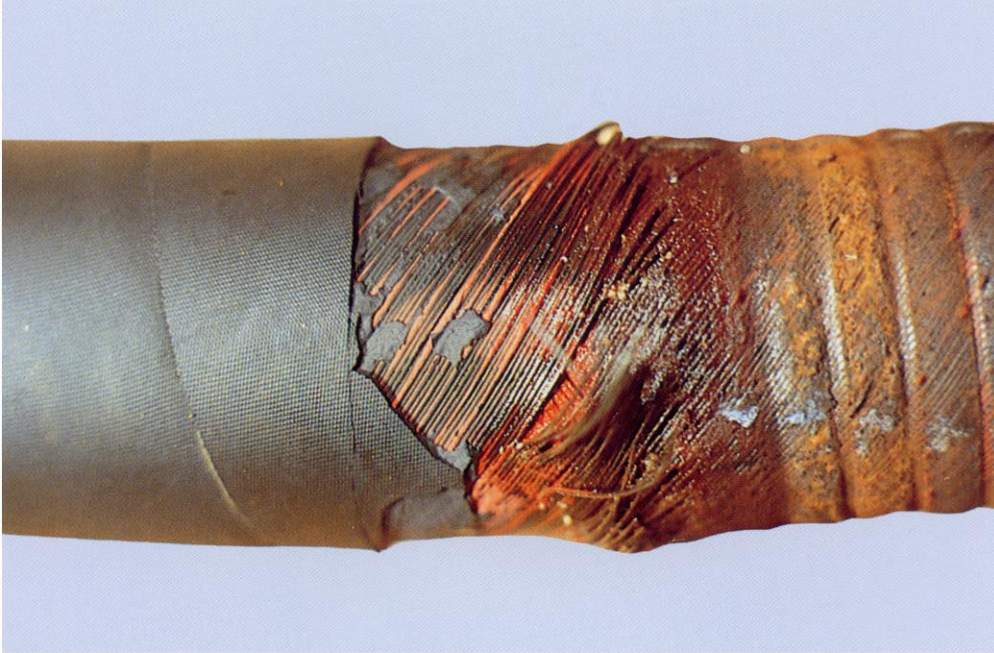
21

Disassembled view.

As rusting proceeds, the outermost, reinforcing layer of wire weakens and breaks.

- (1) A stone hits the rubber cover and damages it.
- (2) Moisture entering through the damaged rubber leads to rusting of the outermost wire layer.
- (3) As rusting proceeds, the reinforcing wire weakens and breaks.
- (4) Deprived of the reinforcement provided by the outermost layer, the inner layer is more subject to metal fatigue, so it rapidly deteriorates.

The rubber cover is provided to protect both the reinforcement layer and the rubber tube inside. Replace a hose as soon as possible if it has been damaged and the wire is exposed.

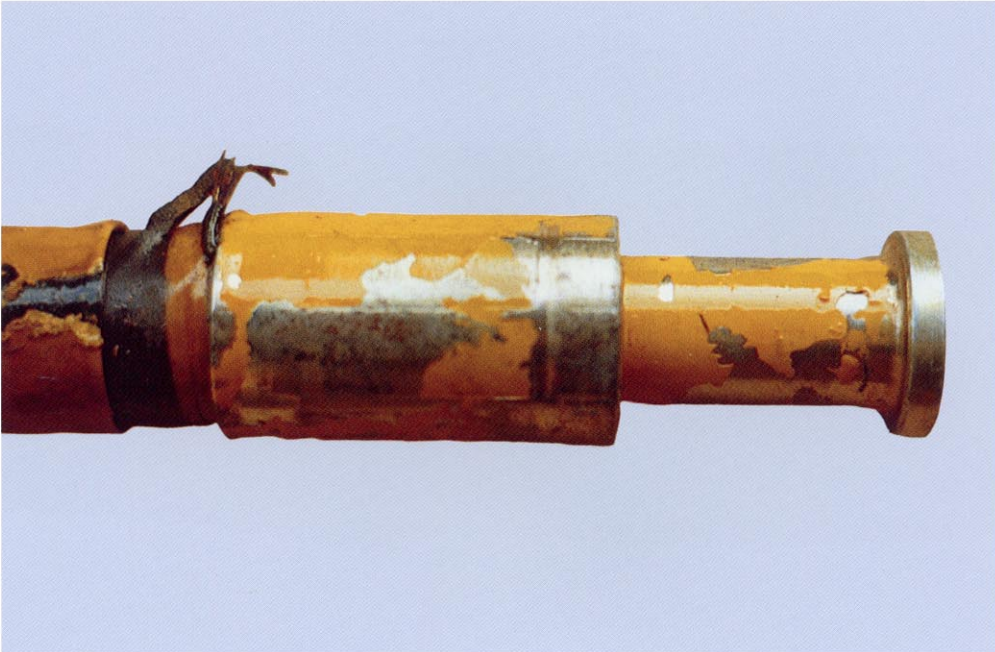
22

DO NOT USE AGAIN

- Longitudinal wear marks on the hose with breakage near the fastening.

- An external force has twisted, bent, or stretched the hose, weakening the wire layers.

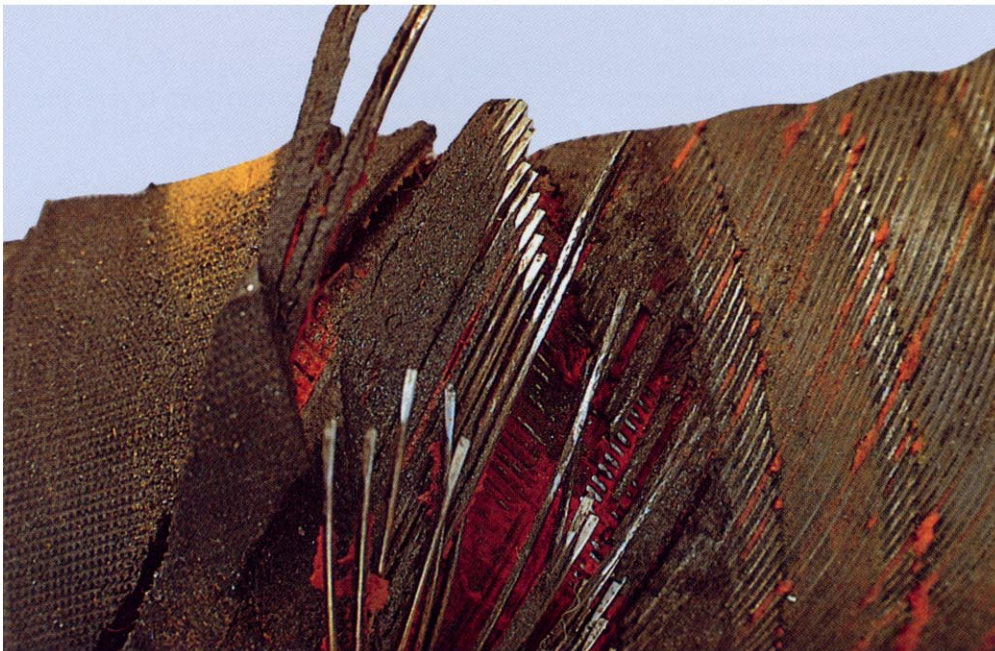
23

Disassembled view of worn wires.

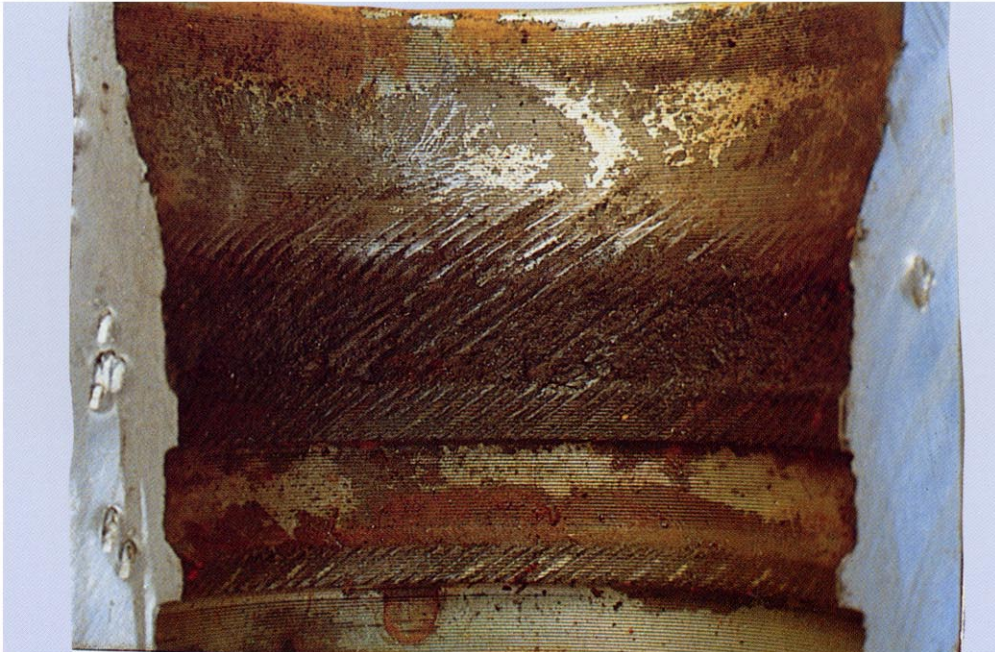
24

Disassembled view.

Contact with the reinforcing wire has produced rapid wear on the inside of the adapter socket.

An external force which twists, bends, or stretches the hose can, in certain cases, lead to this sort of damage. Therefore make sure that all hoses lie in their proper arrangement at all times.

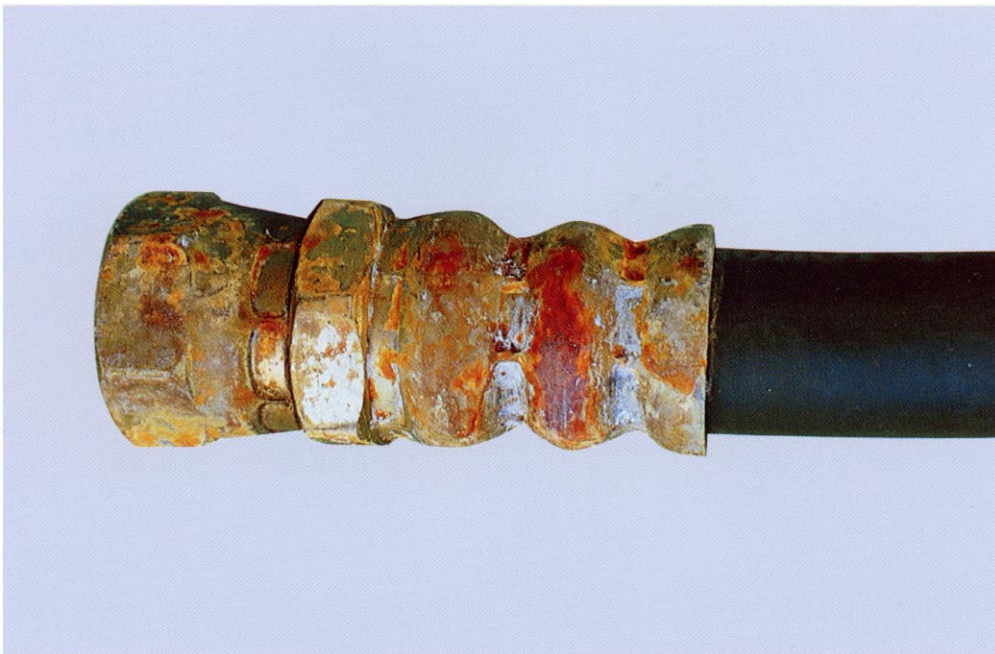
25

DO NOT USE AGAIN

- Rust or corrosion on metal parts.

- Site conditions conducive to rusting and corrosion have made this part unusable.

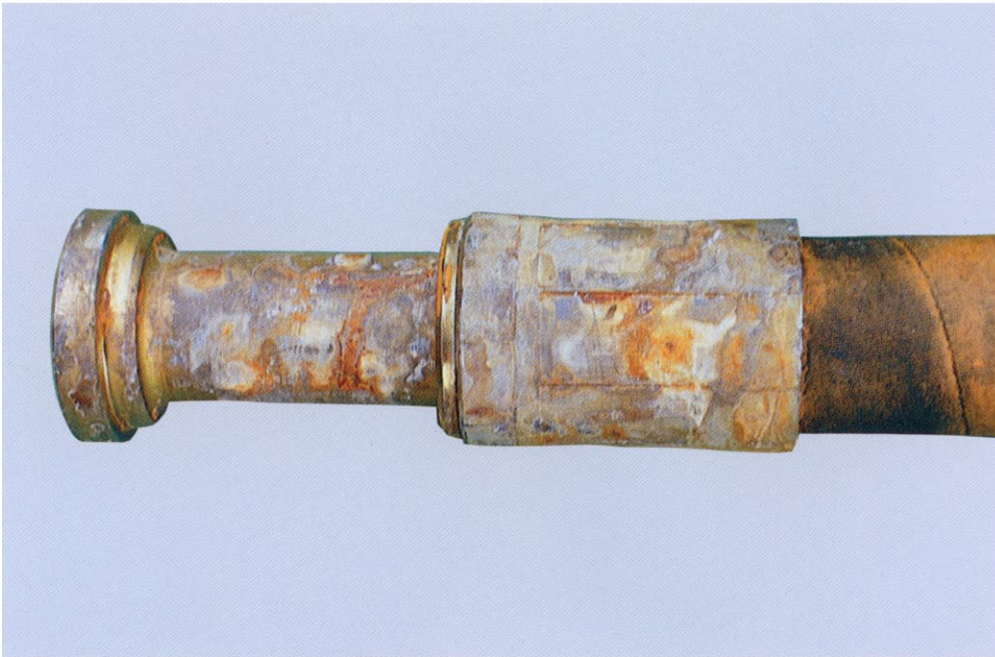
26

DO NOT USE AGAIN

- Rust or corrosion on metal parts.

- Site conditions conducive to rusting and corrosion have made this part unusable.

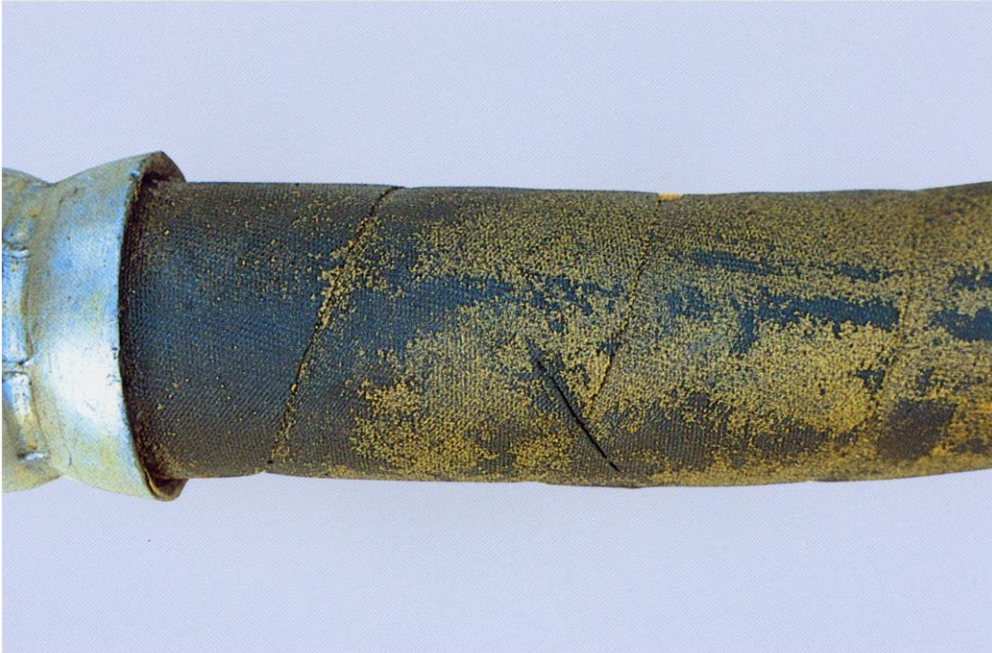
27

USE AGAIN

- Cuts in the rubber cover are shallow and do not reach the reinforcing wire layer.

- Interference with a sharp edge.

As these cuts grow, they eventually let in moisture which can foster rusting which will weaken the reinforcing wire layer. It is therefore advisable to watch them closely and to replace the hose before cuts get too big.

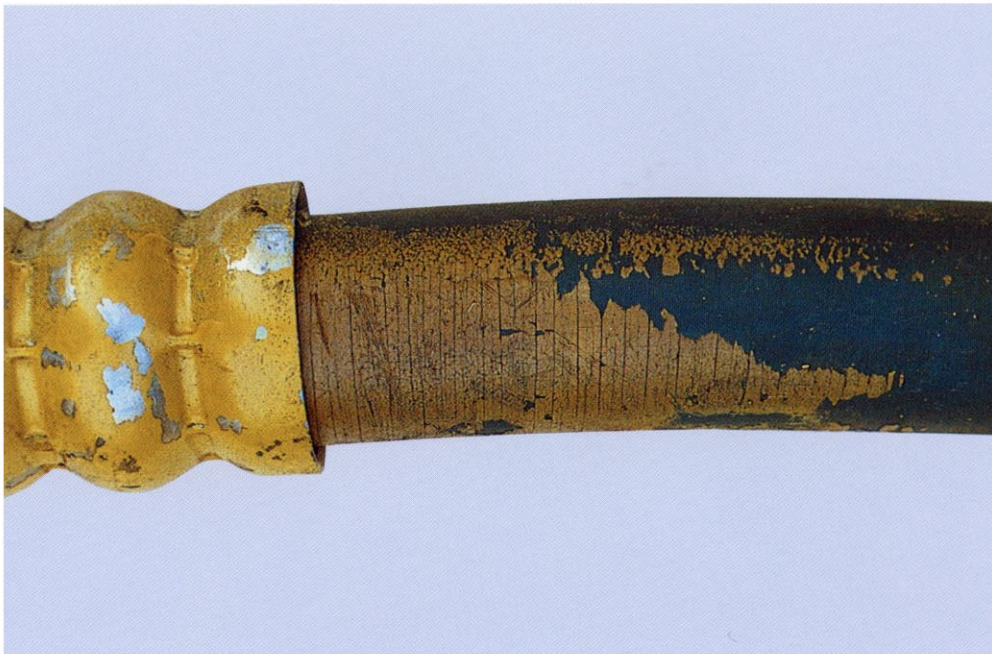
28

USE AGAIN

- Cracking in the painted surface of the hose and in the rubber cover beneath.

- Repeated flexing of the hose.

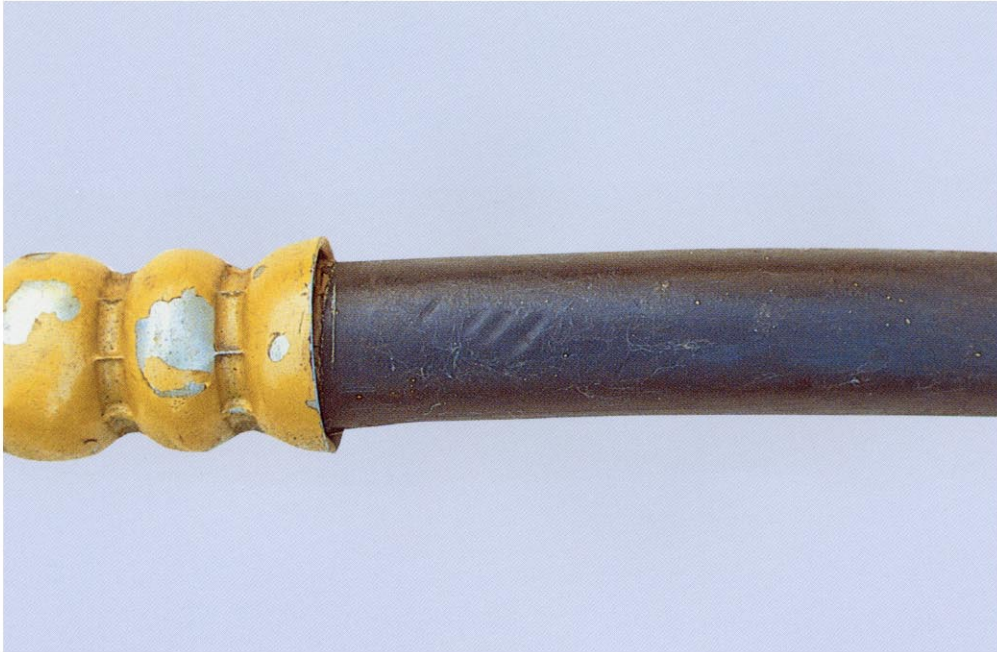
29

USE AGAIN

- Slight splitting of the rubber.

- Blows to the rubber or interference.

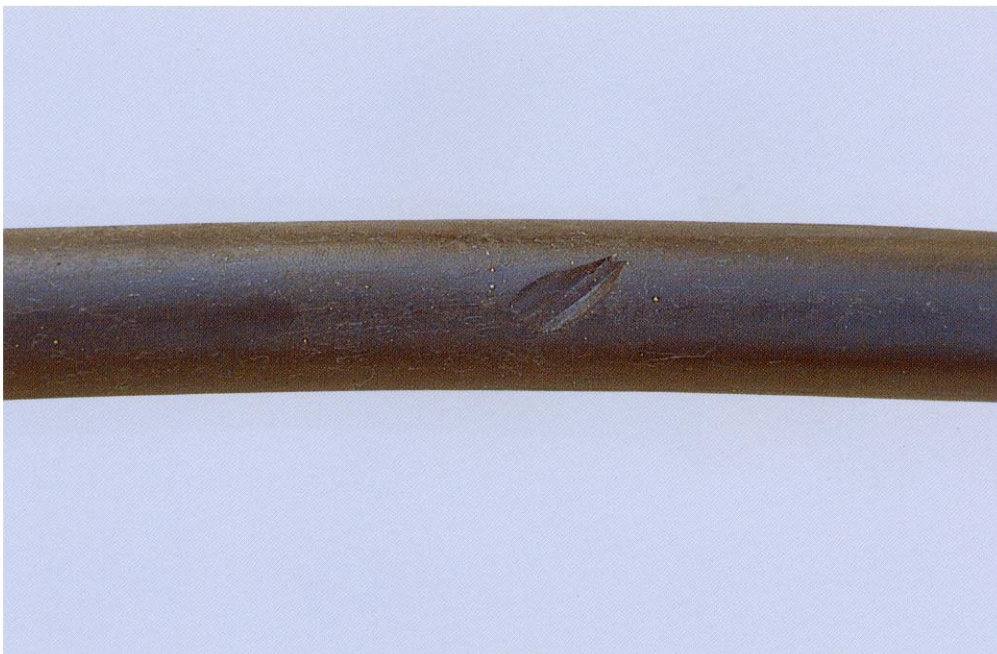
30

USE AGAIN

- Depression evident in rubber cover, but hose not crushed and reinforcing wire layer not exposed.

- Blows to the rubber or interference.

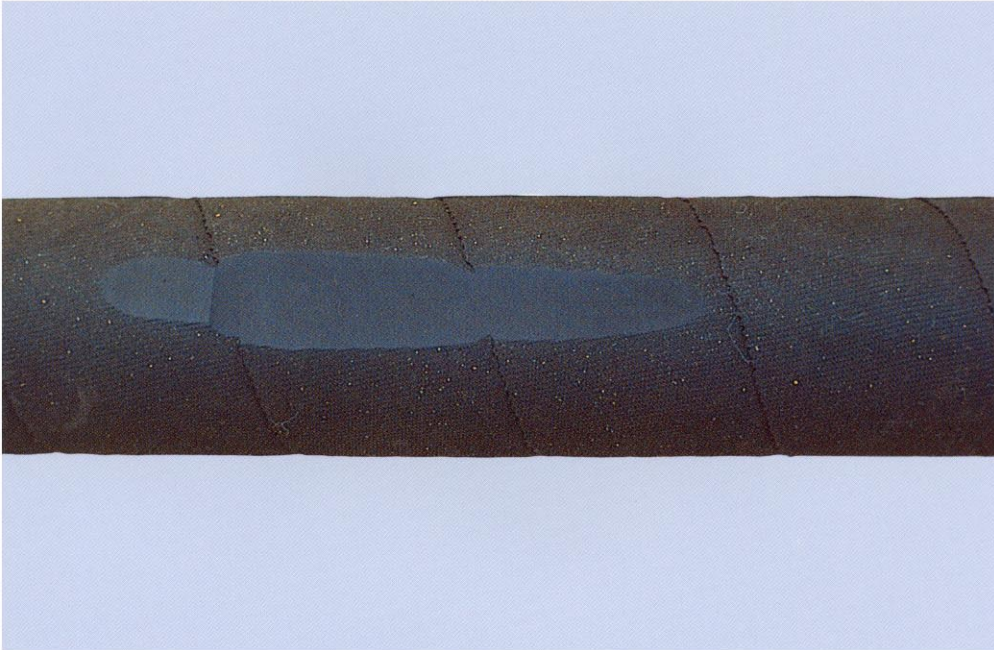
31

USE AGAIN

- Wear evident in rubber cover, but hose not crushed and reinforcing wire layer not exposed.

- Interference.

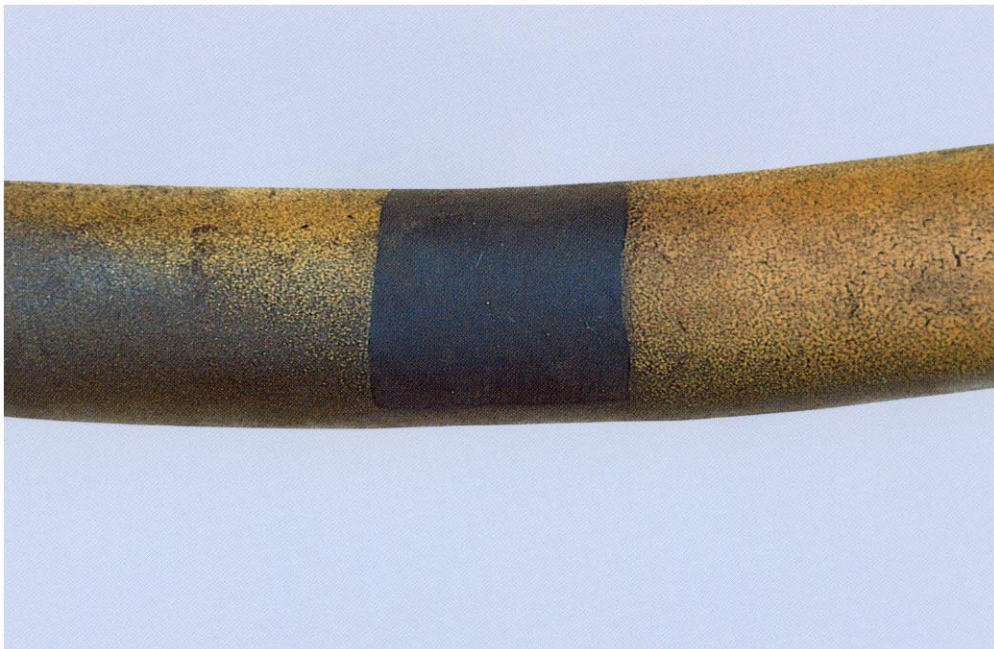
32

USE AGAIN

- Hose slightly crushed.
- Clamping too tight.

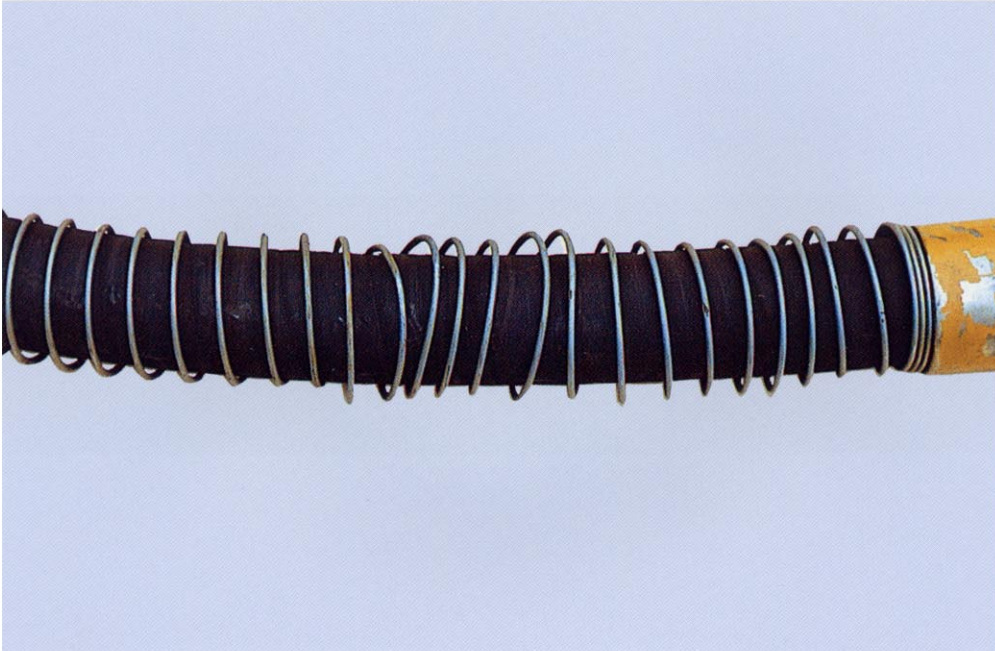
33

USE AGAIN

- Outer protective spring crushed or deformed, but not enough to bite into the hose; hose not crushed.

- External force.

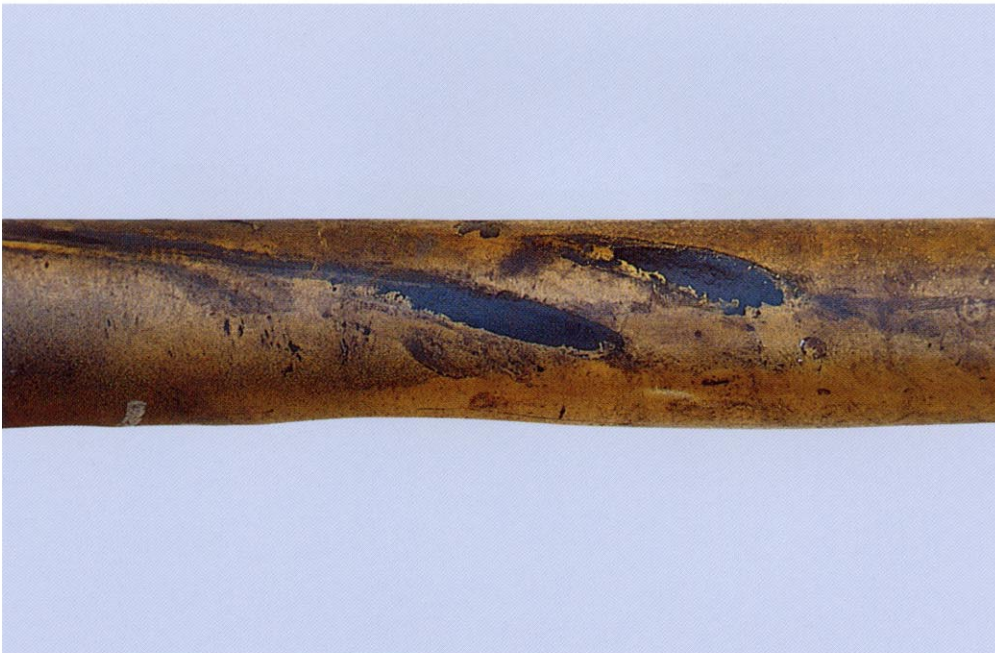
34

USE AGAIN

- Plastic protective cover damaged, but not the rubber beneath.

- Interference.

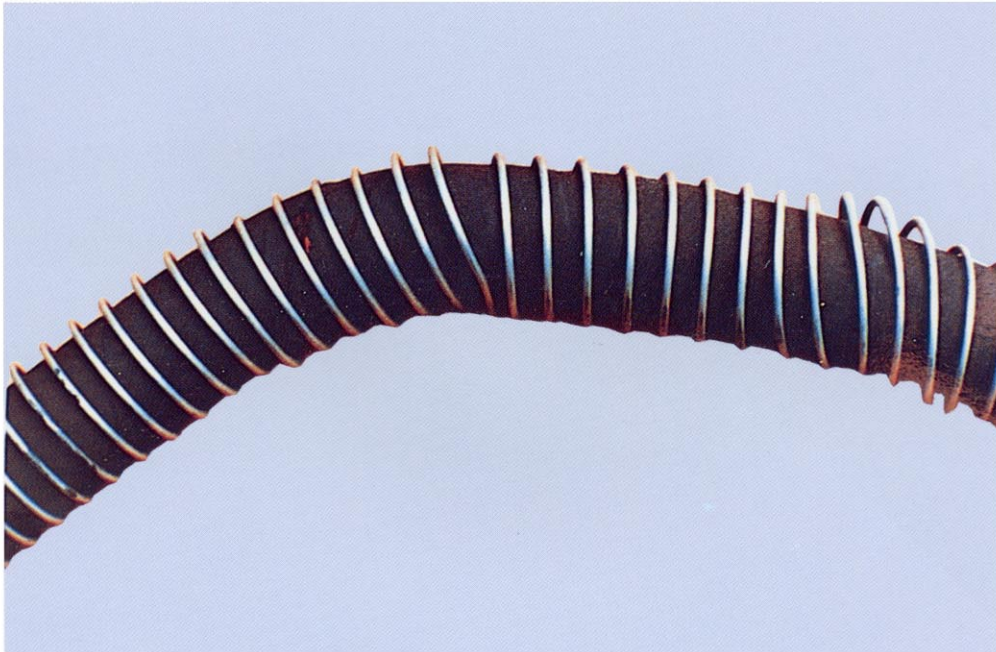
35

DO NOT USE AGAIN

- Protective spring crushed, deformed, and biting into the rubber.

- Excessive bending under an external force.
