SHOP MANUAL

GUIDANCE FOR REUSABLE PARTS

RUBBER HYDRAULIC HOSES

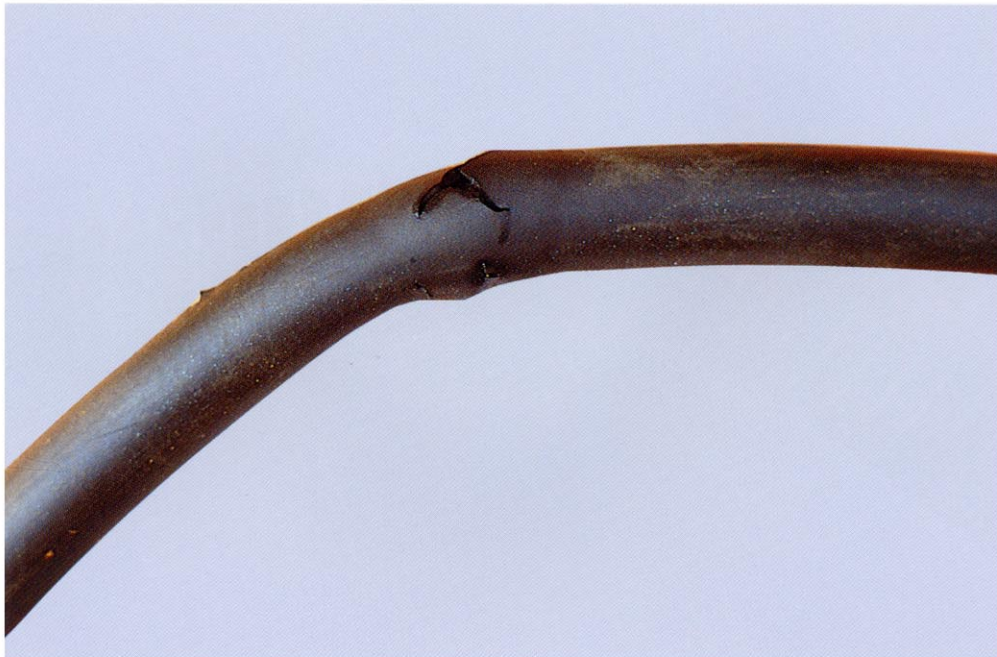
37

DO NOT USE AGAIN

- Hose bent with the rubber cover split.

- Hose crushed under external force.

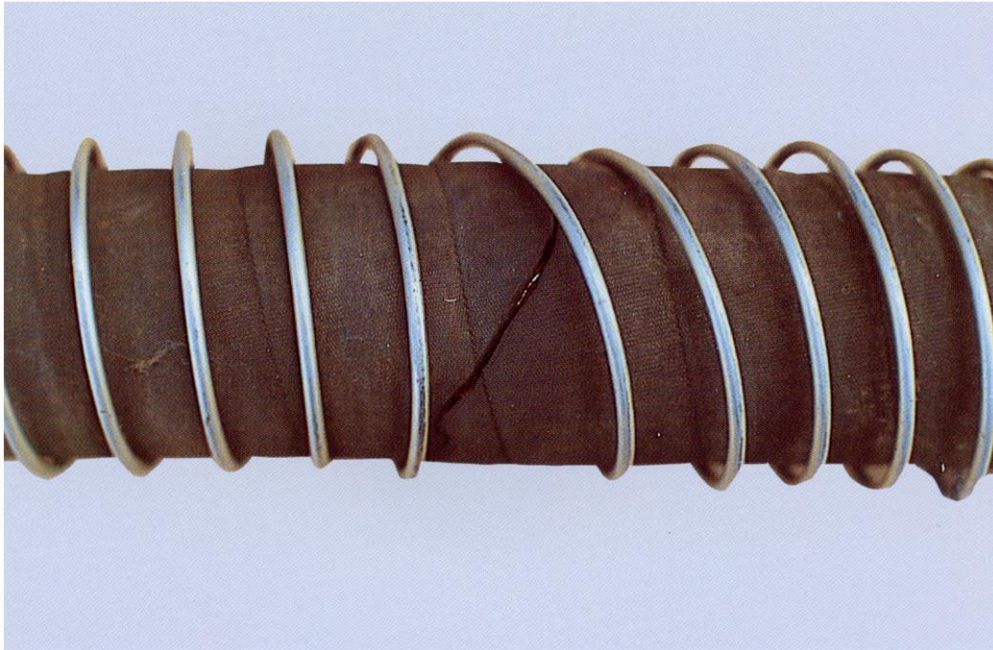
39

DO NOT USE AGAIN

- Protective spring deformed, hose crushed, hose crushed, and rubber cover split.

- Hose crushed by external force against sharp corner.

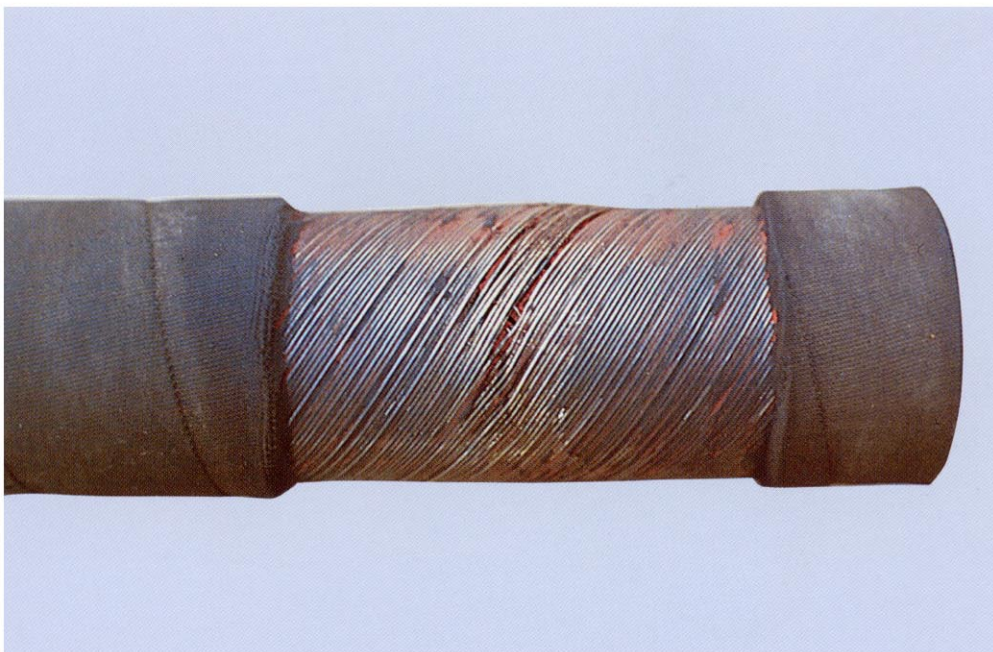
40

Disassembled view.

This photograph shows how the wires in the outermost protective layer (the fourth layer) have been pushed out of alignment with some of them actually bent, but with none of them broken. Note that the second layer, which has the same orientation, is in the same state.

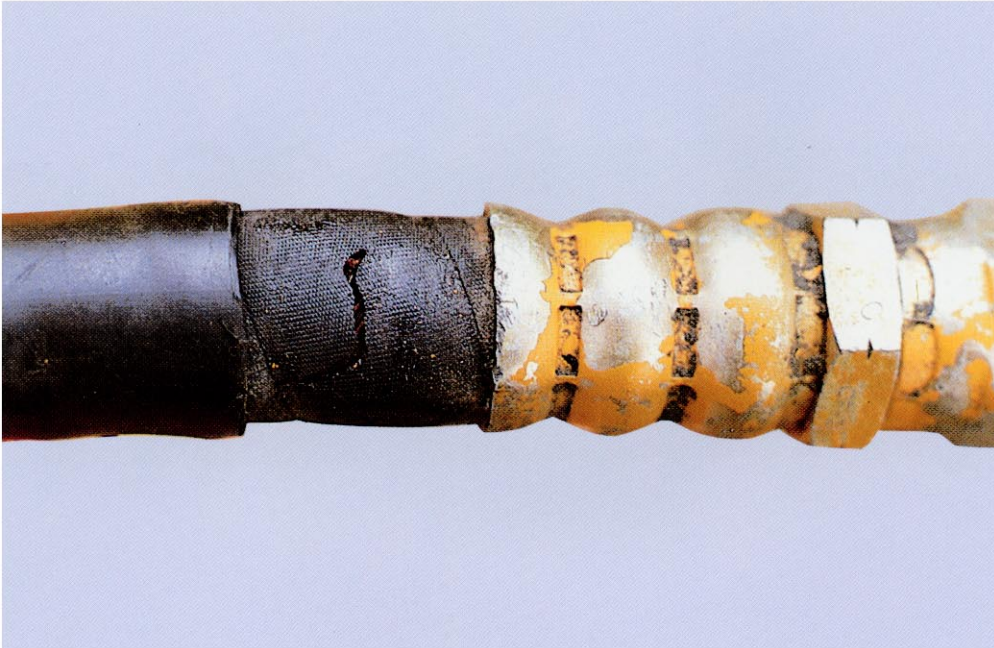
41

DO NOT USE AGAIN

- External marks on adapter and hose with hose crushed and rubber cover broken.

- Hose crushed under external force.

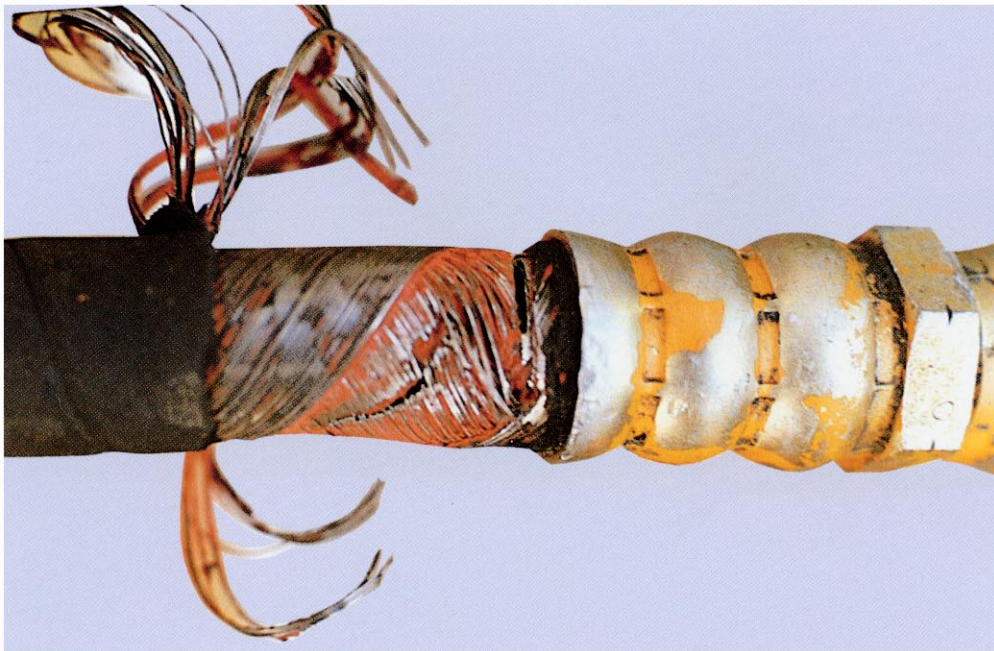
42

Disassembled view.

The wires in the intermediate reinforcement layers are broken at an angle to the spiral formed by the wires in the outermost layer—with the rubber tube split at the same angle.

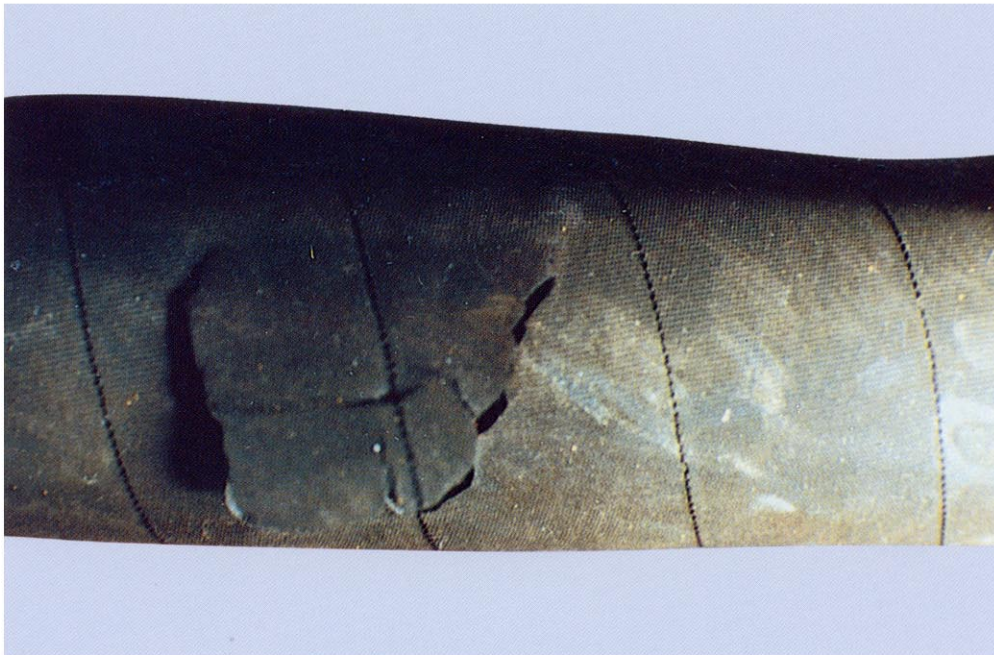
43

DO NOT USE AGAIN

- Rubber cover broken and separated from the layers underneath.

- Protruding object has struck the hose and deformed the reinforcing wire layer.

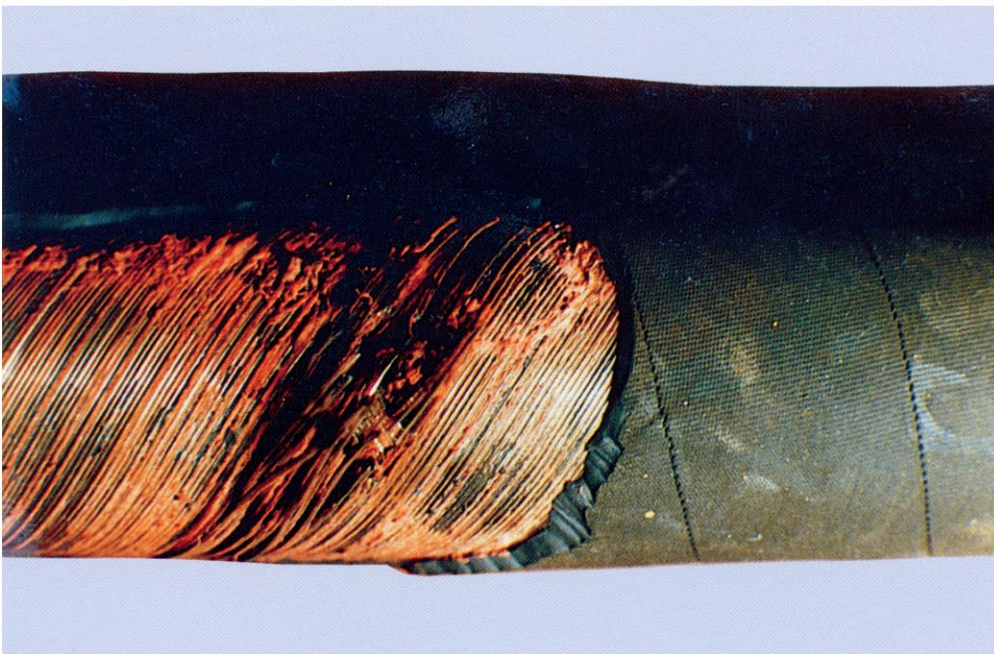
44

Disassembled view.

The portion of the wire layer exposed by the separation of the rubber cover is crushed with some of the wire twisted or broken.

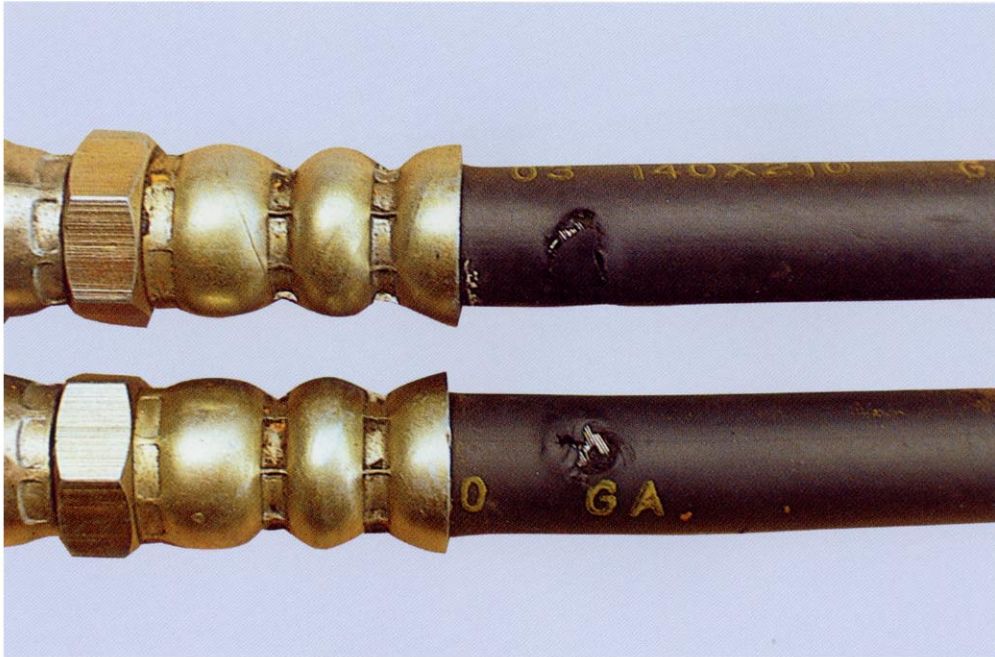
45

DO NOT USE AGAIN

- Rubber cover gouged with the reinforcing wire exposed.

- Replacement with a hose of the wrong length has led to interference of the hose with the machine.

When replacing hoses, always be sure to use the ones with the specified Parts Numbers and the specified lengths.

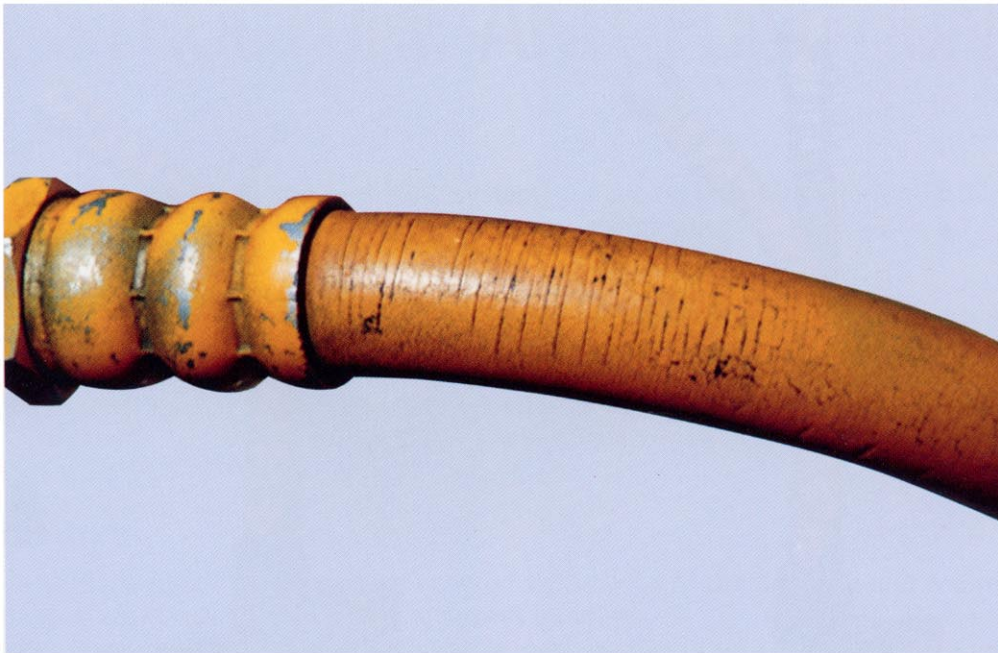
47

DO NOT USE AGAIN

- Many fine cracks in the rubber cover.

- Deterioration due to excessively high temperatures or the presence of ozone.

This type of failure is generally very difficult to detect especially when the hose is dirty. To check the hose, remove the dirt with cleaning oil and then bend the hose. Note that if the hose is not exposed, this type of failure is not likely to occur in a short time.

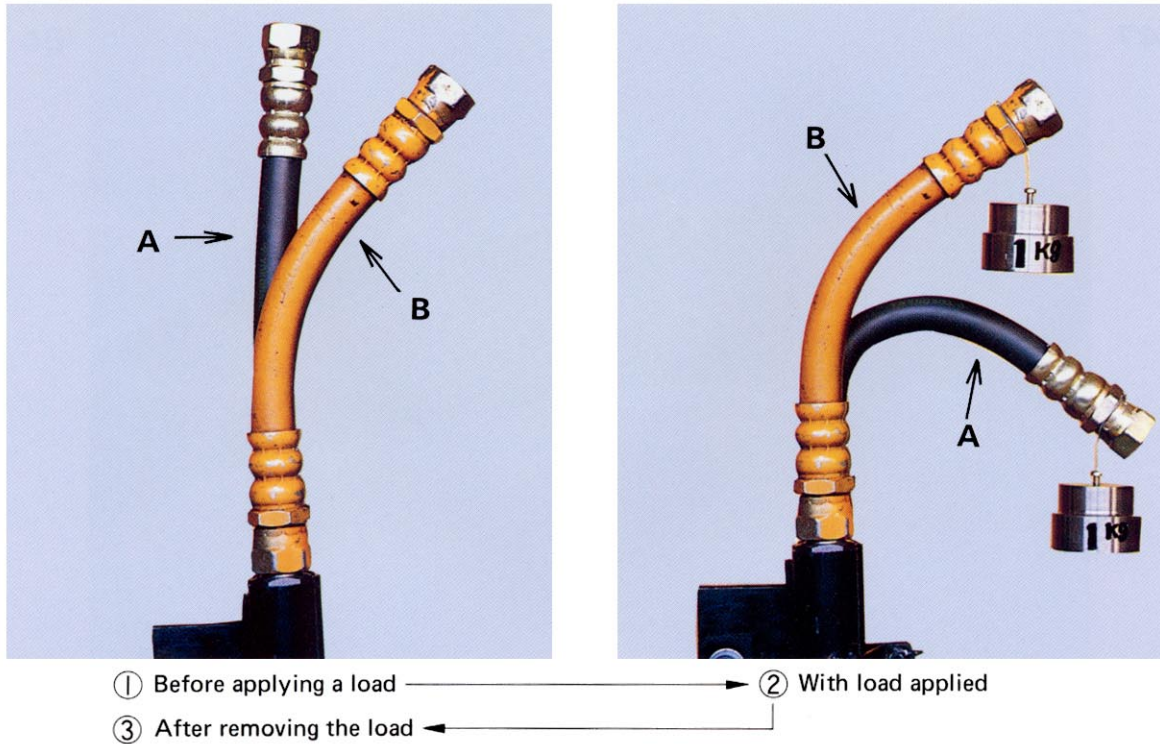
An example of judging hose flexibility

Ⓐ : Use again

Put a load on the hose. If the hose sags, then springs back when the load is removed, the hose can be reused.

Ⓑ : Do not use again

Put a load on the hose. If the hose is in such bad condition that it does not sag, replace the hose.

- Excessive resistance to bending.

- Deterioration due to excessively high temperatures or the presence of ozone.

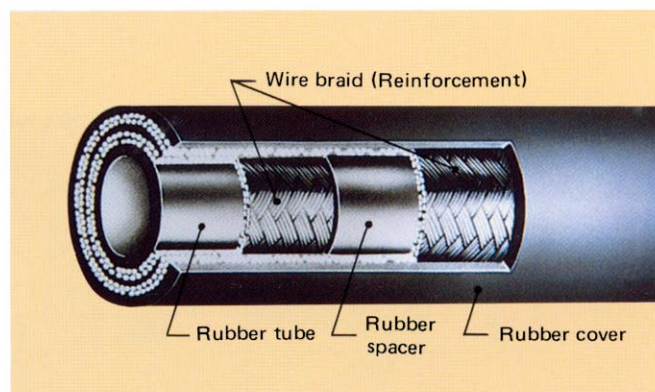
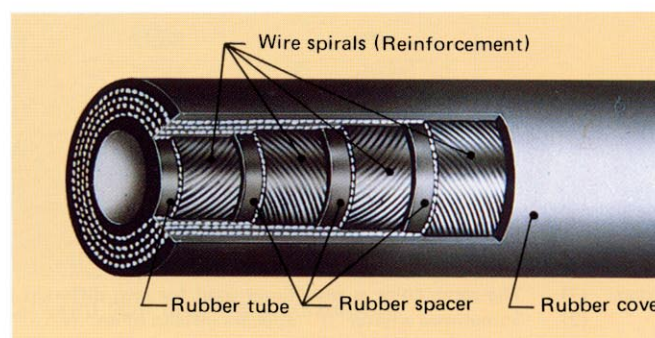
The hose is made up of a rubber tube covered with layers of braided wire and enclosed in a rubber cover.

The wire layers are made up of tough wires 0.3 to 0.6 mm in diameter braided into a mesh which keeps the rubber tube from bursting under the hydraulic pressure inside and from collapsing under pressure from the outside. These layers are numbered from the inside—No. 1 wire layer, No. 2 wire layer, etc. The greater the number of layers, the greater the hose's ability to withstand pressure.

In addition to the wire braid hoses just discussed, there are also hoses which use wire spirals for reinforcement. Since the wires are not braided together, they are much more resistant to metal fatigue. Such hoses also have great resistance to pressure, so they are ideal for lines subject to sudden pressure changes.

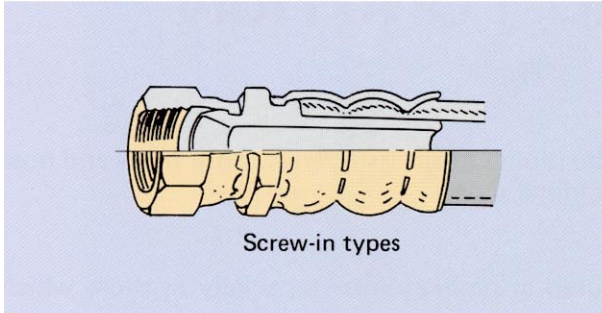
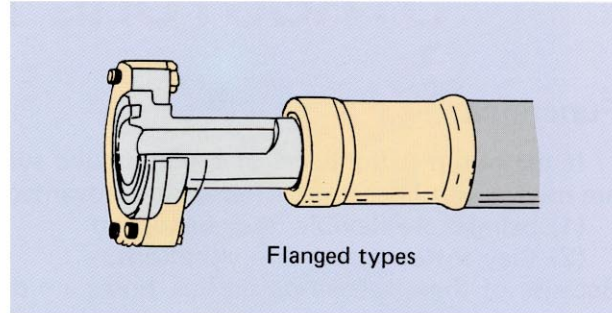
Adapter Structure

Hoses are fitted with adapters at the ends so that they may be attached to other piping. The accompanying illustrations show the two types of adapters used: flanged and screw-in types.

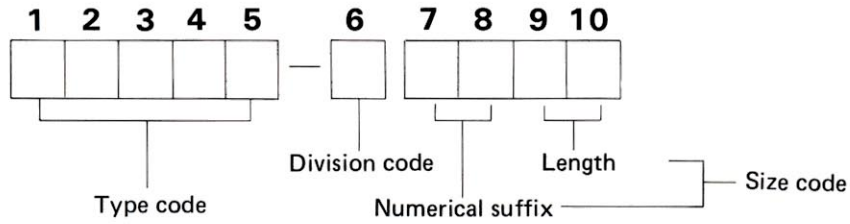
Parts Numbers are assigned in accordance with the following format:

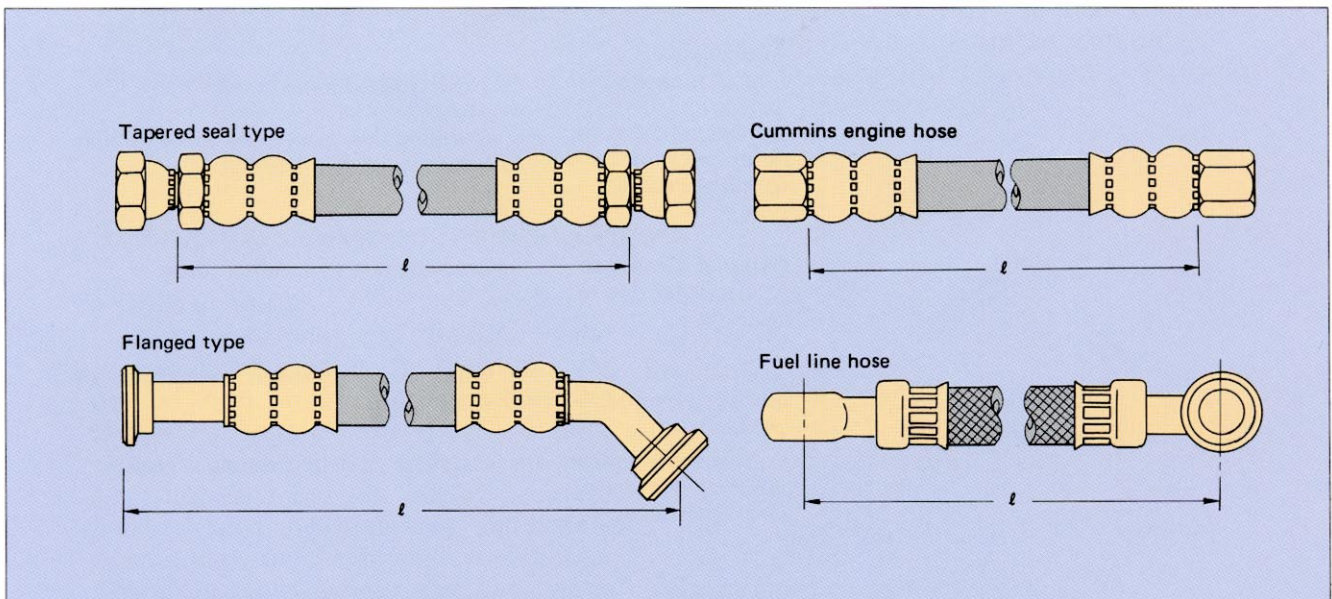
How to Measure Length of Hoses

Notes: The term "length" is defined differently for tapered seal and flanged hoses.

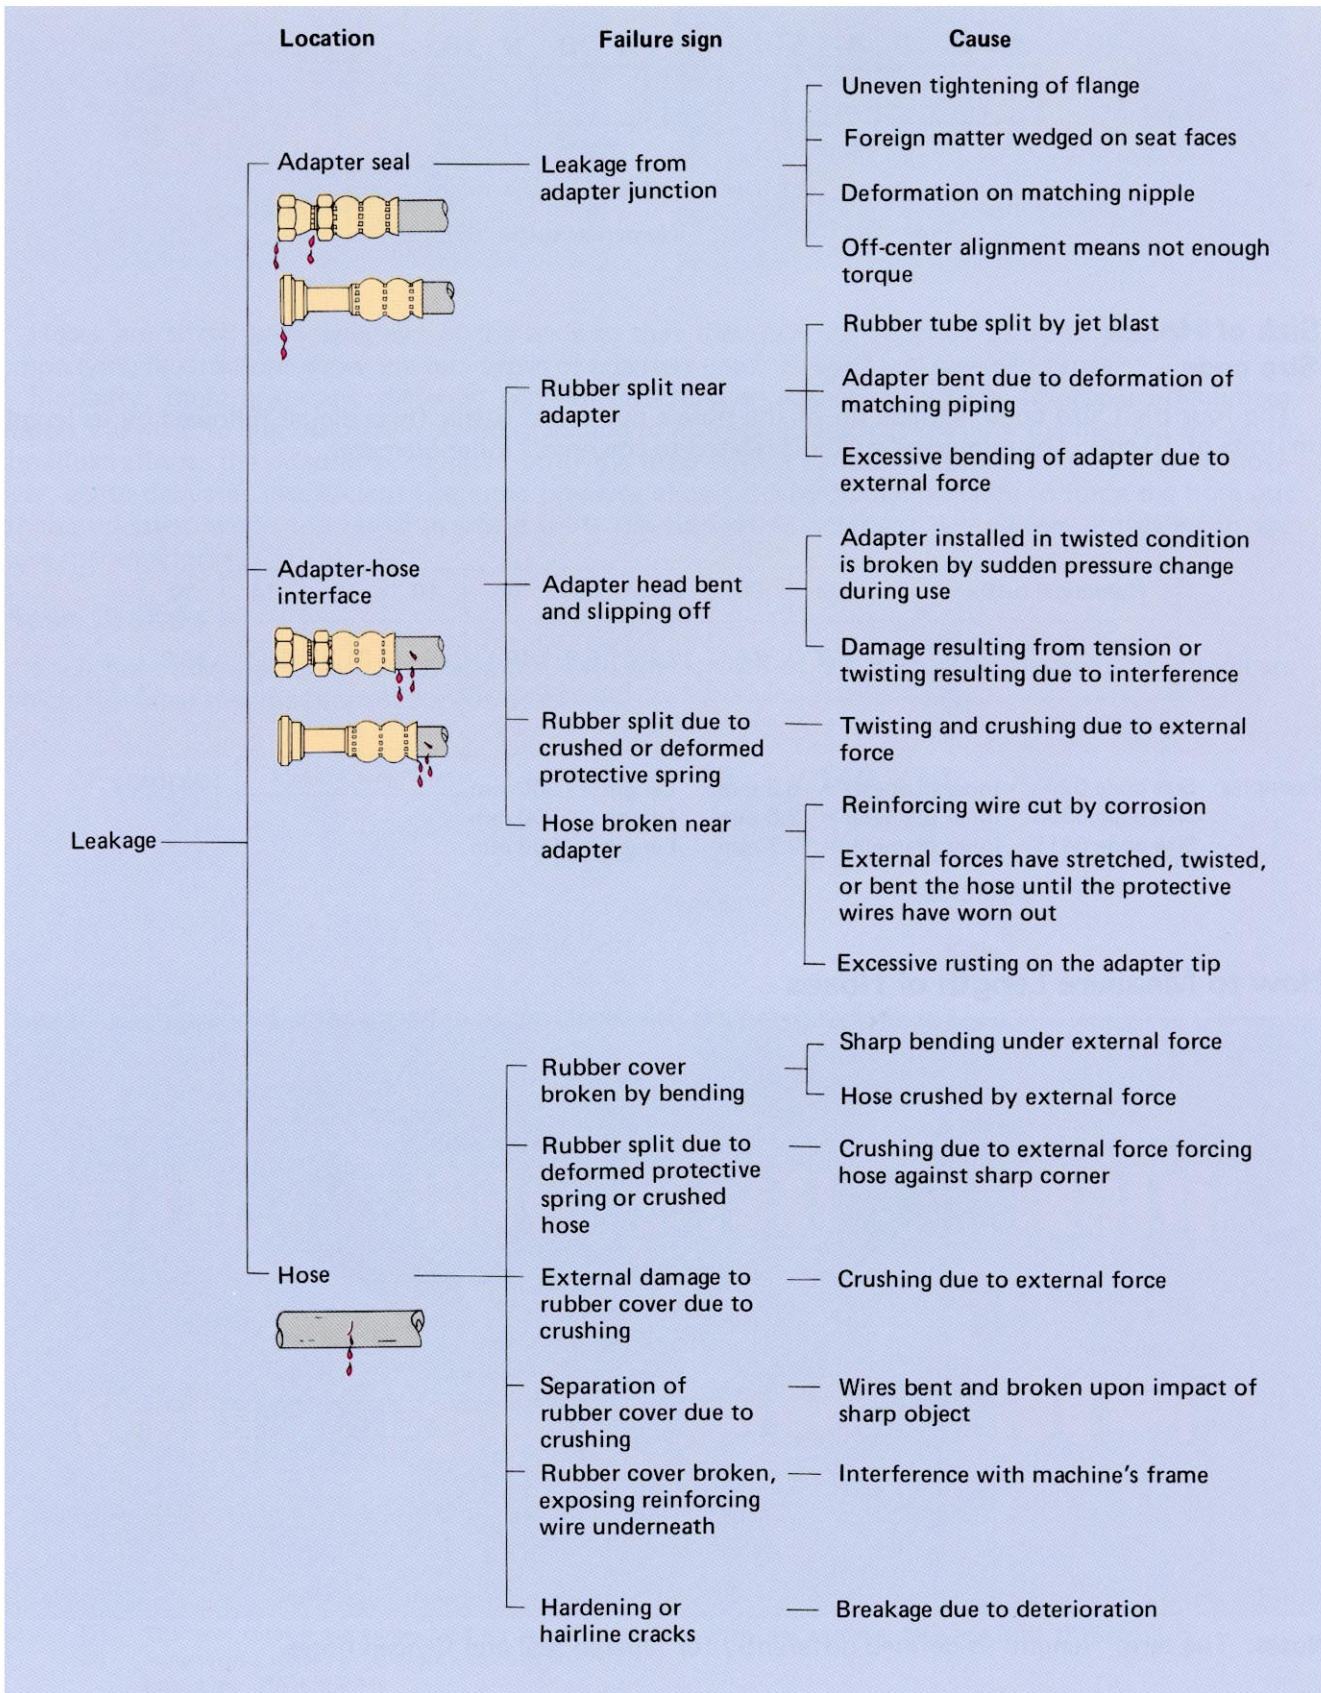
Leakage from high-pressure rubber hoses can be due to any number of causes: for example, marks on the adapter seat surfaces, breakage near the hose-adapter interface, damage to the hose's surface. The following chart outlines the more common failures and their causes.

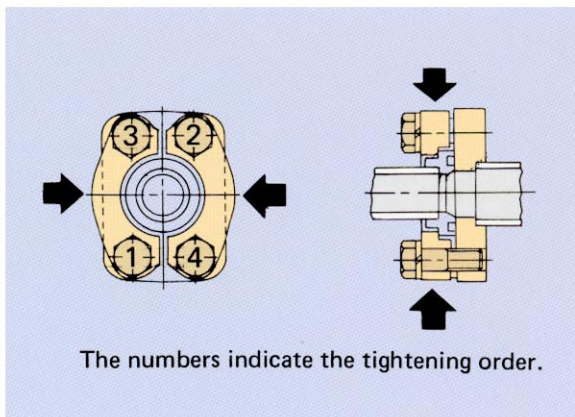
When installing split flanges, make sure that the gaps in the bolt holes are pushed into the center and that the tightening torques are equal on both sides. If these gaps are left on the outside, the head can slip out of position, making the flange unevenly tightened—a situation that can lead to leakage. Therefore, always press the two halves inward (in the direction of the arrows in the accompanying diagram) when tightening the bolts.
