SHOP MANUAL

GUIDANCE FOR REUSABLE PARTS

HYDRAULIC CONTROL VALVES

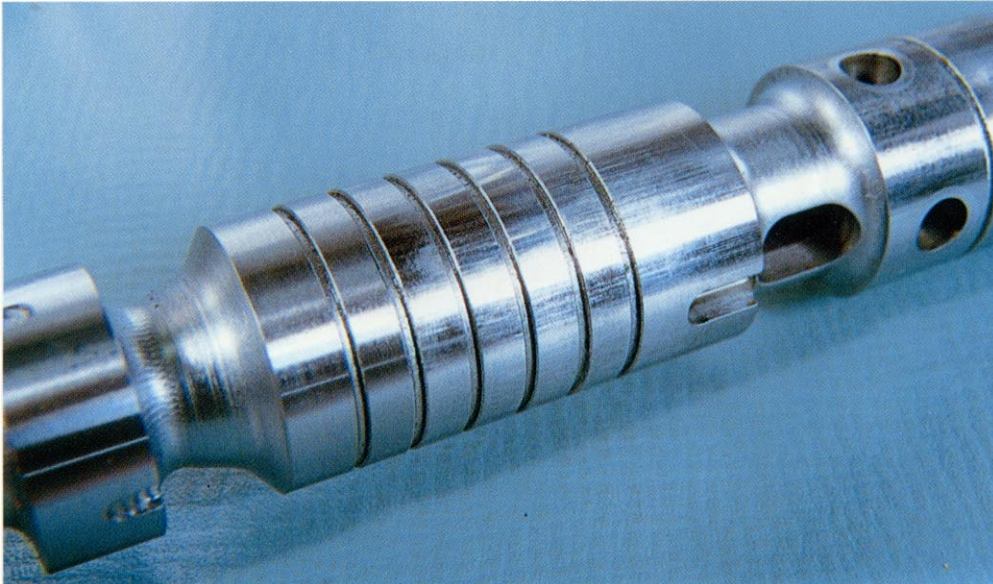
Category: B

- Contamination of oil, catching of wear particles.

- Correct carefully with sandpaper #600 – 800. See P14.

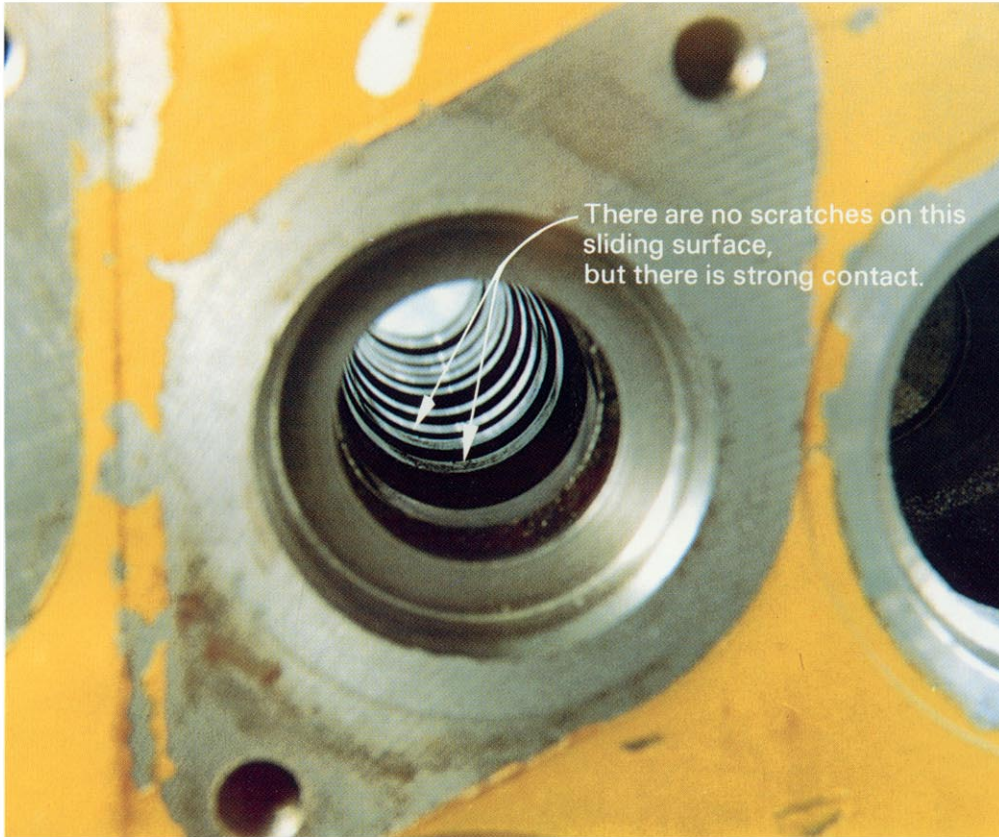
Valve Body: Spool Sliding Surface (Inside Wall)

Category: **B**

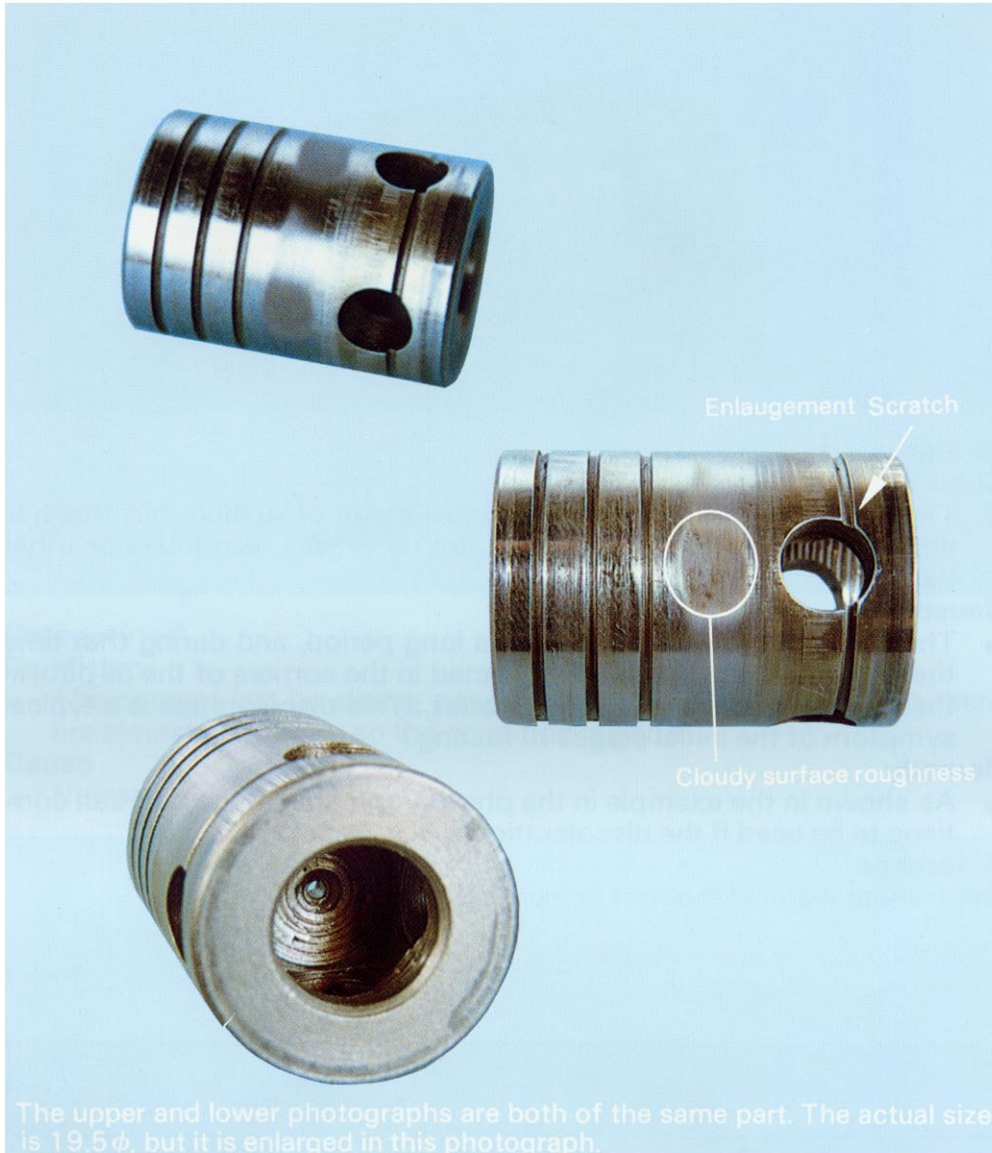
Main Valve: Sliding Surface

Category: C

- The cause is probably improper maintenance of the hydraulic oil leading to accelerated contamination and catching foreign material in the sliding surface, or the catching of broken pieces coming from damage to other hydraulic equipment.
- ★ Action to take for broken hydraulic parts: the equipment must be cleaned thoroughly by flushing the hydraulic circuit.

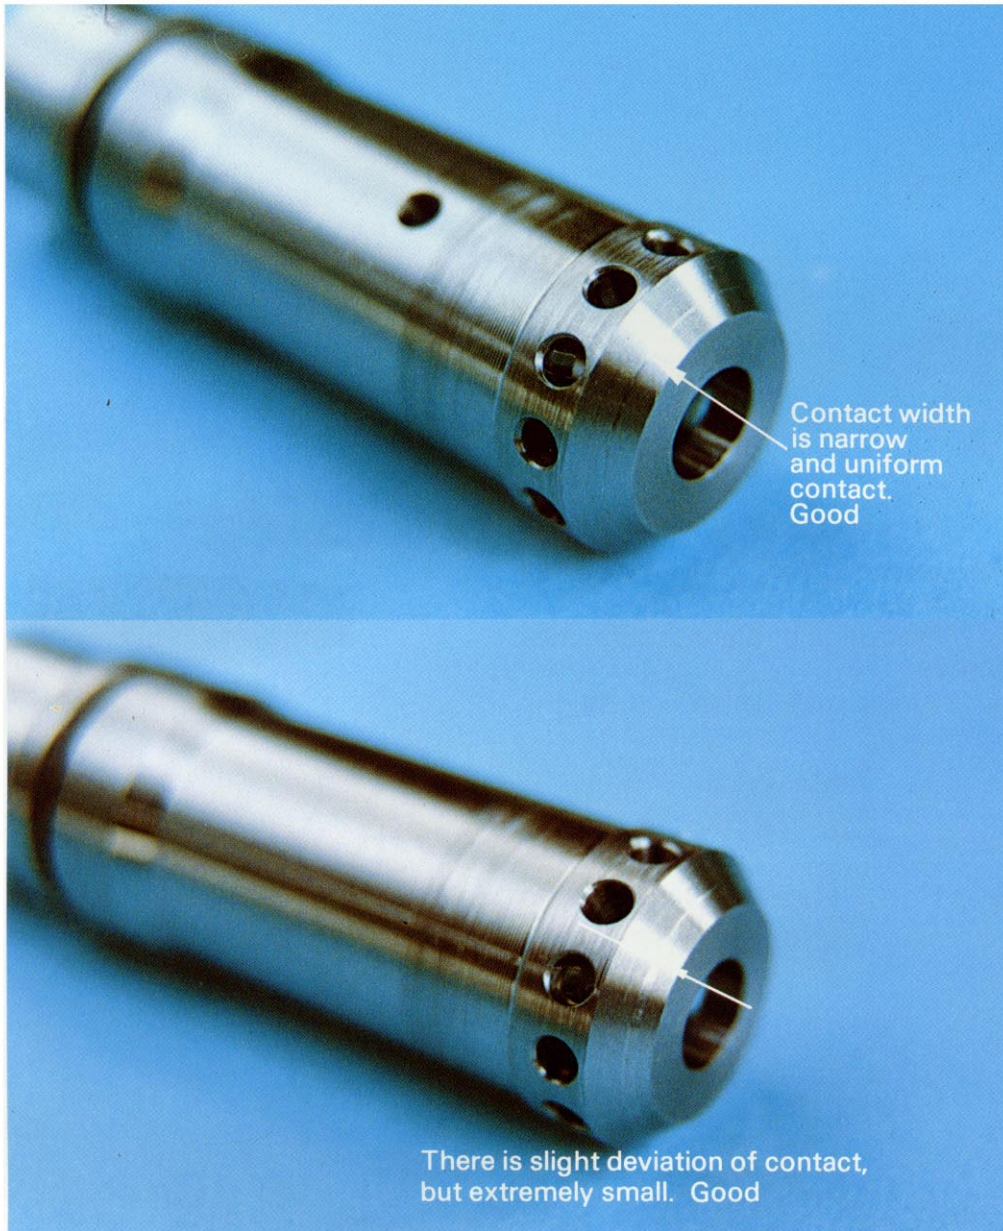
Suction Valve: Valve Seat Portion

Category: A **Condition**

- The contact of the valve seat shows the initial contact condition, and there are no scratches, so the condition is good. In the top photograph, the contact width is narrow, and the contact is uniform around the whole circumference. In the bottom photograph, there is slight deviation of the contact, but this is extremely small, so the condition is good.

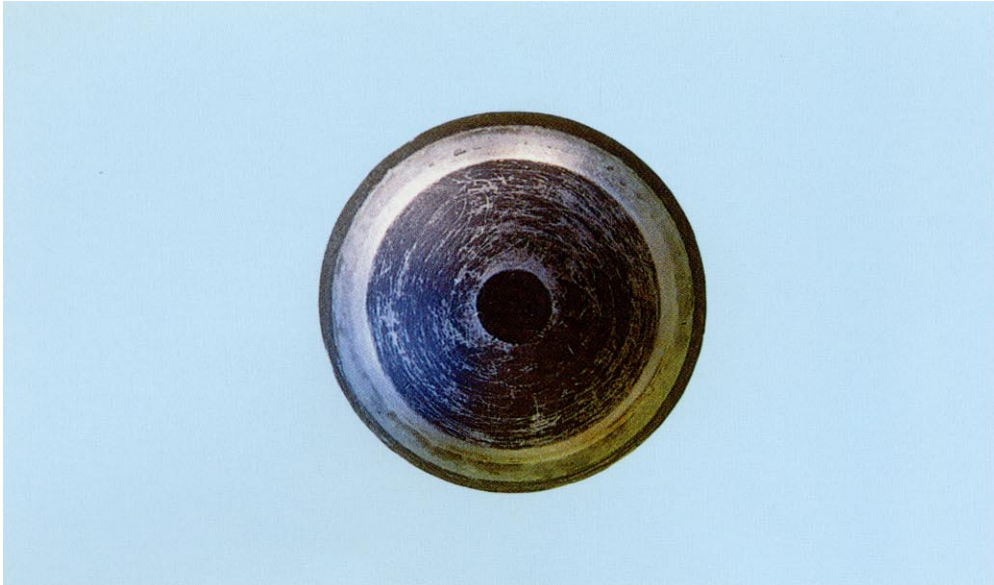
Check Valve: Valve Seat

Category: B

- Slide together with the valve body to correct by lapping.
