# SHOP MANUAL

## **GUIDANCE FOR REUSABLE PARTS**

# **HYDRAULIC CYLINDER**

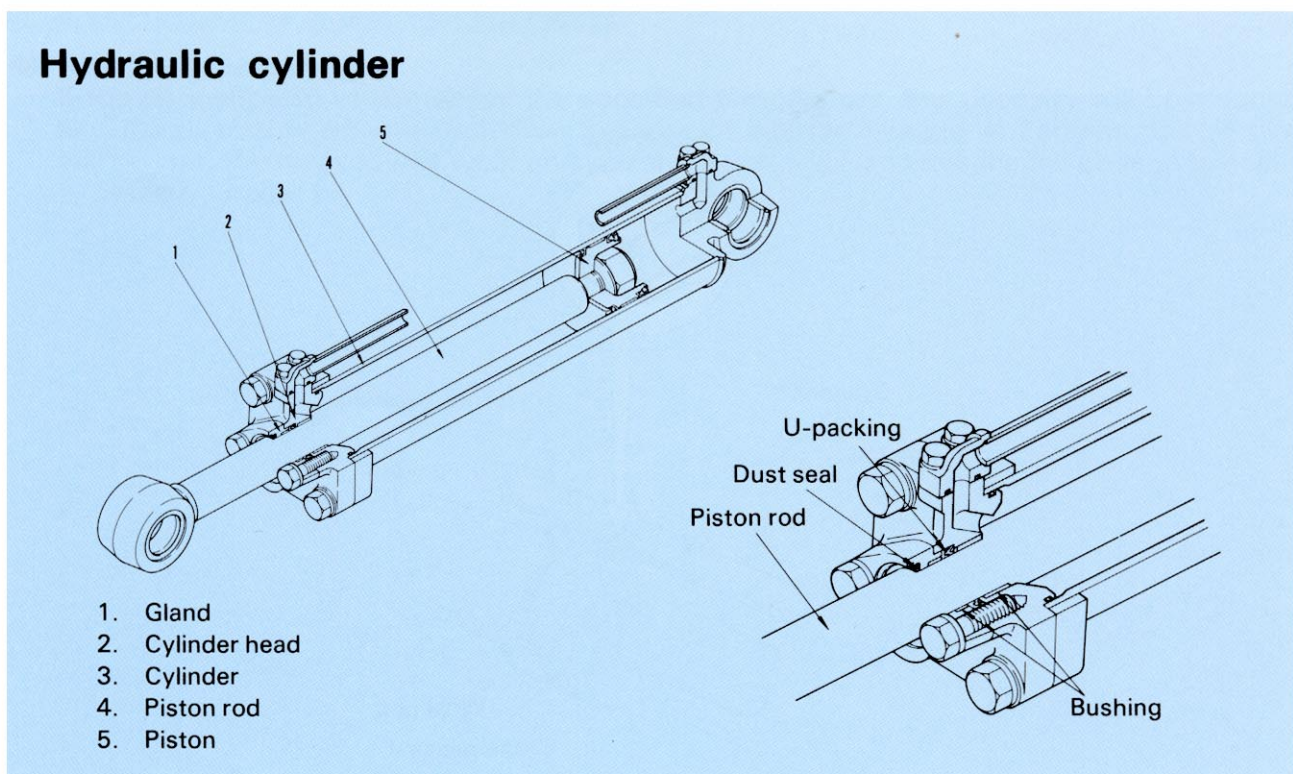
Cylinders are made of steel piping with a base welded to the bottom. The inside of the piping is finished by honing in order to prevent oil leakage and abrasion with the packing.

The cylinder head has a center hole through which the piston rod is passed. This hole is fitted with a bushing to prevent the piston rod from rubbing directly against the cylinder head.

This section is also packed to prevent leakage of cylinder oil through the gap between the cylinder head and piston rod. In addition, a dust seal is employed to prevent grit adhering to the piston rod from being carried into the cylinder when the rod is pushed in.

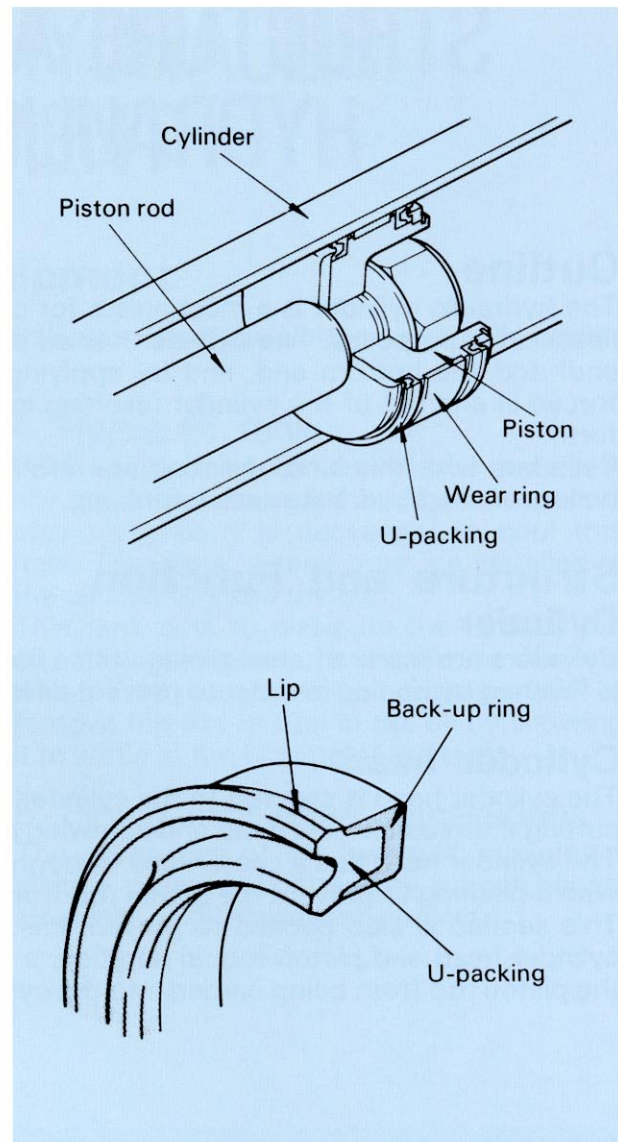
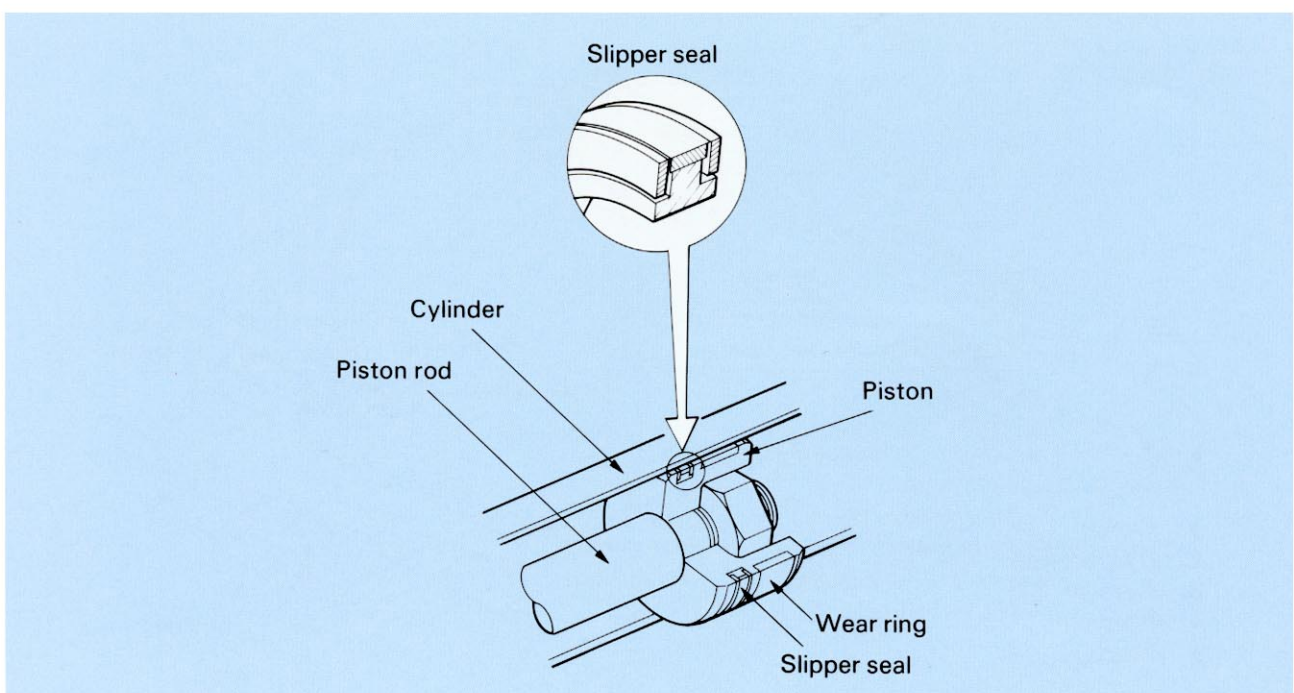
The illustration at right shows how U-packing or slipper seal is mounted to prevent oil leakage from the clearance between the piston and cylinder.

When hydraulic pressure is applied to the hollow side of U-packing, the lip (portion projecting outward) is pushed against the cylinder and piston to prevent oil leakage.

But, if hydraulic pressure is applied to the opposite direction, oil leakage will result.

Therefore, 2 sets of U-packings each in opposite directions should be used to prevent oil leakage from both directions so that hydraulic pressure may be applied from both directions.

For a slipper seal, hydraulic pressure can be applied from both directions.

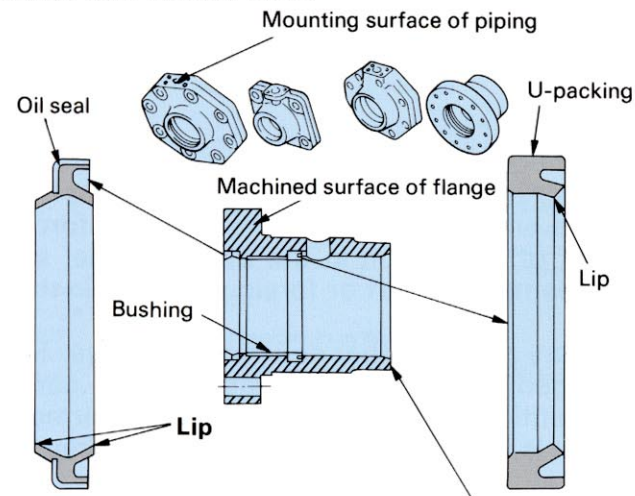
Part Name	Check Portion	Check Point
<p>Cylinder head sub-assembly</p>	<p>[Flange type cylinder head]</p>

<ul style="list-style-type: none"> <li>Check for any wear or scratches on the lips of the oil seal and U-packing.</li> <li>★ Check when removing from the piston rod, and if there are no scratches or wear, leave them assembled to the cylinder head and continue to use.</li> </ul> <p>If there is any oil leakage, replace them regardless of whether there are any scratches or wear.</p> <p>When overhauling, replace all O-rings, oil seals, and U-packings.</p> <p><b>Cylinder Head</b> [Flange type]</p> <ul style="list-style-type: none"> <li>Are there any dents or impressions in the machined surface of the flange?</li> <li>Are there any dents or scratches in the mounting surface of the piping (O-ring mounting surface)?</li> <li>Are there any impressions at the piston stopper?</li> <li>Is there advanced wear or uneven wear of the bushing?</li> </ul> <p>Are there any scratches? [For details of repair limits, see the shop manual.]</p> <p>[Screw type]</p> <ul style="list-style-type: none"> <li>Is there any scuffing of the thread? (Is it possible to screw in smoothly at the cylinder end?)</li> <li>Other points are the same as for the flange type.</li> </ul>

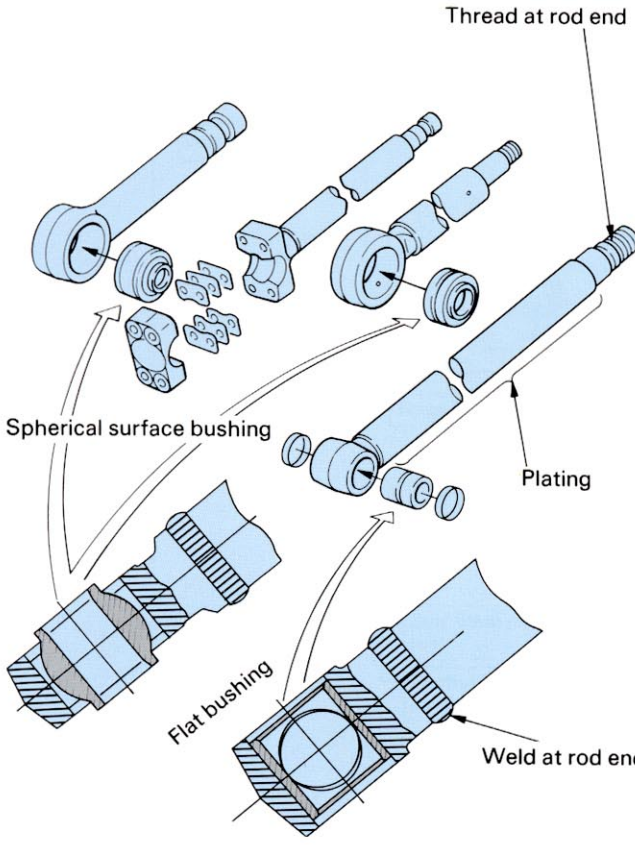
<p>Piston rod sub-assembly</p>

<p><b>Piston Rod</b></p> <ul style="list-style-type: none"> <li>Is there any damage such as scratches or dents in the plating (sliding surface)?</li> <li>Is there any scuffing or uneven wear of the bushing at the rod end, or is the wear advanced? [For details of repair limits, see the shop manual.]</li> <li>Is there any scuffing of the thread at the rod end?</li> </ul> <li>★ Check of weld at rod end and curvature of rod in the following cases:             <ul style="list-style-type: none"> <li>If the damage to the inside of the cylinder is excessive, or there is judged to be an abnormal condition.</li> <li>If the machine is being used under particularly heavy-duty conditions.</li> <li>If there has been any abnormality, such as rolling over of the machine.</li> </ul> </li> <p>If there have been these or other such abnormalities, carry out appropriate checks of the following items.</p> <p>Are there any cracks in the rod end weld? Carry out a color check to check for cracks.</p> <p>Is the rod bent? Use a dial gauge to measure the radial runout.</p>

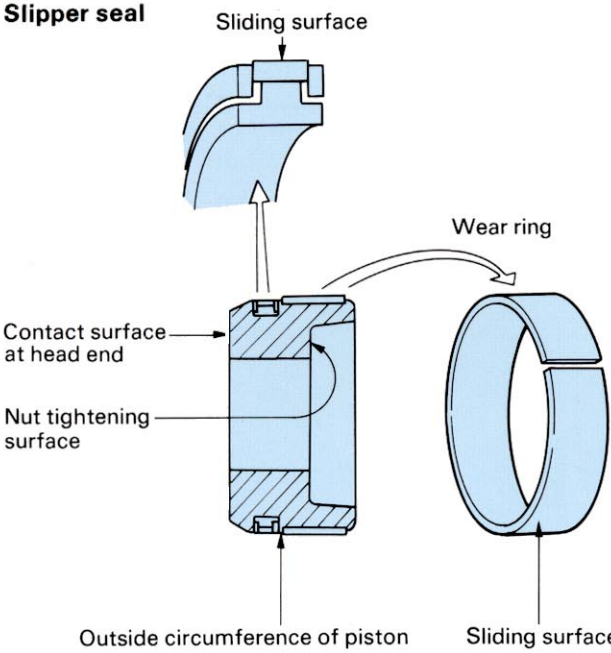
Part Name	Check Portion	Check Point
Piston sub-assembly

<p>The diagram illustrates the piston sub-assembly with several key components labeled: 'Slipper seal' at the top, 'Sliding surface' on the upper part of the piston, 'Wear ring' shown as a separate ring, 'Contact surface at head end' on the piston's top edge, 'Nut tightening surface' on the piston's side, and 'Outside circumference of piston' at the bottom. Arrows indicate the relationship between these parts and the 'Sliding surface' of the wear ring.</p>	<p><b>Wear ring &amp; slipper seal</b></p> <ul style="list-style-type: none"> <li>• Are there any abrasions, scratches, or damage to the sliding surface?</li> <li>• Are there any metal particles embedded or broken pieces caught?</li> <li>• Is there any damage or carbonization from explosions?</li> <li>• Is there advanced wear?</li> </ul> <p><b>Piston</b></p> <ul style="list-style-type: none"> <li>• Are there any abrasions, scratches or scuffing on the outside circumference? Are the scratches damaging the wear ring mounting groove or slipper seal mounting groove?</li> <li>• Are there any impressions or abrasions at the contact surface at the head end?</li> <li>• Is there any scuffing of the nut tightening surface?</li> </ul>

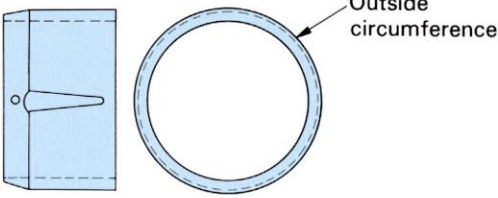
Cushion plunger

<p>The diagram shows a cross-section of the cushion plunger and its 'Outside circumference'.</p>	<p><b>Plunger</b></p> <ul style="list-style-type: none"> <li>• Are there any abrasions, scratches, or scuffing on the outside circumference?</li> </ul>
Cylinder tube

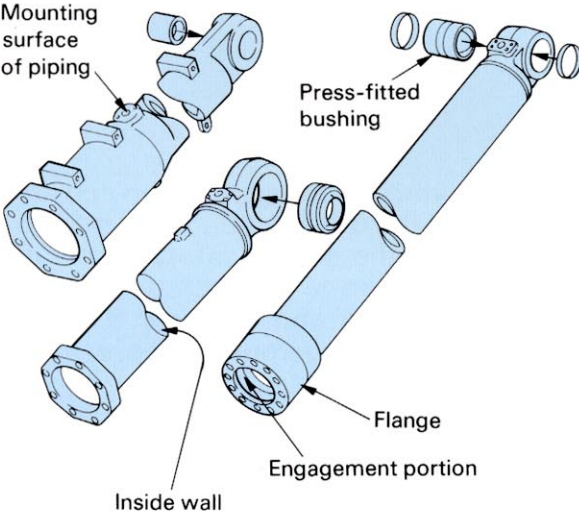
<p>The diagram shows the disassembled cylinder tube assembly with labels: 'Mounting surface of piping' on the top flange, 'Press-fitted bushing' on the tube, 'Inside wall' of the tube, 'Flange' at the bottom, and 'Engagement portion' where the tube meets the flange.</p>	<p><b>Cylinder tube</b></p> <ul style="list-style-type: none"> <li>• Are there any abrasions, scratches, or scuffing on the inside wall of the tube?</li> <li>• Are there any scratches or dents on the engagement portion of the flange (O-ring contact surface)?</li> <li>• Is there any scuffing of the insertion bushing at the bottom end? Is there any uneven wear? Is there advanced wear? (For details of repair limits, see the shop manual.)</li> </ul> <p><b>Appearance check</b></p> <ul style="list-style-type: none"> <li>• Are there any depressions in the tube? (Check for any rocks or wood caught, or abnormalities such as rolling over.)</li> <li>• Are there any bulges in the tube?</li> </ul>

- ★ When carrying out checks of the inside wall of the cylinder tube, first wash the inside thoroughly and dry off the oil completely before checking. It is easy to overlook deep but small scratches on the inside of the cylinder. Check carefully right to the end of the cylinder.
- ★ For details of the checking procedure, see page 35.
- Press-fitted bushing on cylinder (including bushing at rod end). There is a tendency to pay little attention to scuffing of the bushing. Seizure and scuffing are indirect causes of internal damage to the cylinder. Check the condition of damage at the pin end, and judge both when making a decision.  
[Explanation of the pin is not included in this manual.]

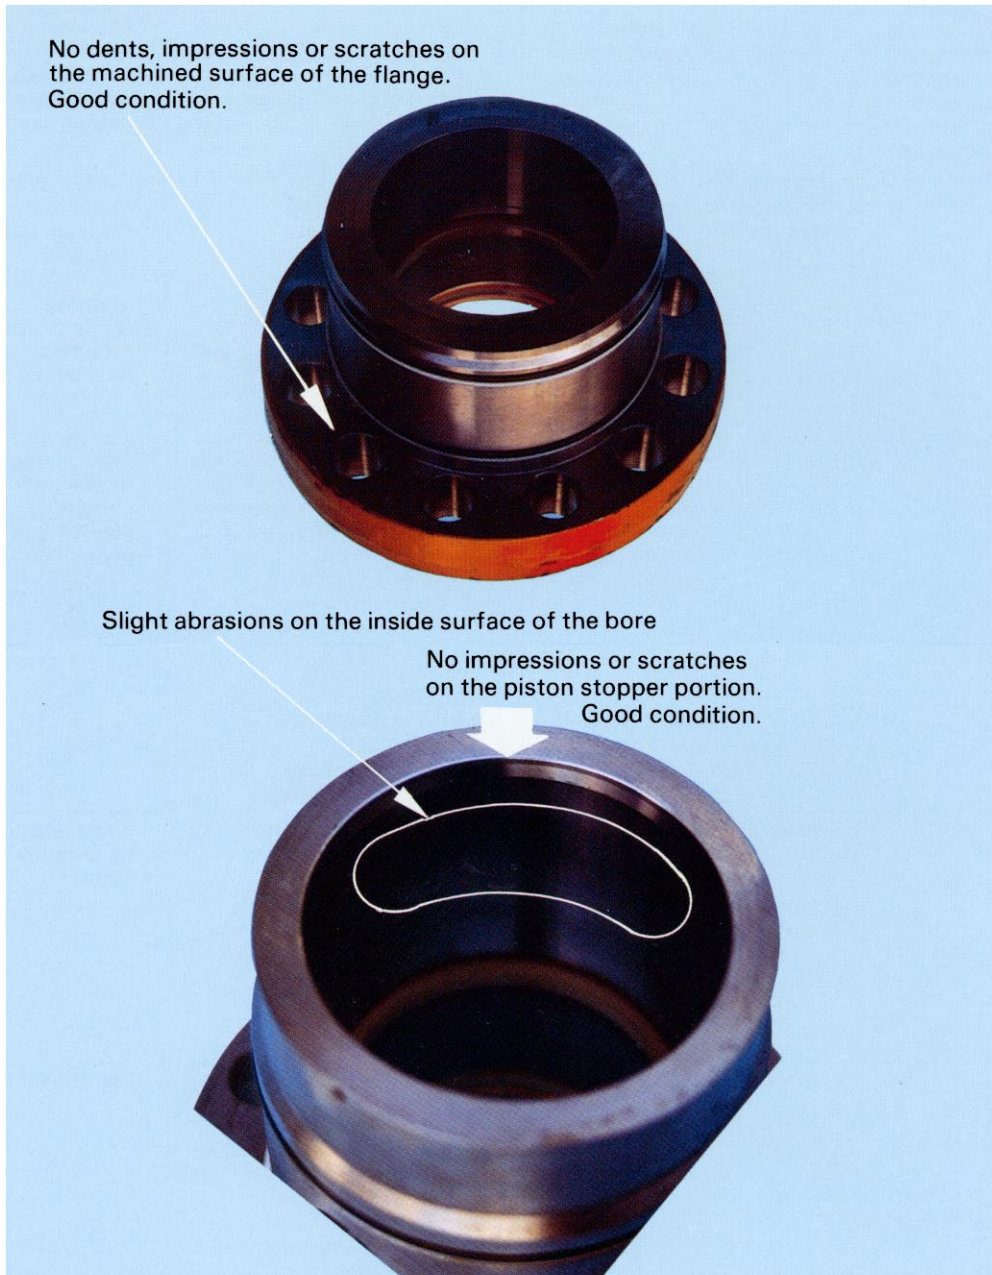
1

**Cylinder Head (Piston Stopper Portion, Machined Surface of Flange, Inside Wall Surface of Bore)**

**Category: A**  
**Condition**

- There are slight abrasions on the inside surface of the cylinder head bore, but there are no dents, impressions, or scratches on either the machined surface of the flange or the piston stopper portion.

- Abrasion is caused by foreign material getting caught

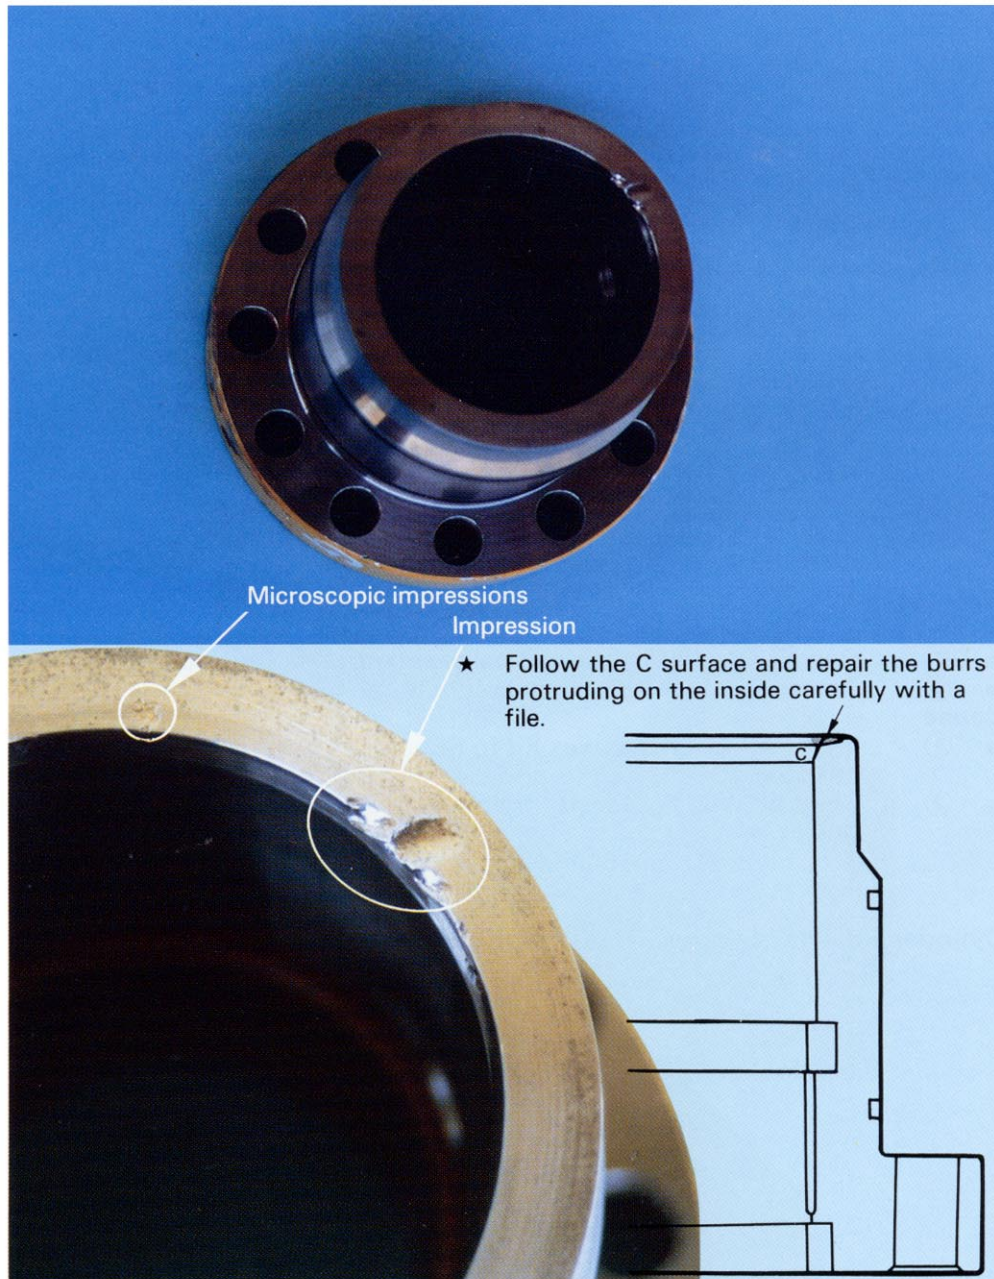
2

## Cylinder Head (Piston Stopper Portion)

### Category: **B**

- Broken pieces got caught

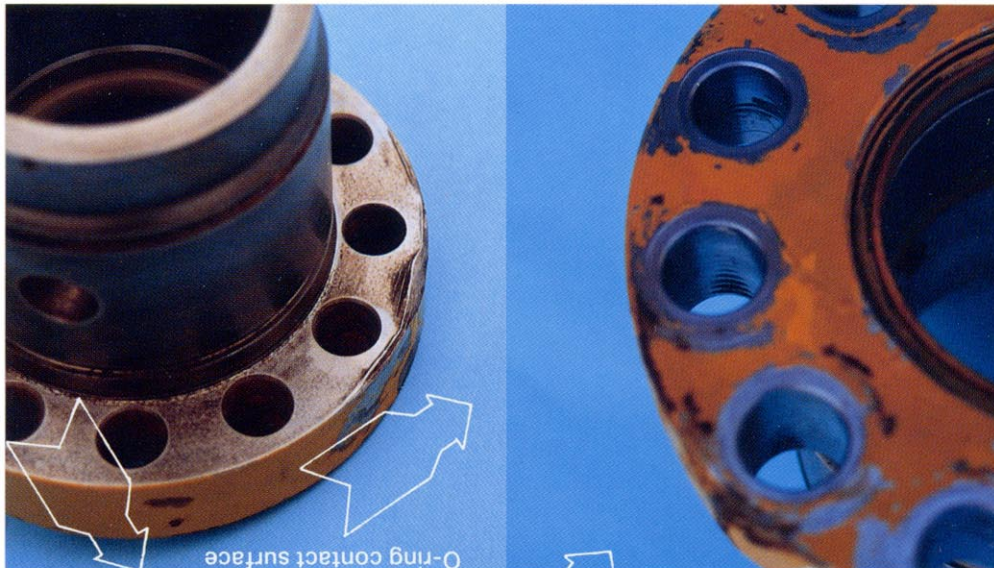
3

### Cylinder Head (Machined surface of flange, Bolt hole)

#### Category: B Condition

- ① Dents on end of flange and bulges in machined surface
- ② Traces of screw biting into bolt hole can be seen

- ① The part concerned was hit to remove it during disassembly of the cylinder.
- ② The bolt was tightened forcibly when not centered properly in the bolt hole.
  - ★ This may damage the screw, so be careful.Both caused by basic mistake during disassembly and assembly

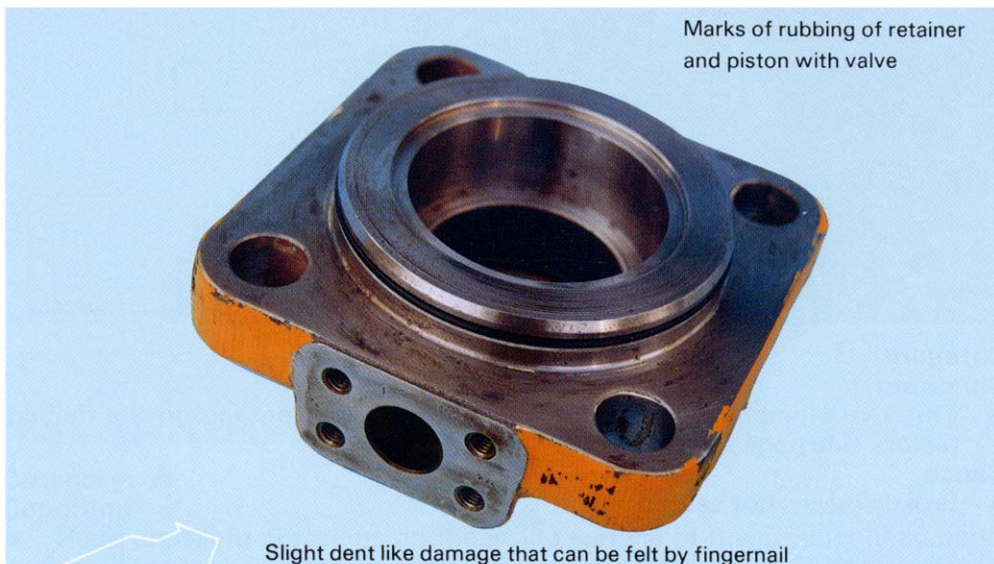
4

### Cylinder Head (Mounting surface of piping and piston stopper portion)

#### Category: A Condition

- There is slight dent like damage that can be felt by the fingernail in the piping mounting surface.
- ★ Slight abrasion on the piston stopper contact surface. This is made by rubbing of the retainer of the piston with valve at the stroke end caused by the swivel movement of the cylinder mount and the ball joint at the end of the piston rod. This is not an abnormality.

- The damage to the mounting surface of the piping is caused by a mistake in handling the components.

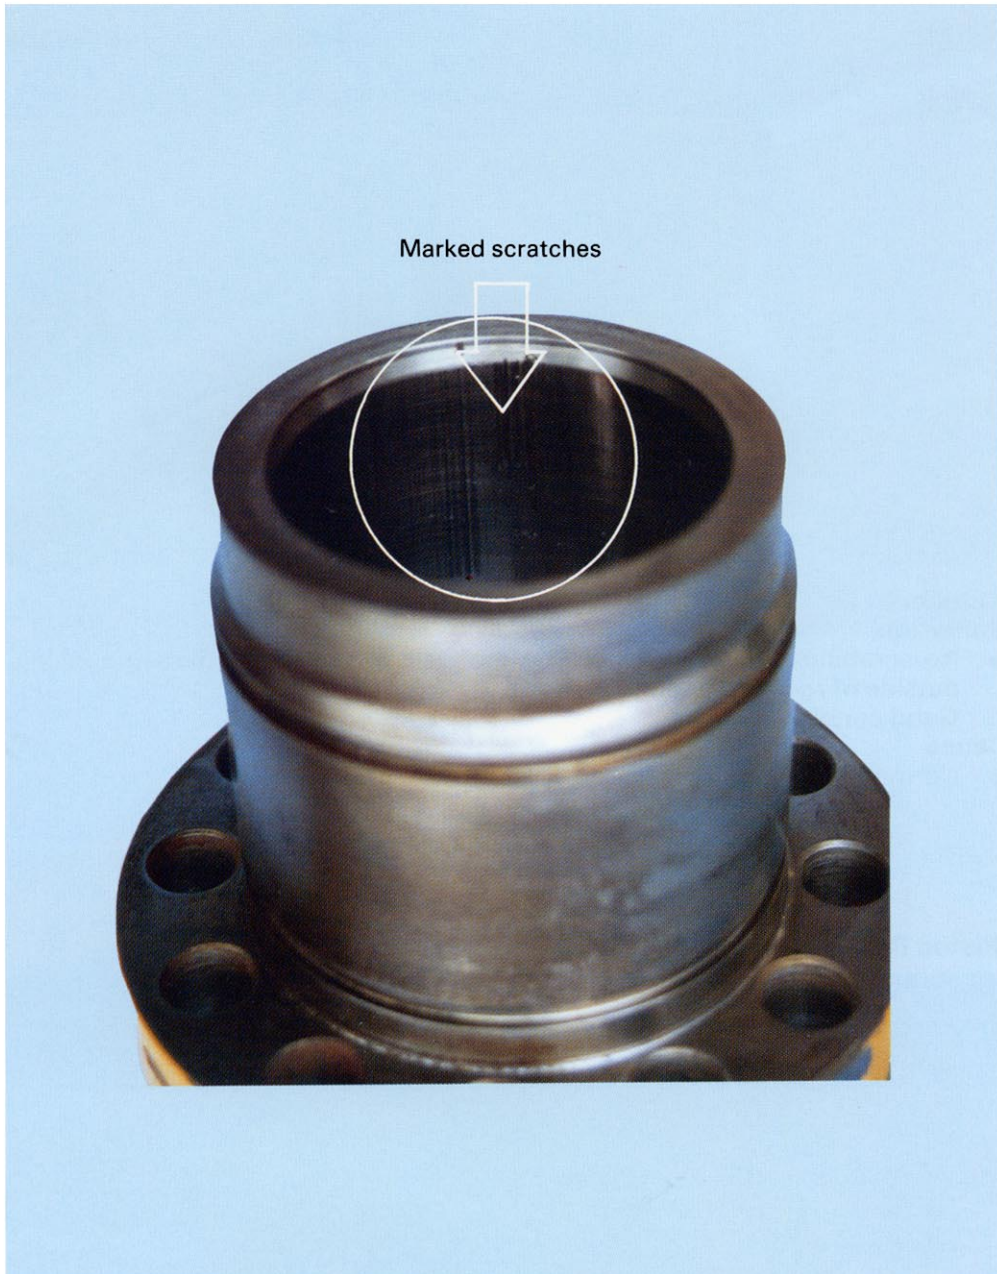
5

## Cylinder Head (Inside surface of Bore)

### Category: **C**

- Broken pieces from damage inside the cylinder got caught.

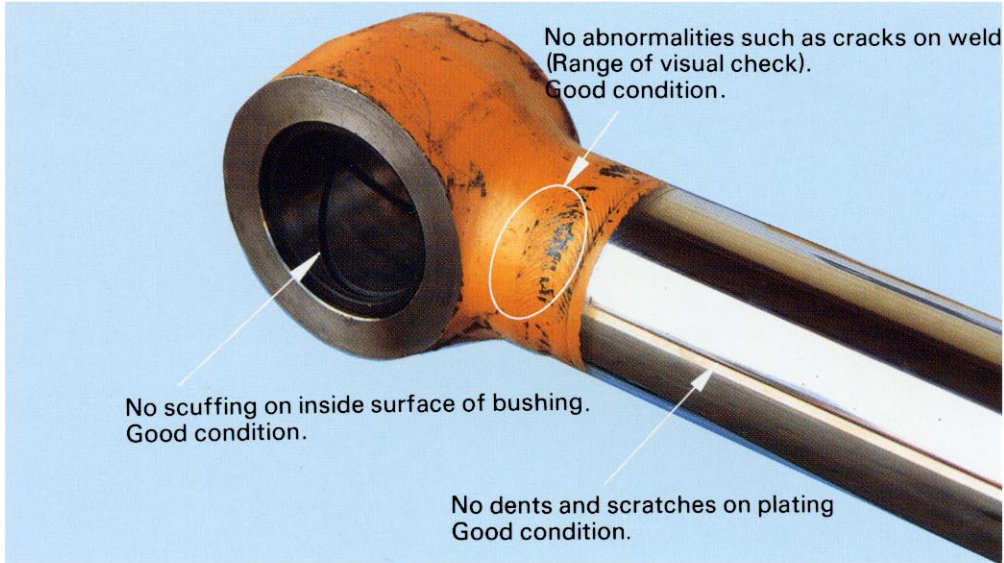
**6**

**Piston Rod (Rod end bushing, Weld at rod end, Plating)**

**Category: A**

- No scratches, dents, or cracks on the weld at rod end, insertion bushing, outside of rod end, or plating. Good condition.

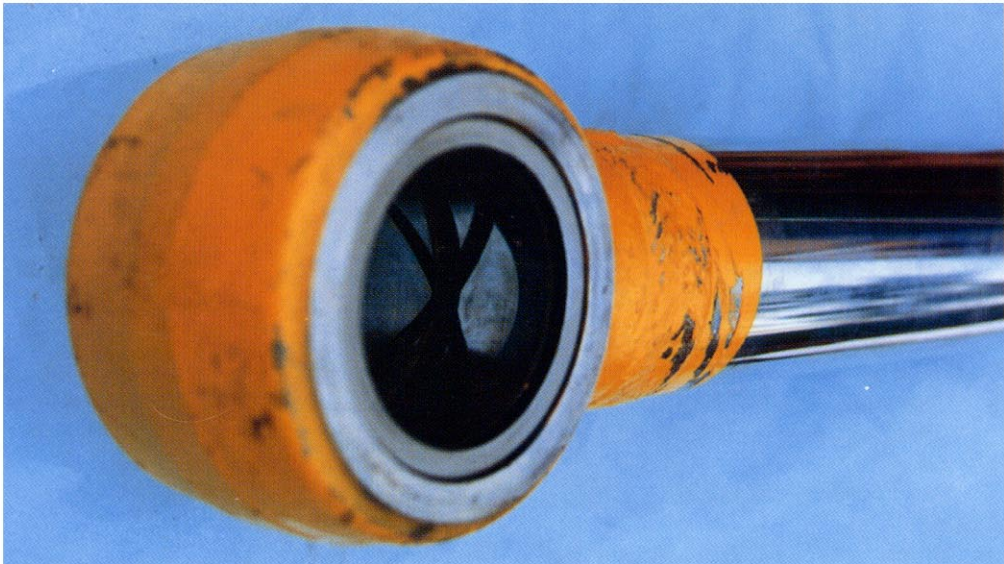
**7**

**Piston Rod (Rod end bushing, Weld at rod end, Plating)**

**Category: A**

- No scratches, dents, or cracks on the weld at rod end, insertion bushing, outside of rod end, or plating. Good condition.

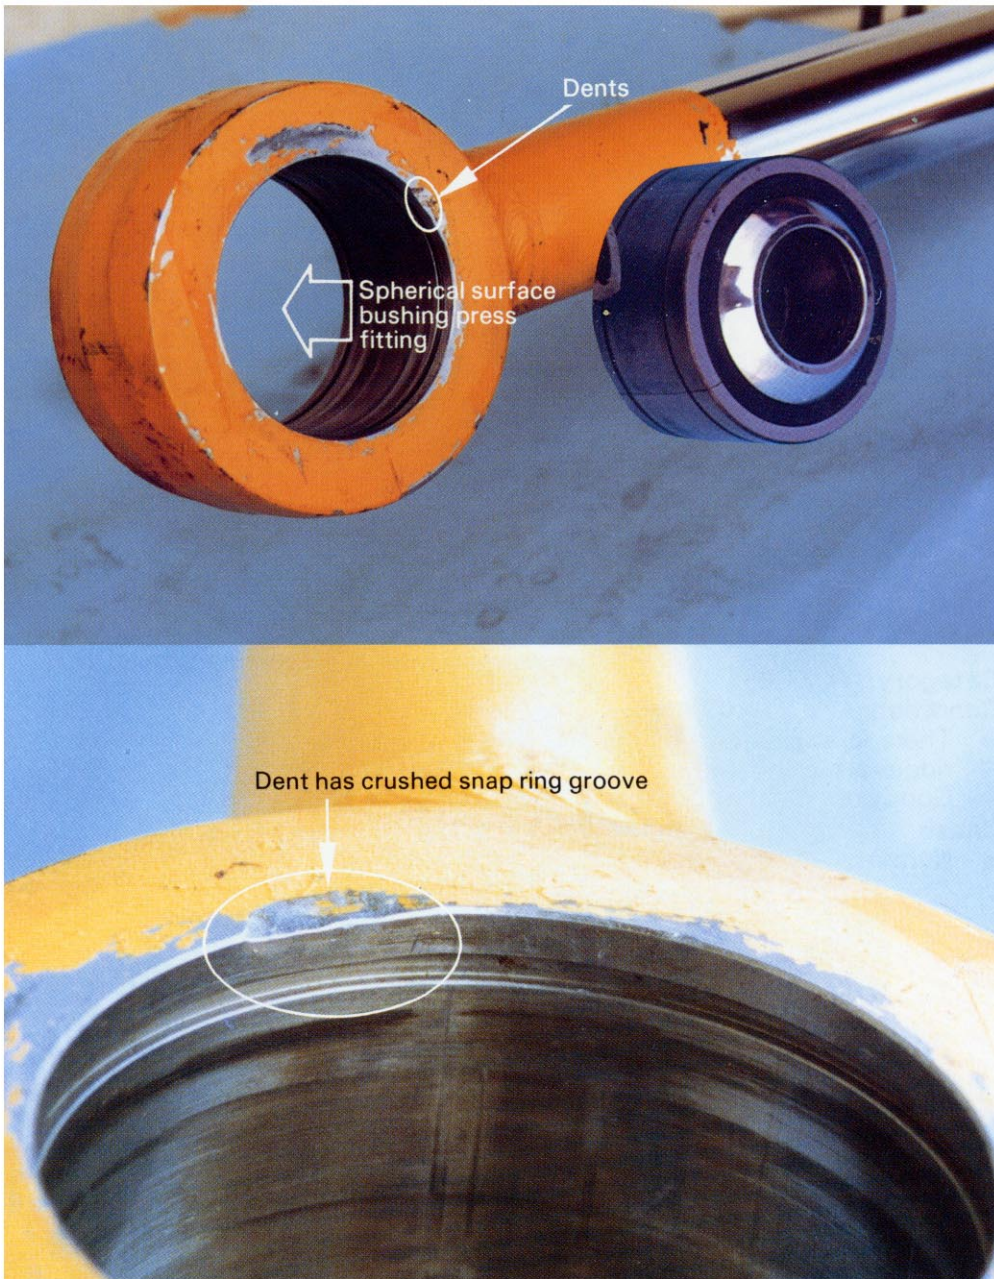
**8**

**Piston Rod (Press fitting hole for bushing at rod end)  
(Outside appearance of rod end)**

**Category: B**

- The dent is probably caused by a mistaken blow when using a hammer in some work.  
The longitudinal scratch on the inside surface of the hole is normal abrasion caused when press fitting or removing the bushing.

- Repair of dent:  
Remove the protruding part at the main part of the groove and the inside diameter of the hole with a hand tool.  
If the snap ring fits easily into the groove, there is no need to repair the groove.
- Repair of longitudinal scratch:  
Remove the burrs, and rub the main part several times with #180 sand paper to repair.

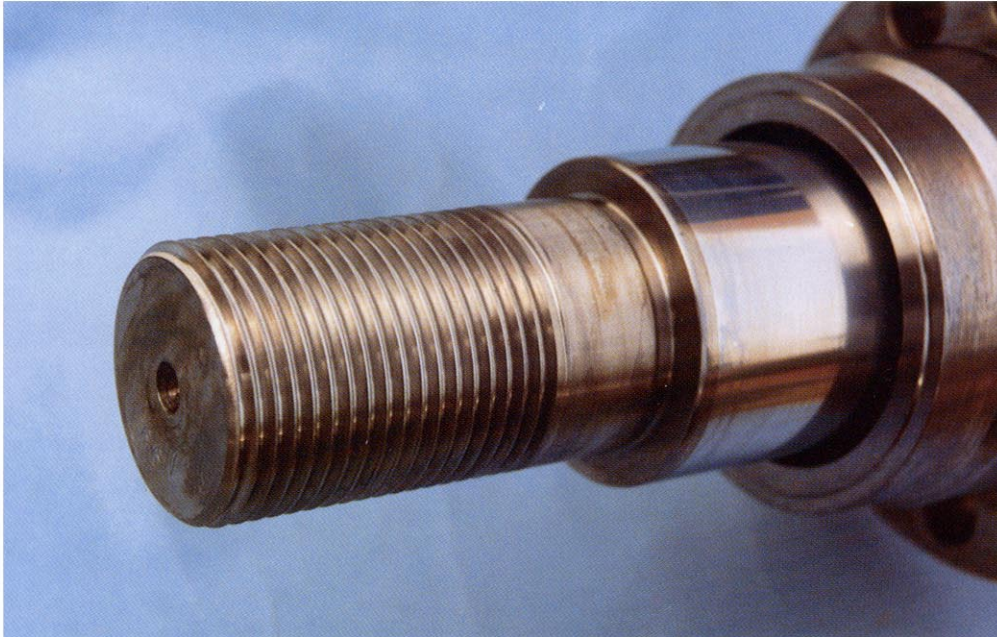
**9**

**Piston Rod (Screw at rod end)**

**Category: A**

- There is no scuffing of the screw at the rod end, and none of the thread ridges are crushed.  
Good condition.

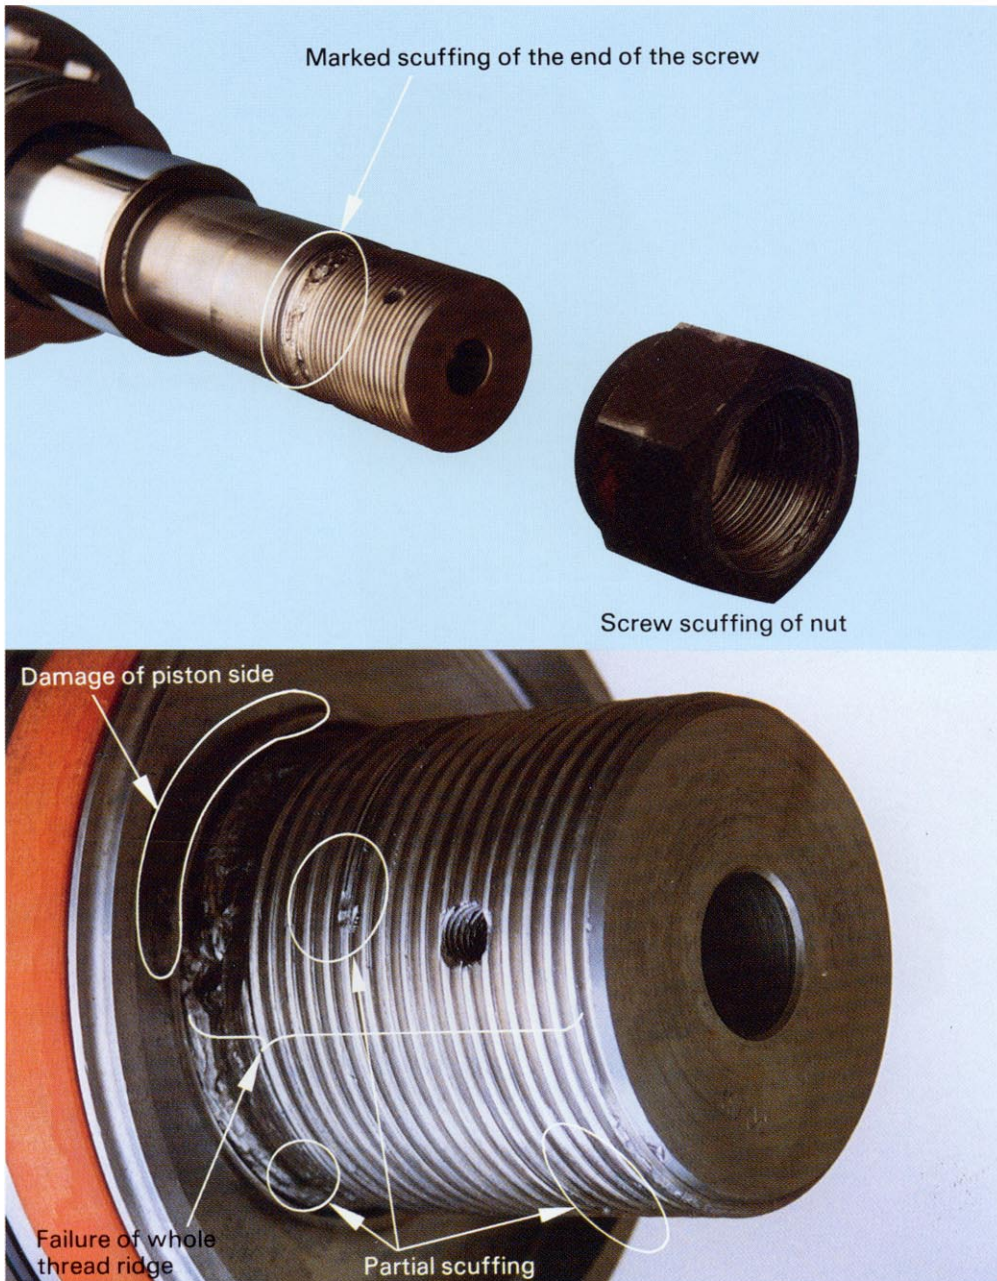
**10**

**Piston Rod (Screw at rod end)**

**Category: C**  
**Condition**

- Crushed thread ridges can be seen at various parts of the rod end screw, and there is partial scuffing at the end of the screw at the tip of the rod. In particular, the scuffing of the end of the screw is marked, and the damage extends also to the piston.

- Mistaken operation. This was probably caused by an abnormality in the assembly operation for the piston, or by an abnormality in the tightening operation. (The piston was fitted half way and then screwed in although it was at an angle)

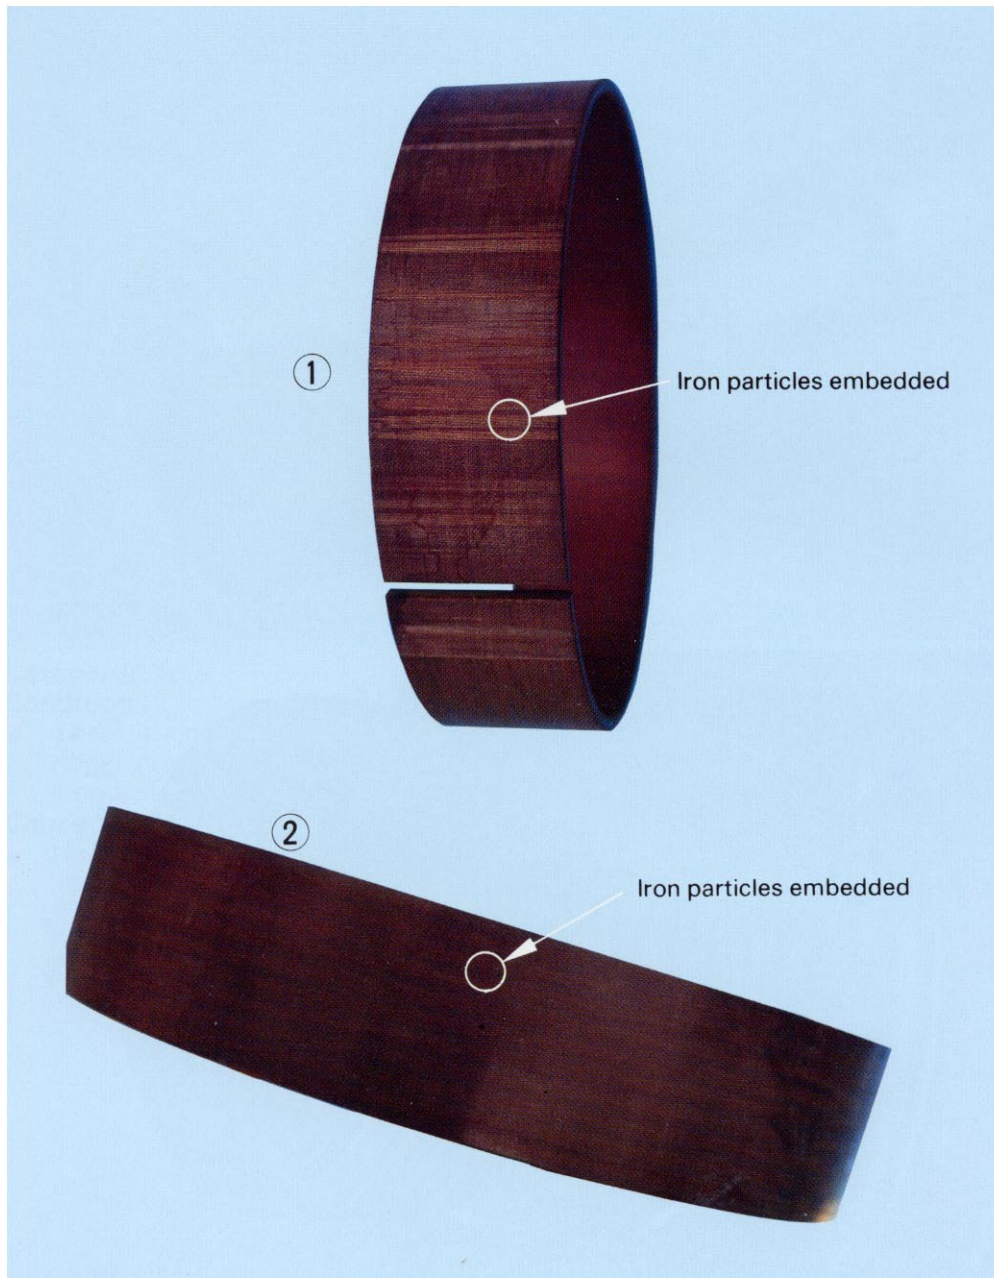
11

## Wear Ring (Sliding surface and outside appearance)

### Category: C

- The scratches in above ① are caused by foreign material getting caught or scuffing of the inside wall of the cylinder.

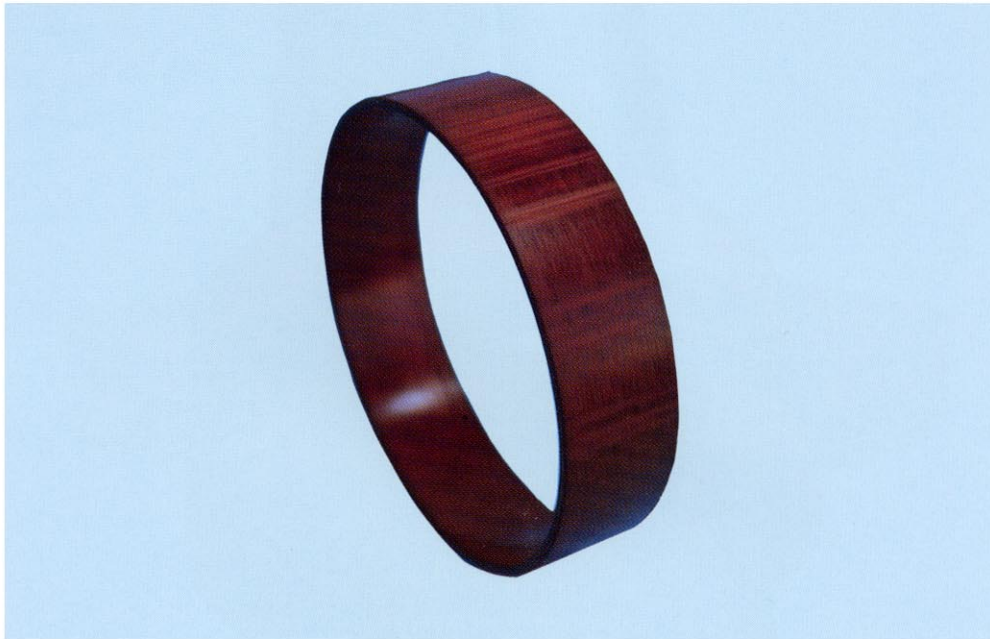
**12**

**Wear Ring (Sliding surface)**

**Category: C**

- This is caused by foreign material in the hydraulic oil getting caught.

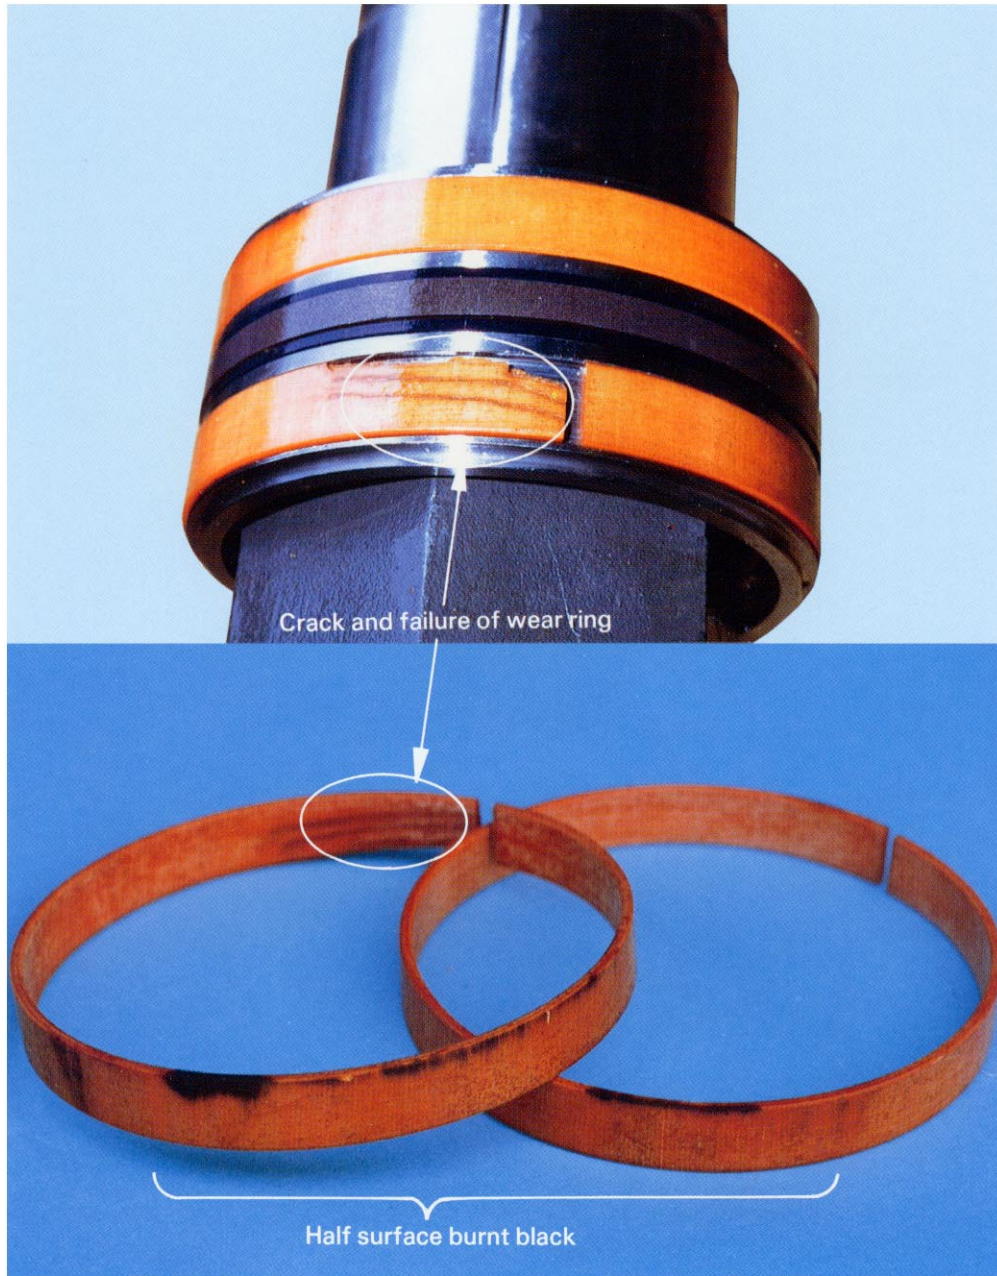
13

## Wear Ring, Slipper Seal (Sliding surface)

### Category: C

Note: There are cases where the inside of the slipper seal is damaged by air blowing out from the combustion pressure.  
Replace the seal also.

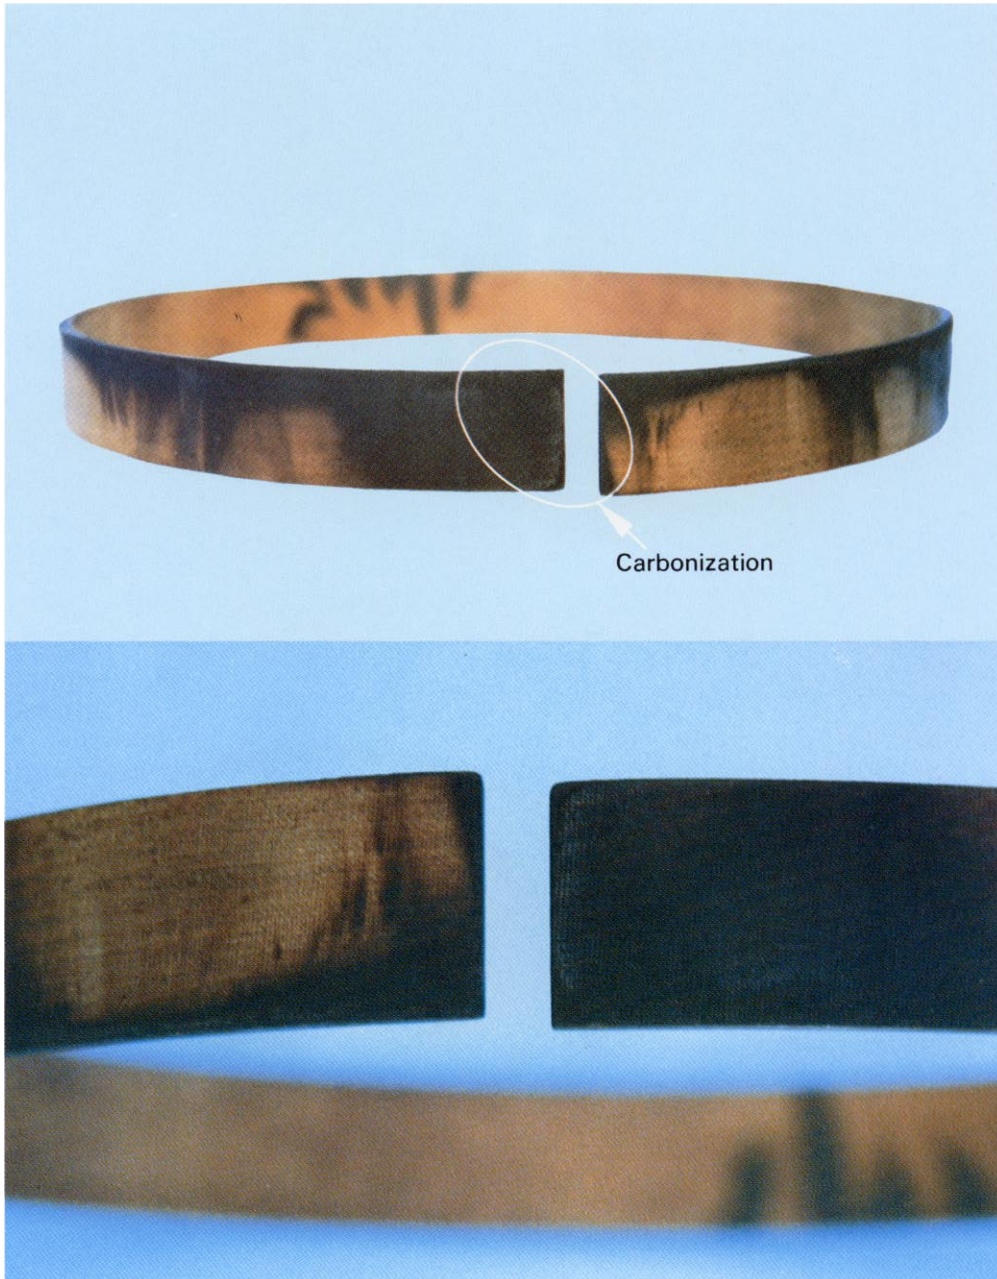
**14**

**Wear Ring (Outside appearance)**

**Category: C**

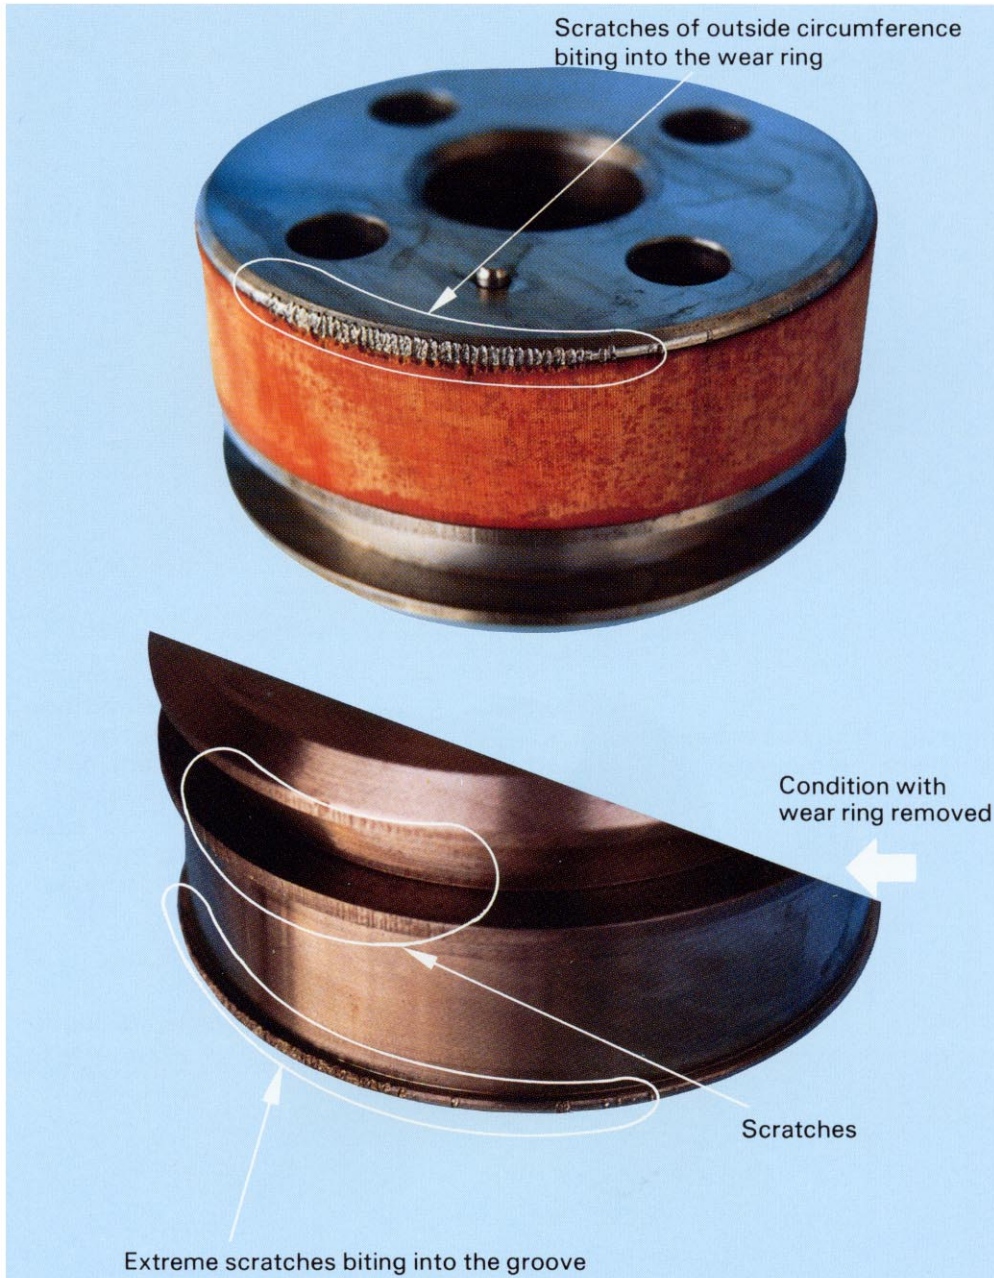
**20**

**Category: C**  
**Condition**

- There are marked deep scratches from the end of the outside circumference of the piston to the wear ring, and they are biting strongly into the wear ring. Compared to the size of the scratches on the piston, the scratches on the wear ring are restricted in size.

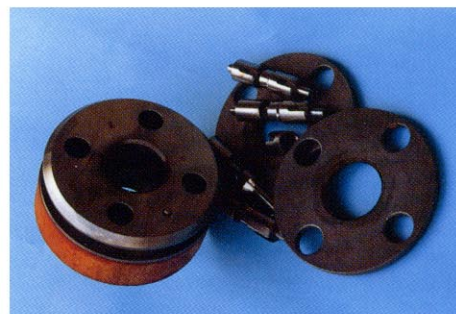
**Piston (Outside circumference and groove)**

The photograph shows piston with piston valve.
