# SHOP MANUAL

## **GUIDANCE FOR REUSABLE PARTS**

# **HYDRAULIC CYLINDER**

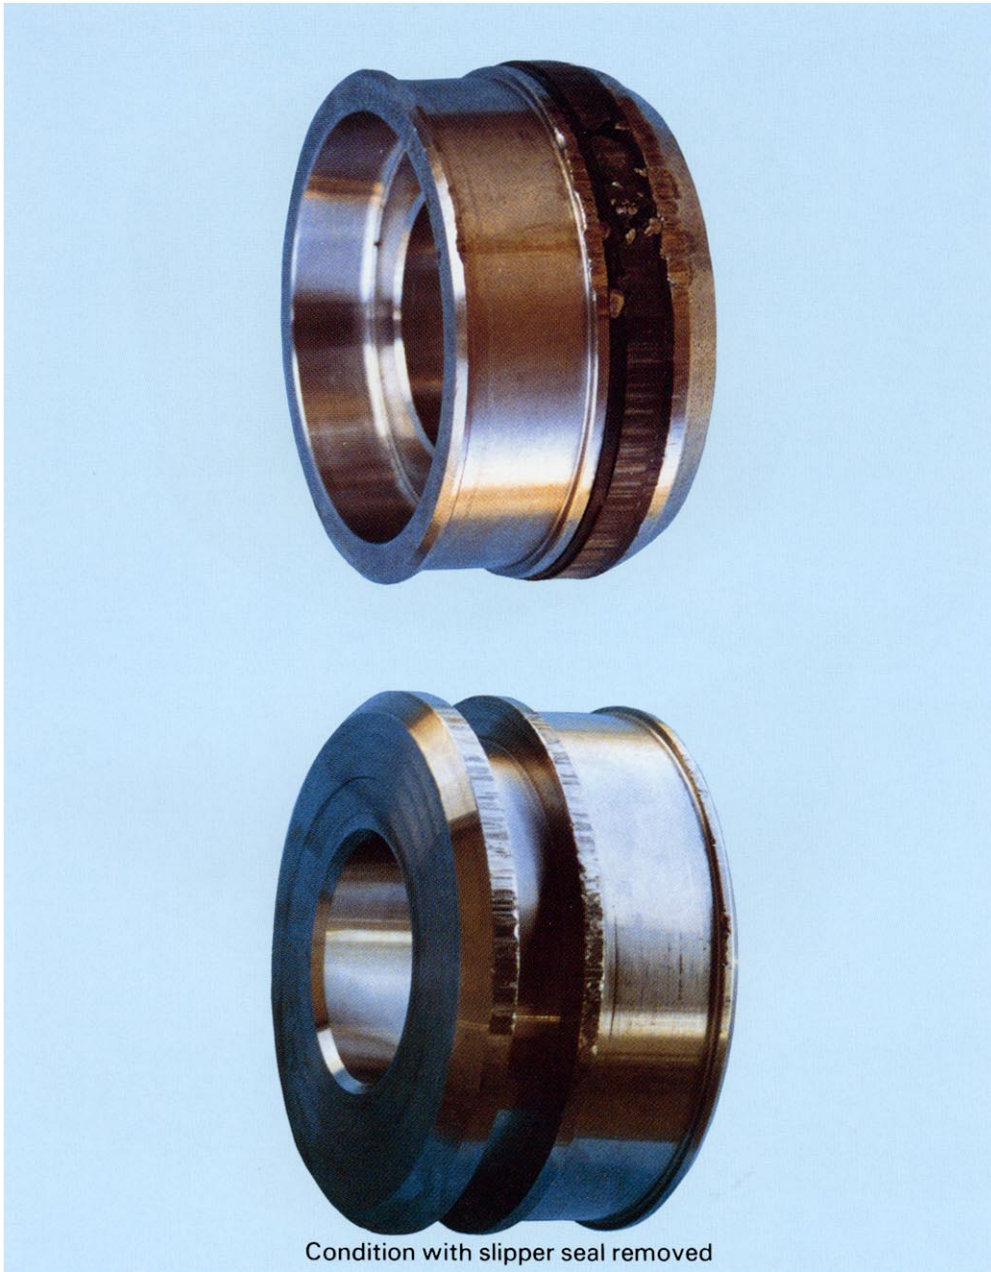
**21**

**Piston (Outside circumference and groove)**

**Category: C**

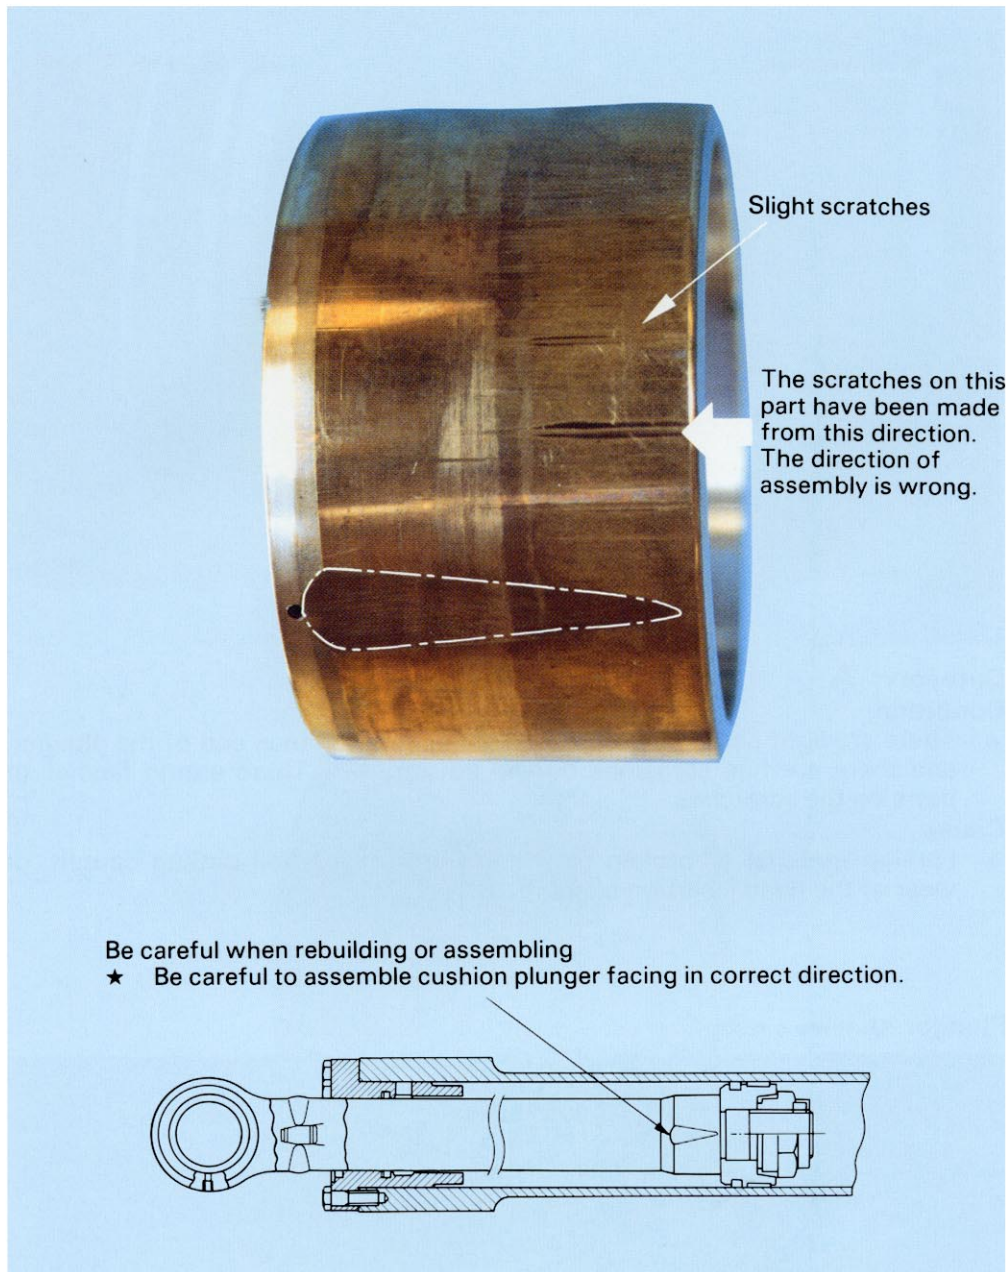
24

### Category: B

- ★ Assemble so that wide slit is facing head

- If there are burrs or protrusions formed on surface of scratch, use a fine file to lightly rub the raised part and remove the protrusion.
  - ★ Be careful not to cut into the base surface.

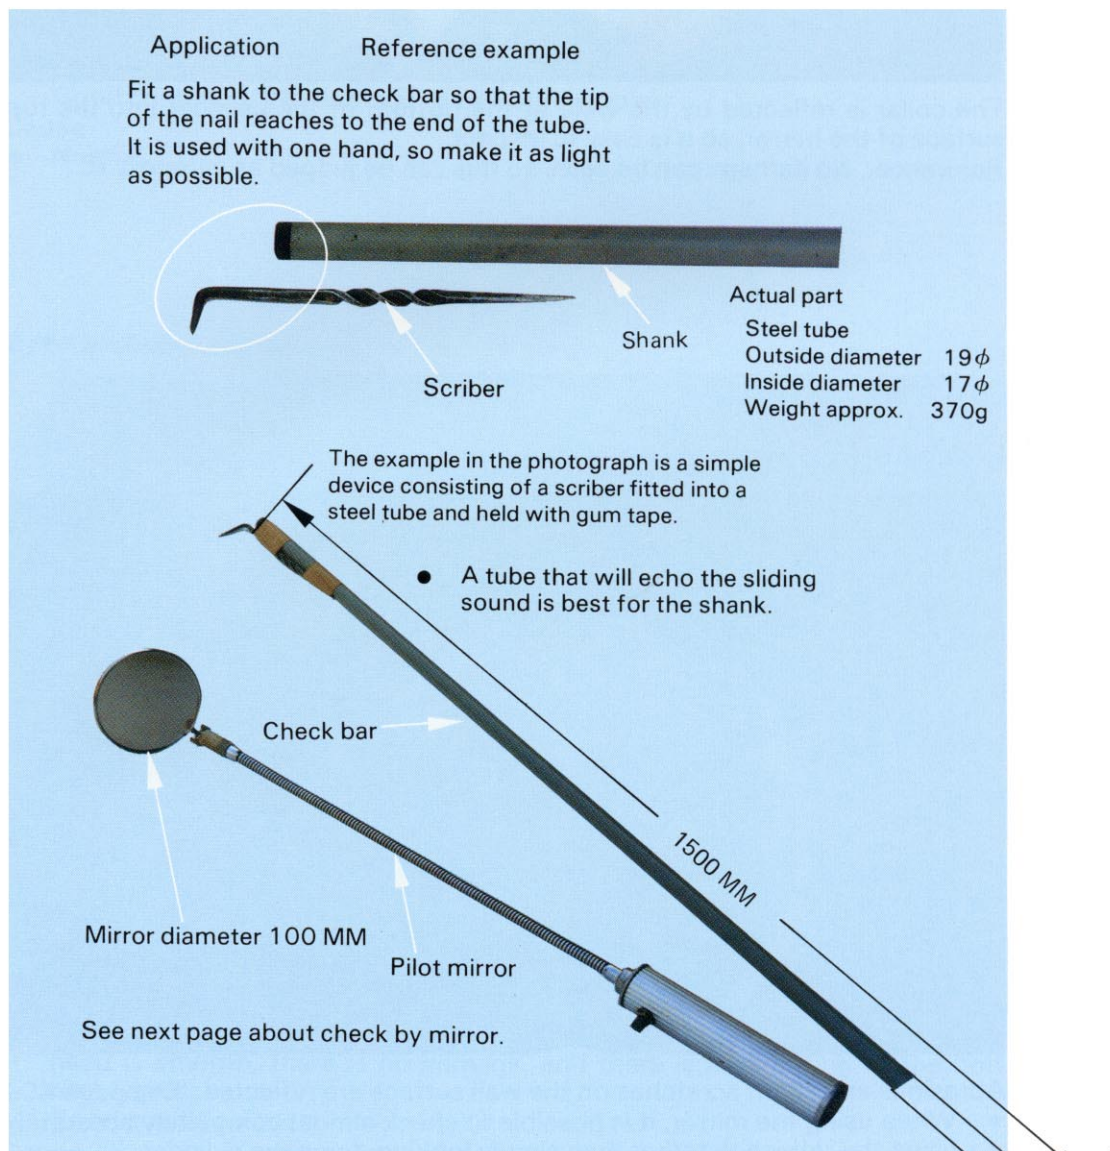
## Applicable Example (Inspection by check bar)

Hold the check bar in one hand, move it up the cylinder along the inside wall of the cylinder tube swinging the check bar like the pendulum of a clock, and gradually move to check the surface. Push only with the weight of the bar, do not add any force.

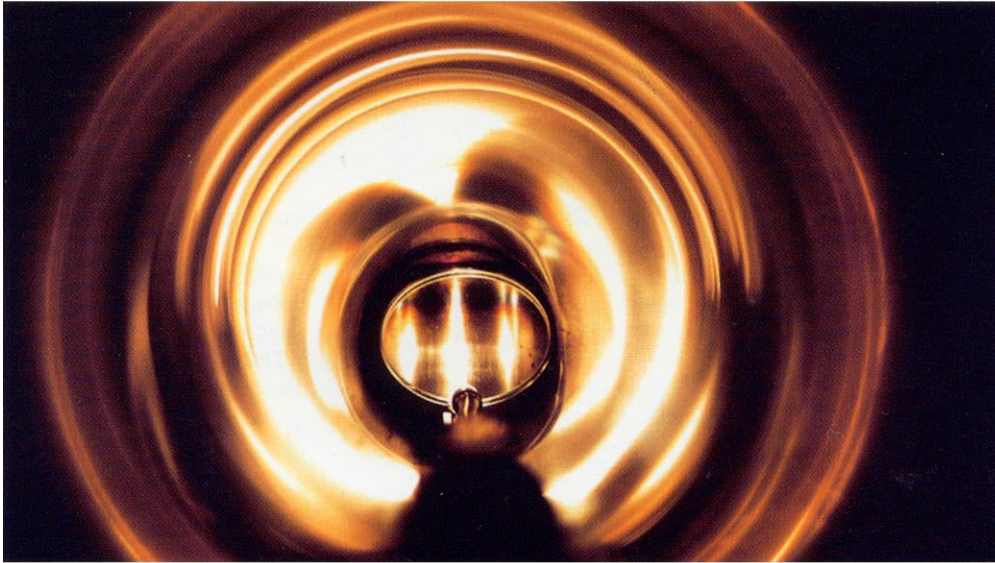
25

The collar is reflected by the weld at the bottom of the cylinder into the top surface of the mirror, so it is easy to inspect.

Reference: No damage can be seen, so this can be judged as category A.

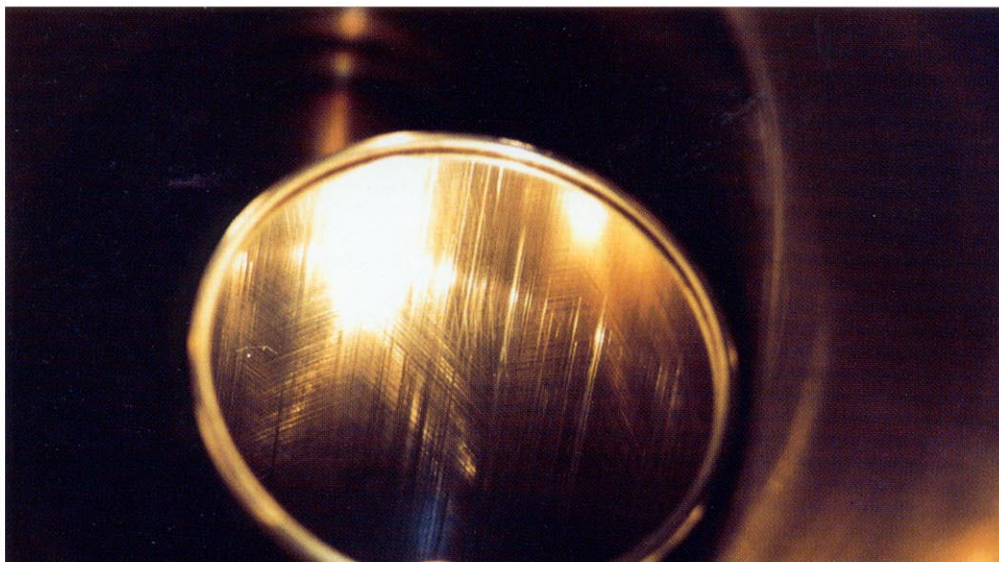
26

Abrasions and slight scratches on the wall surface are reflected. (See page 40.)

★ When using the mirror, it is possible to check almost completely accurately using the reflection rather than simply looking down the cylinder.

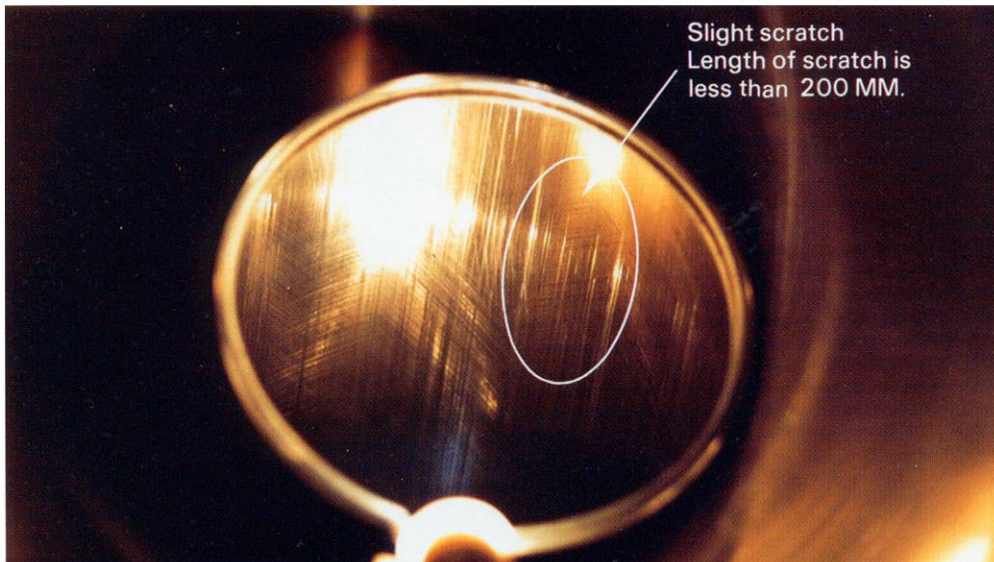
33

**Category: B**

- ★ Note: If the damage at the end of the cylinder tube cannot be corrected by polishing with an oil stone or sandpaper, place in category **C**.

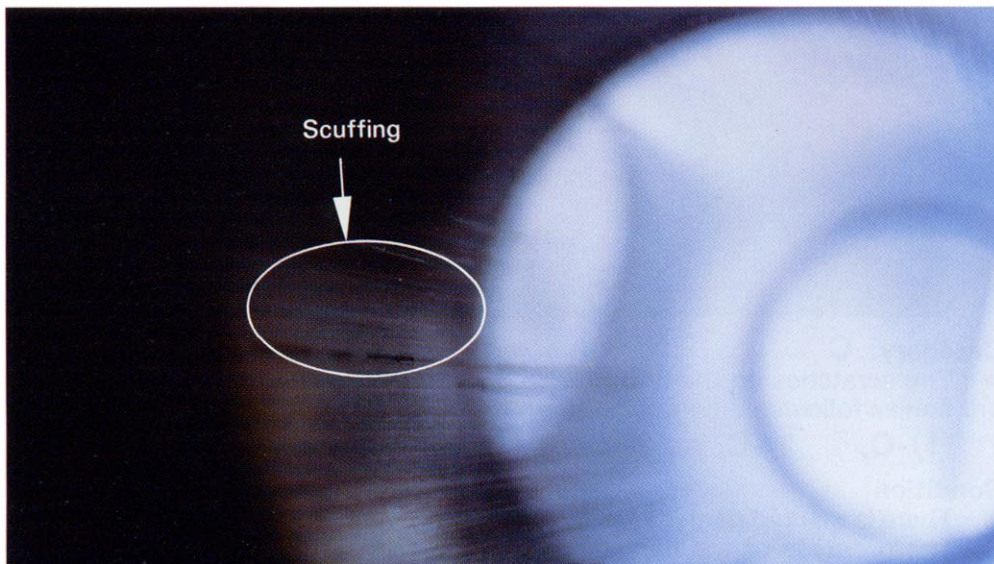
**35**

**Category: C**

Note: If there is scuffing, the parts cannot be reused

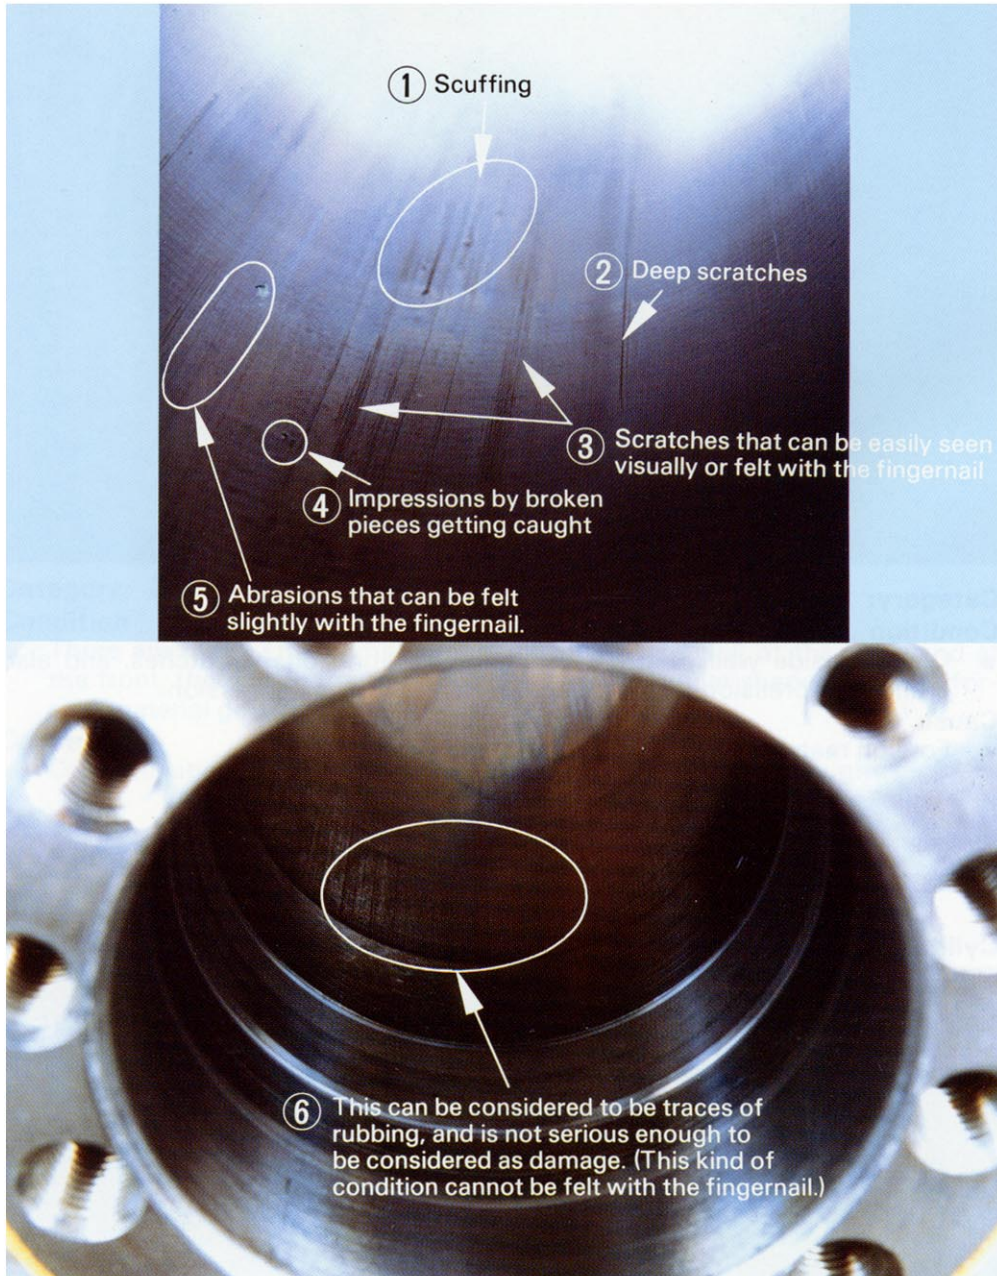
36

### Category: C

★ The scratches on the photograph can be judged according to their condition as follows.

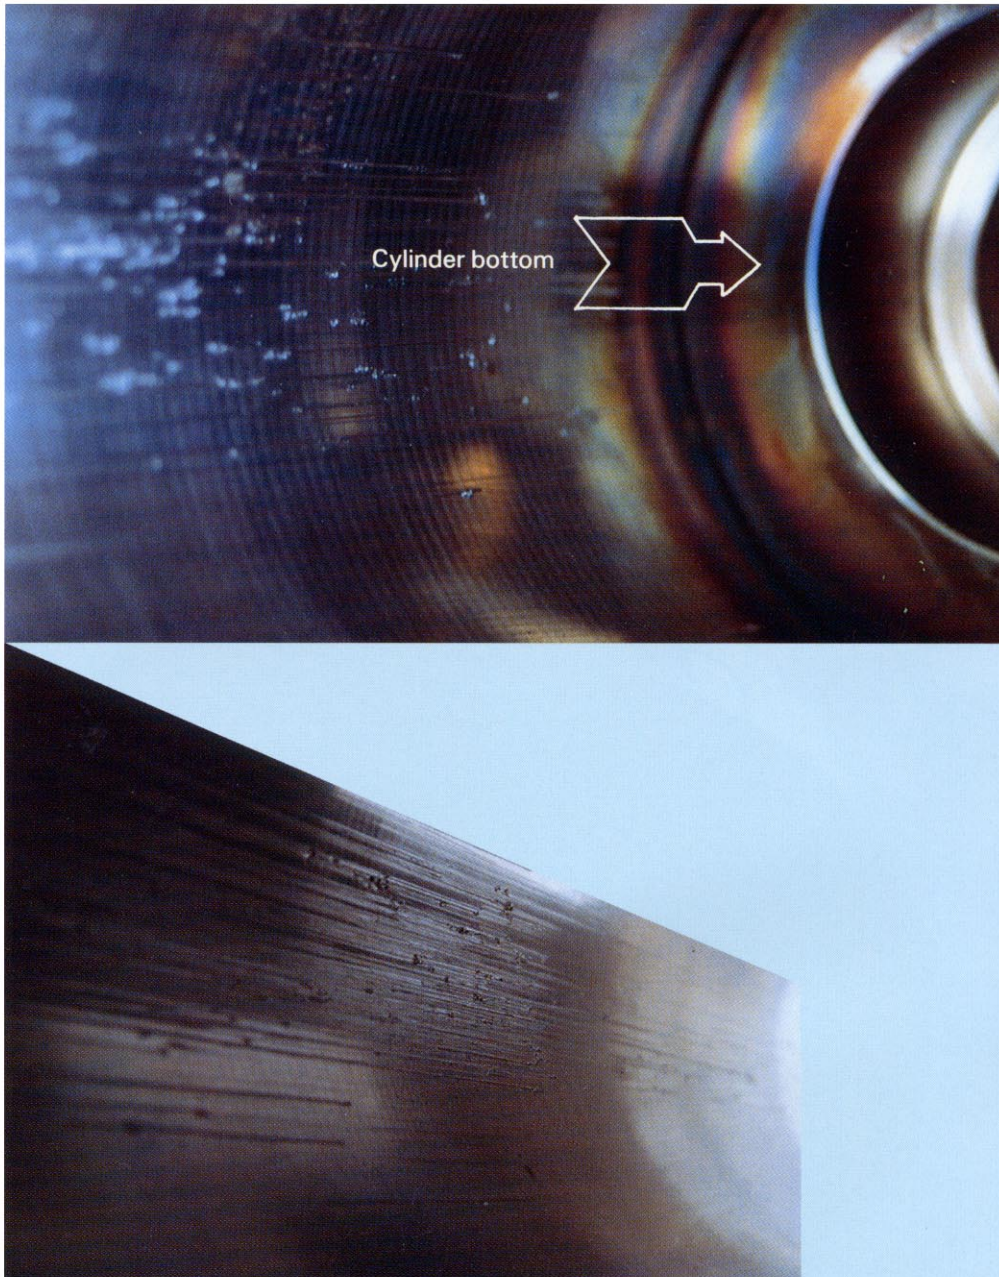
Cylinder Tube (Inside wall)

**Category: C**

**Condition**

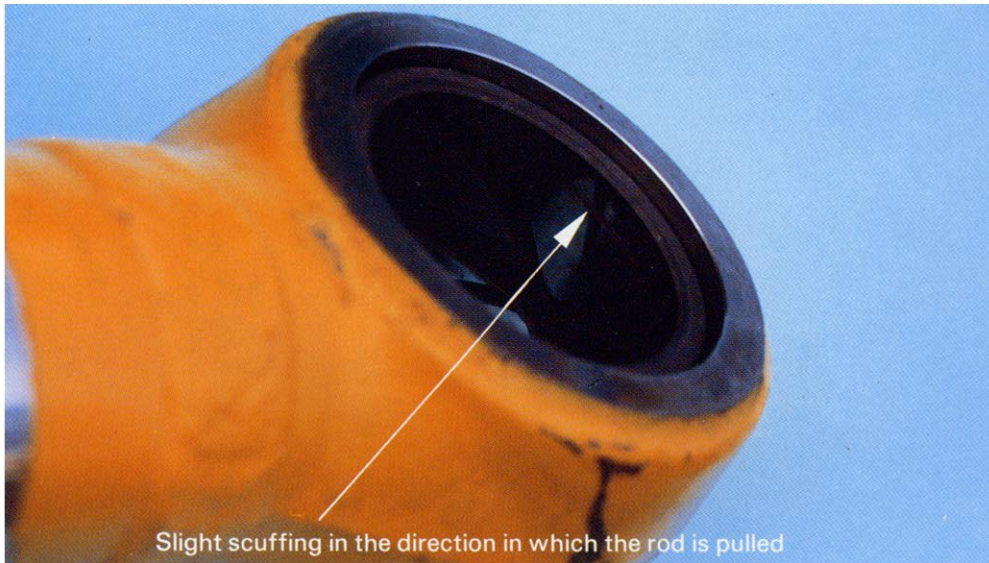
**39**

**Category: B**

Note: Remove the seizure from the mating pin also when correcting

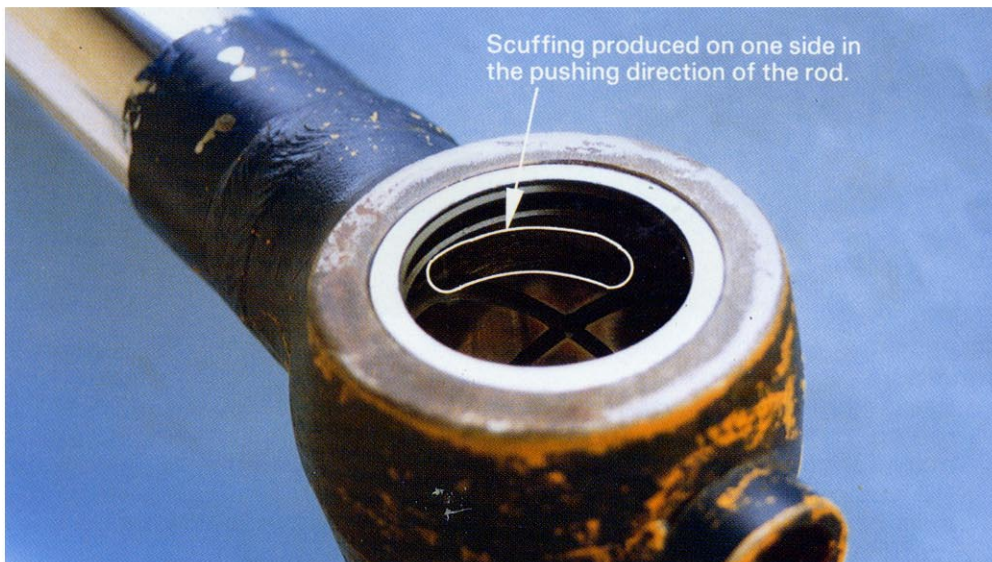
**40**

**Category: B** Note: Replace the mating pin

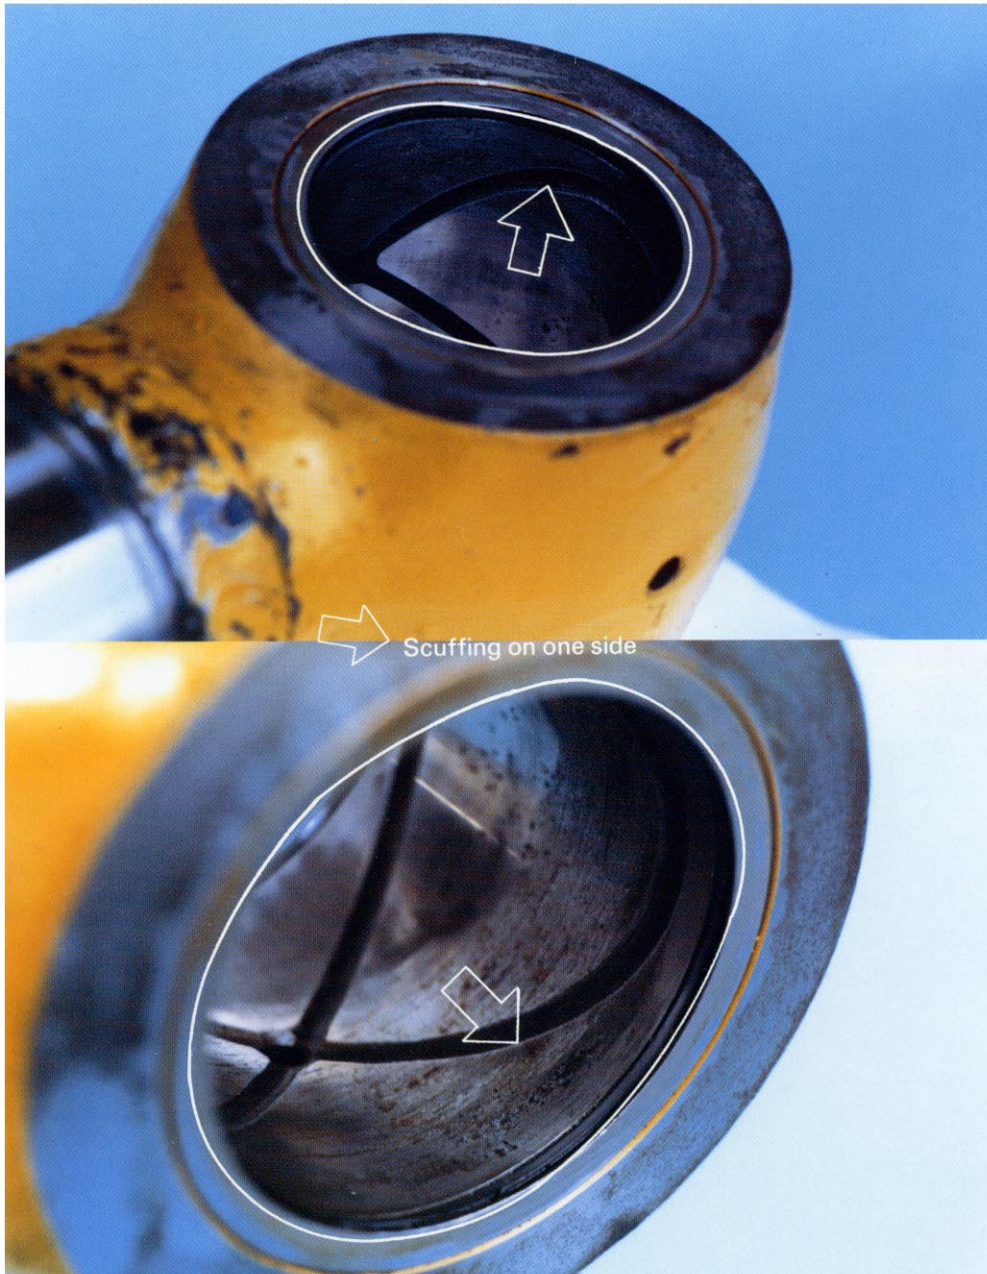
## Bushing (Rod end bushing)

### Category: C

#### Condition

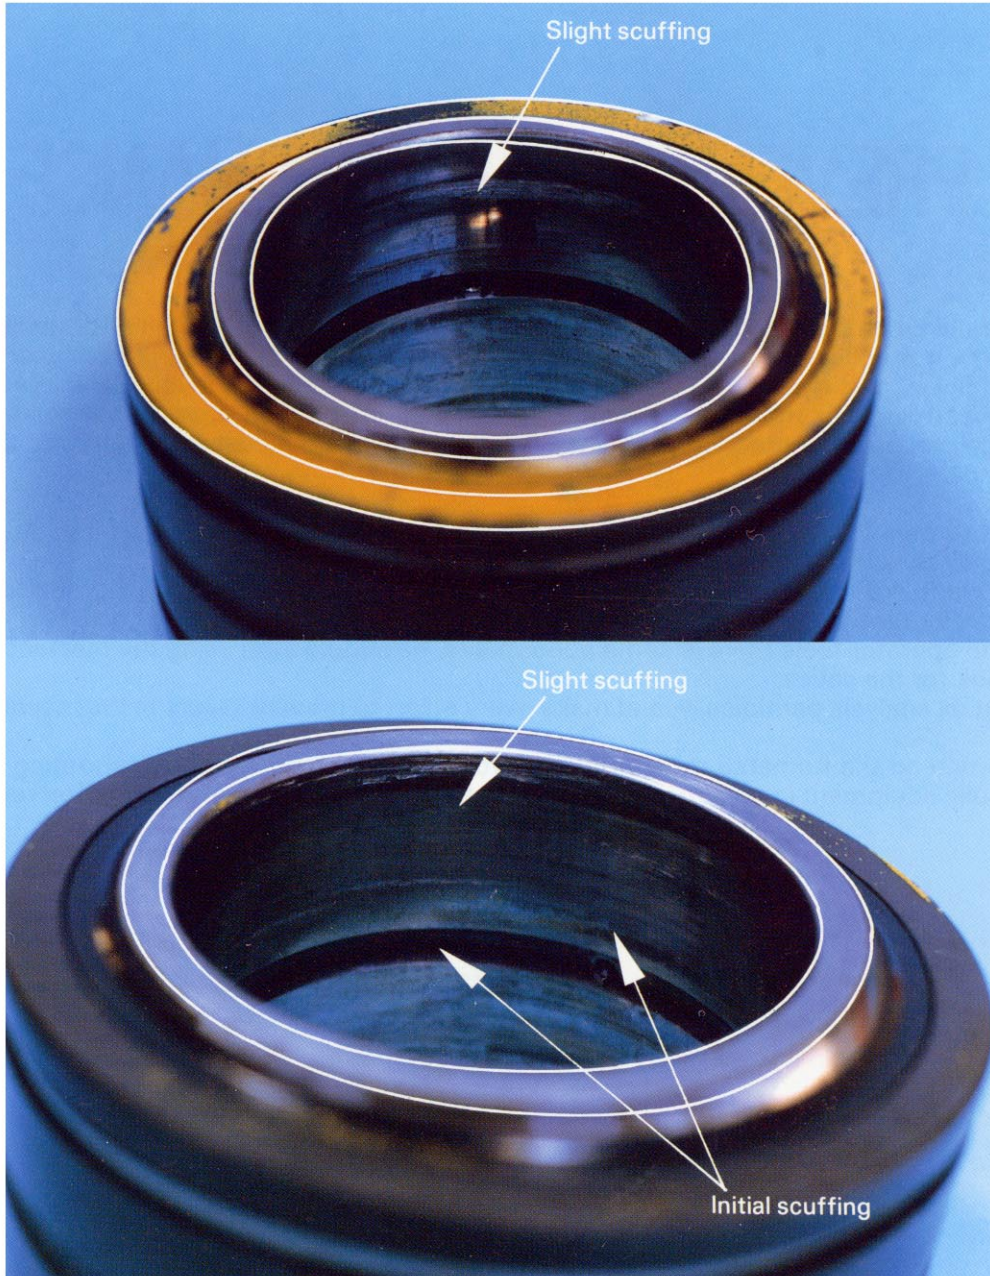
47

**Category: B**

Note: Even if there is damage to the pin hole, if there is no damage such as scuffing on the ball of the spherical bushing, it can be reused.

- Remove the raised part of the damage cause by scuffing carefully with a pencil grinder to finish the surface.

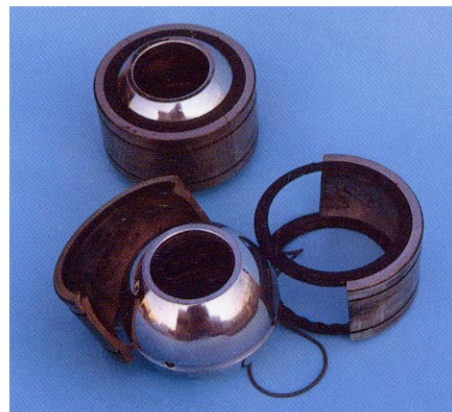
**Remedy**

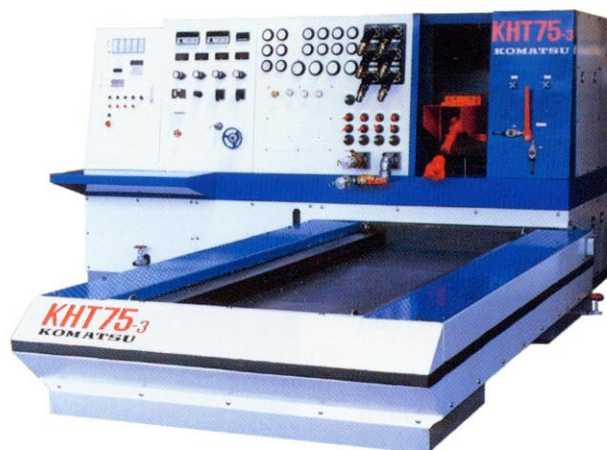
[Part No. 799-402-1003]

## Komatsu multi-purpose hydraulic test stand

Weight; Main body:	5100 kg
Oil tank:	1800 kg
Output;	75 kW
