GUIDANCE FOR REUSABLE PARTS

HYDRAULIC CONTROL VALVES

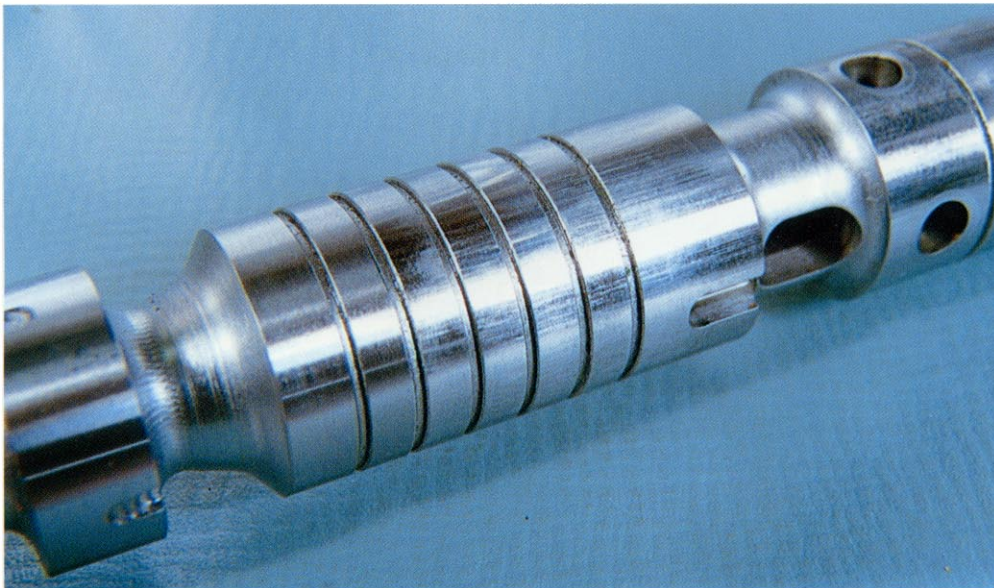
Category: B

- Contamination of oil, catching of wear particles.

- Correct carefully with sandpaper #600 – 800. See P14.

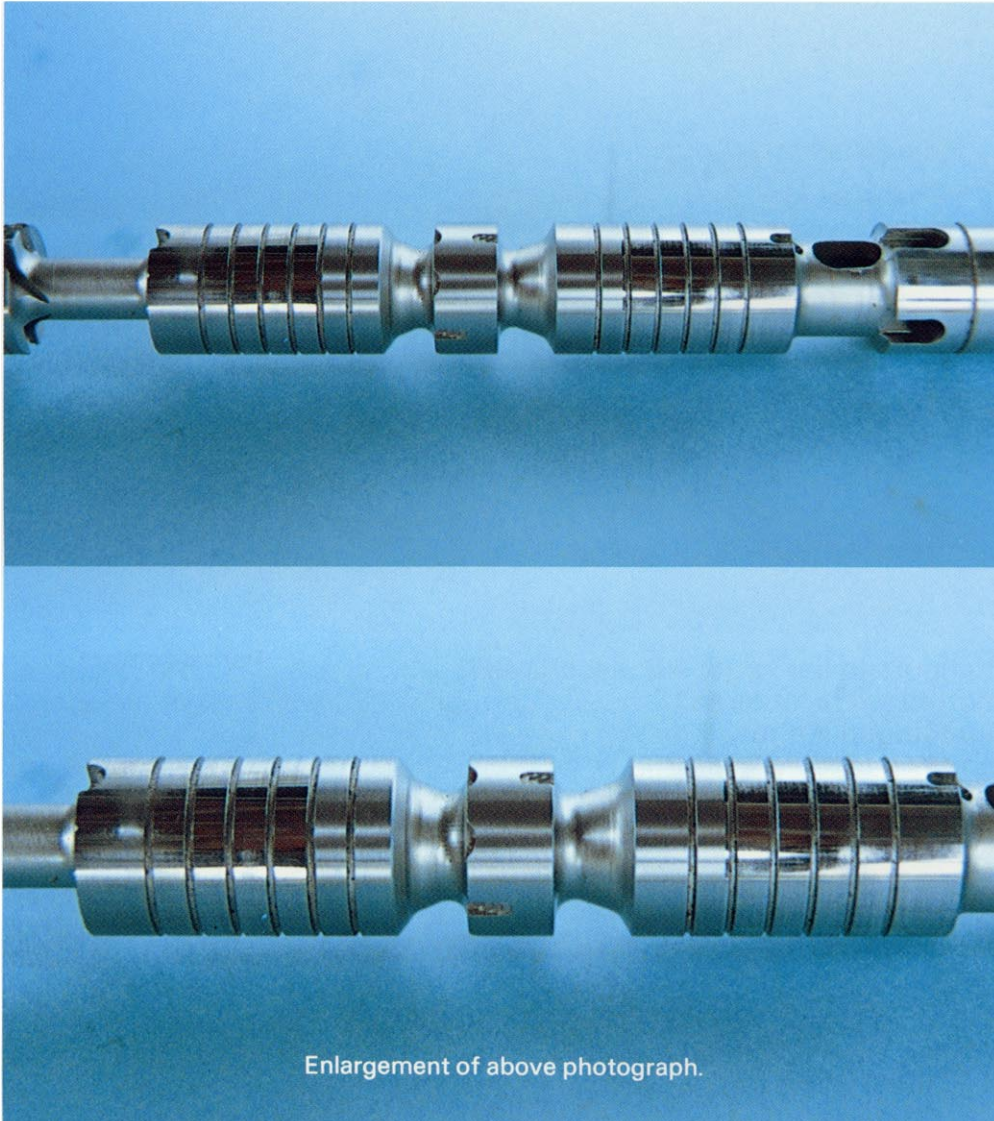
Spool: Sliding Surface

Test on the machine or carry out bench test to check for oil leakage and to check the operating force. If there is no abnormality, place in category **B**. If there is abnormality, place in category **C**.

- There is a black glaze on the sliding surface caused by strong uneven contact (small width of contact), but there are no grazes.
[Note] With strong contact, the contact width is usually narrow.

- There is no trace of dirt or foreign material getting caught or of contamination of oil, so the cause is probably repeated hydraulic lock.

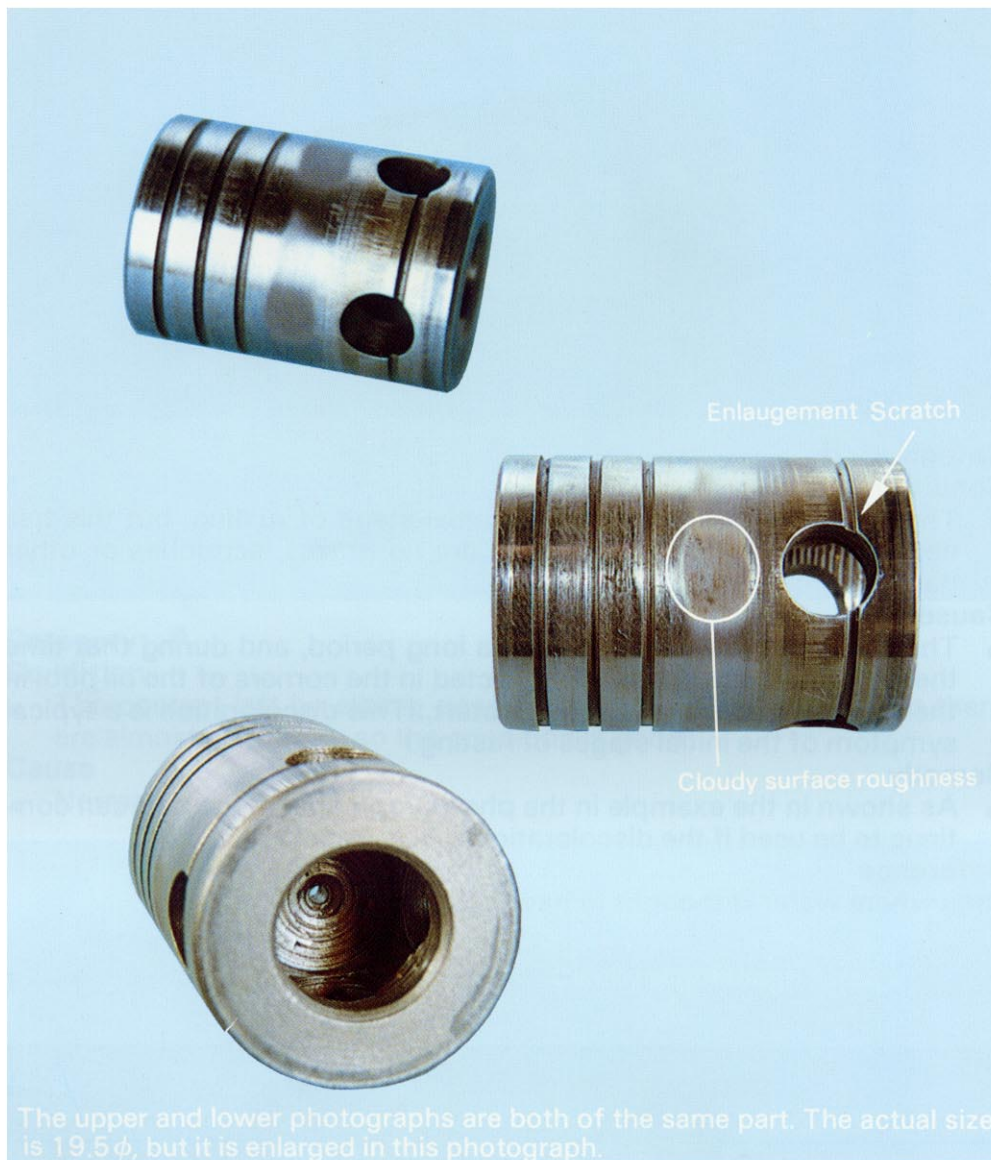
Main Valve: Sliding Surface

Category: C Condition

- At the right port side of the photograph, broken pieces getting caught have caused grazes (which catch the fingernail), and there are traces of seizure on parts of the sliding area. In the central part, there is cloudy surface roughness caused by jets of contaminated oil.

- The cause is probably improper maintenance of the hydraulic oil leading to accelerated contamination and catching foreign material in the sliding surface, or the catching of broken pieces coming from damage to other hydraulic equipment.
- ★ Action to take for broken hydraulic parts: the equipment must be cleaned thoroughly by flushing the hydraulic circuit.

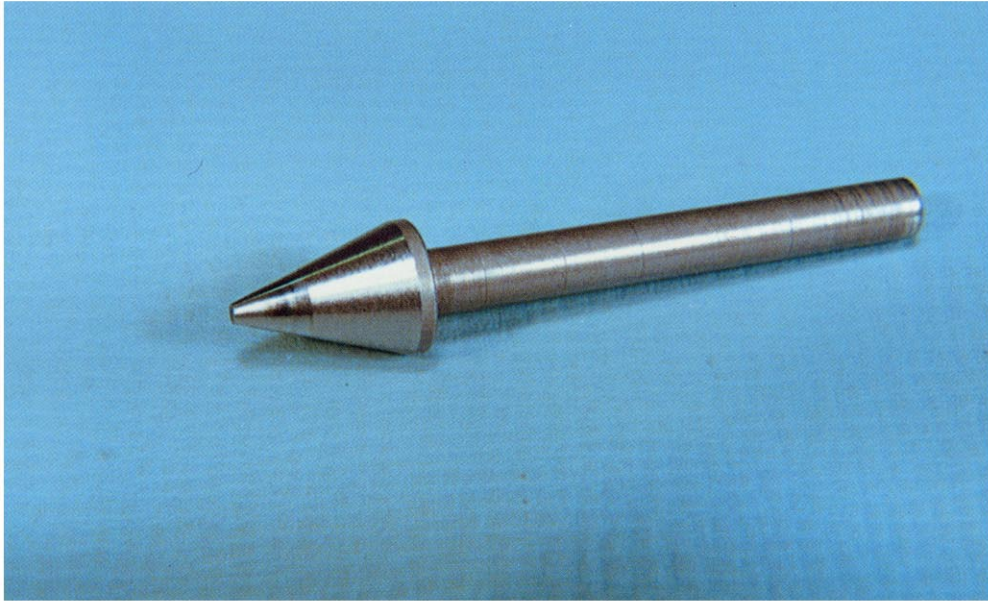
Pilot Poppet: Seat Portion

Category: A

- This is probably caused by hydraulic chattering which has caused defective following of the spring, or the spring is deteriorated.
Note: Check the spring.

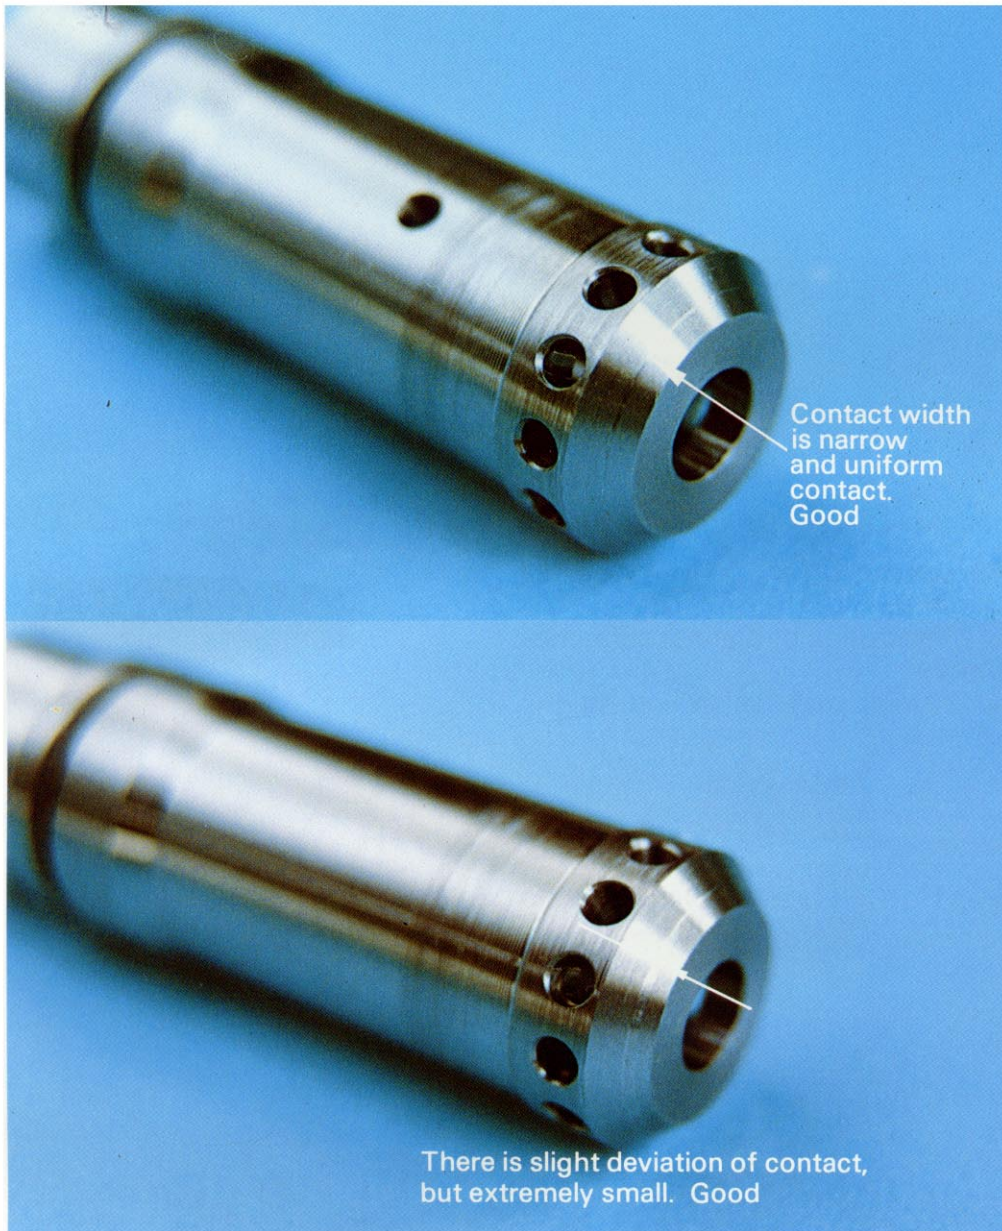
Suction Valve: Valve Seat Portion

Category: A Condition

- The contact of the valve seat shows the initial contact condition, and there are no scratches, so the condition is good. In the top photograph, the contact width is narrow, and the contact is uniform around the whole circumference. In the bottom photograph, there is slight deviation of the contact, but this is extremely small, so the condition is good.

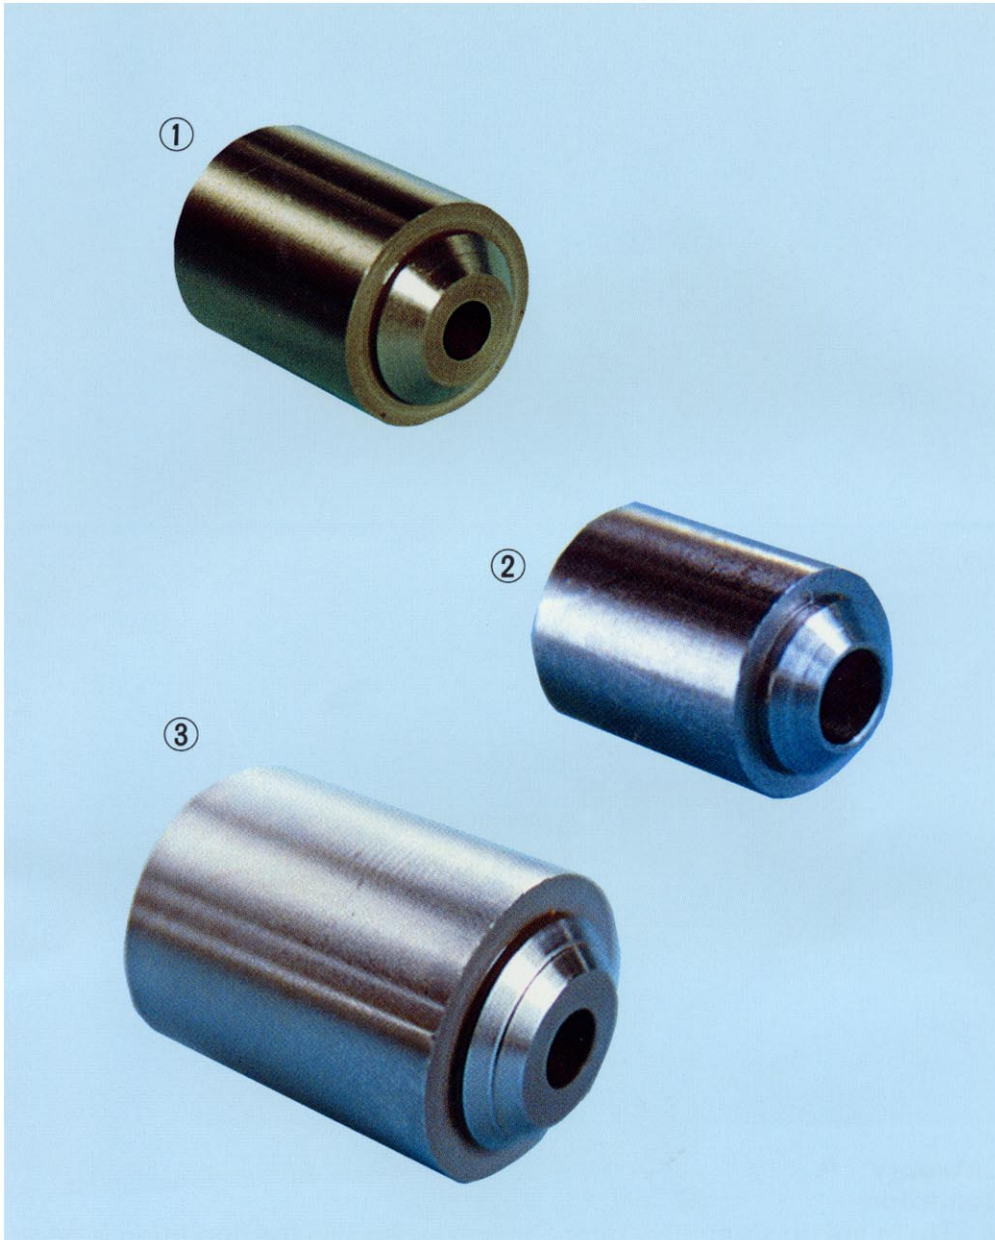
Main Valve: Sliding Surface and Seat Surface

Category: ① **A**; ② **B**

- Slide together with the suction valve to carry out lapping.
Judge category ③ after test on the machine or carry out bench tests to judge.
For no leakage **B**.
For leakage **C**.

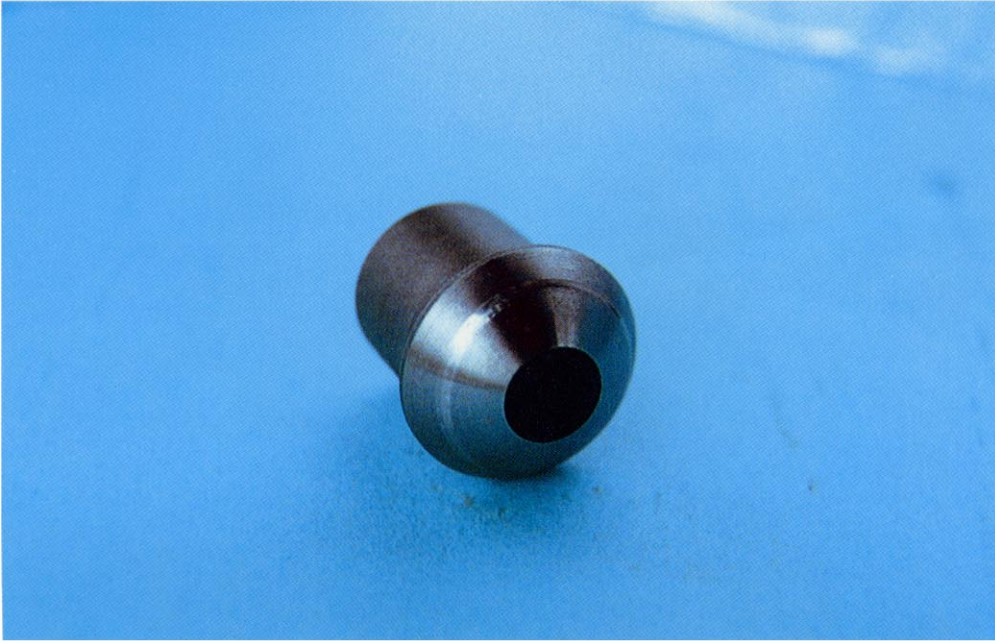
Check Valve: Valve Seat

Category: A Condition

- The valve seat surface contact is more or less uniform, and there is no wear or scratches, so the condition is good.

- Normal

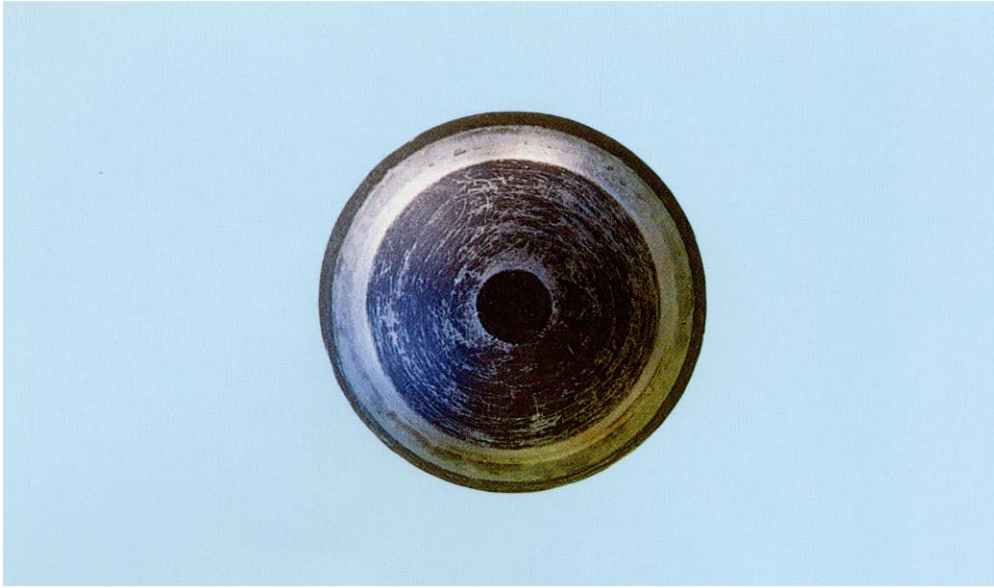
Check Valve: Valve Seat

Category: B

- Slide together with the valve body to correct by lapping.
