## Service Bulletins

BULLETIN NO : SBMA200311  
BULLETIN TO : ALL MARINE DEALERS  
ATTENTION : SERVICE MANAGER AND ALL RELEVANT STAFF  
DATE : March 2003  
SUBJECT : BF 75/ 90 A Oil leak from oil pump

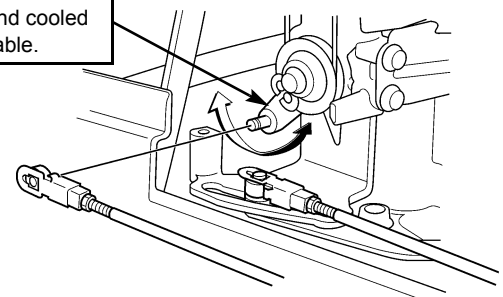
The throttle arm will not operate because the throttle cable inner liner has melted and cooled around the cable.

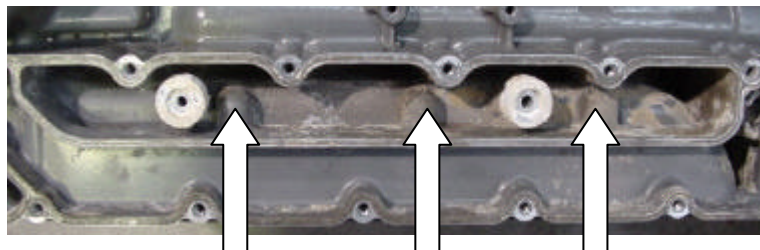
## Illustration

Due to internal stress from the rapid swelling of the exhaust port during acceleration small cracks may occur in the coolant water passage behind the exhaust port.

In order to avoid the concentration of stress the four reinforcement ribs in the exhaust port have been modified.

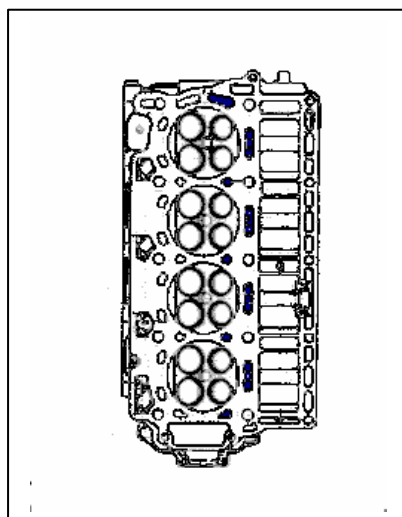
Before C/M

Engine idle is unstable and water can be found in the combustion chamber.

A crack develops between the number 2 and number 3 cylinders allowing water to enter into the combustion chamber.

A cooling water jacket passage has been added in the cylinder head to help the engine have a more even flow of coolant water. The thermostat valve opening temperature has been changed from 72 to 60 degrees Celsius to reduce the coolant temperature.

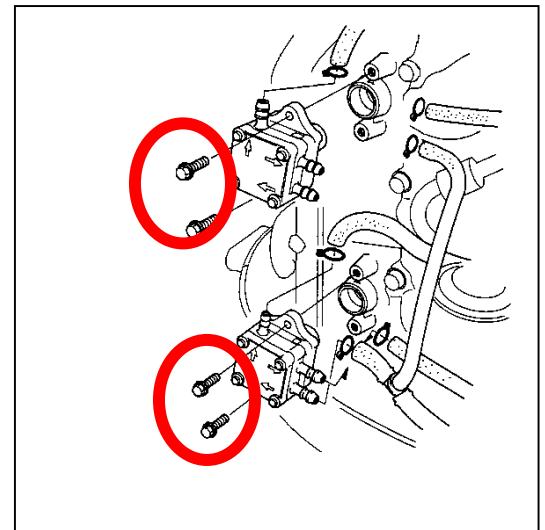
The engine may run rough and leak engine oil due to the fuel pump coming loose.

Fuel pump bolt torque 9 Nm

Re-tension fuel pump bolts to **9Nm** during PDI or routine maintenance.

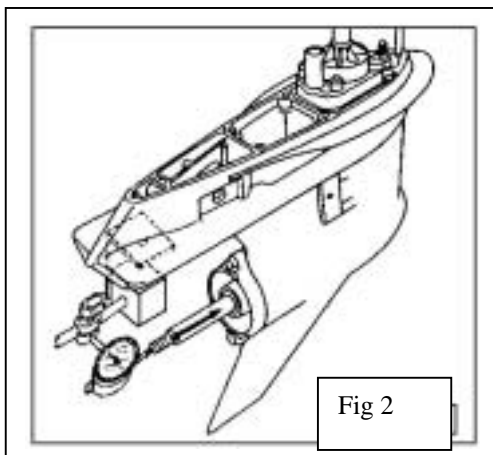
The gear case may become noisy due to a broken tooth or the gear oil may be contaminated by metal particles before the maintenance schedule (100 Hours).

**Step 1 :** Make a jig for the magnet base as shown in fig-1. Remove the trim tab and attach the jig as shown below.

**Step 2 :** Measure the thrust clearance by pushing and pulling the propeller shaft.

Standard Rotation	$0.35 \pm 0.05$ mm
Counter rotation	$0.25 \pm 0.05$ mm

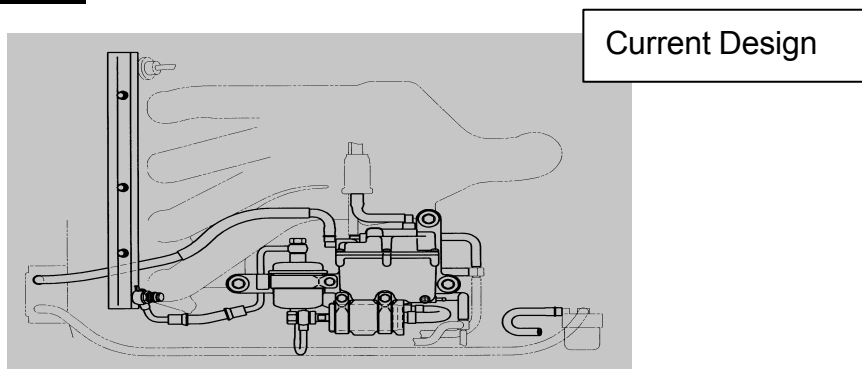
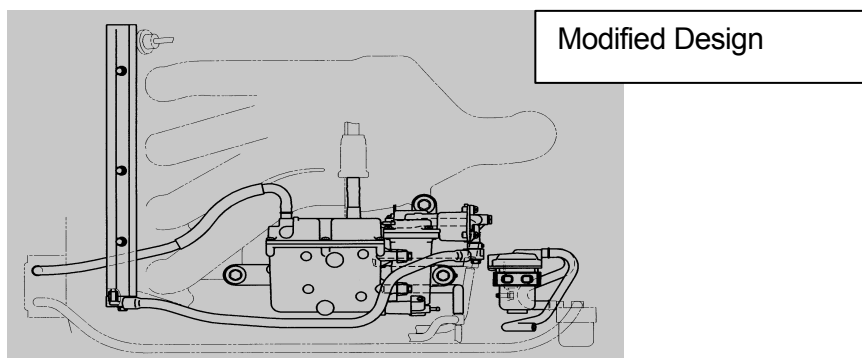
**Illustration**

Engine may become difficult to start.

If water enters the fuel system it can enter into the high pressure fuel pump, causing rust to develop in the metal parts, causing malfunction of the fuel pump and, eventually, a engine starting problem.

1. Combines the vapor separator with the high pressure fuel pump so that intruding water may be drained easily.
2. Adding an internal water separator so that water mixed with the fuel is separated.
3. Parts applied to the fuel route are made from materials which are less susceptible to rust.

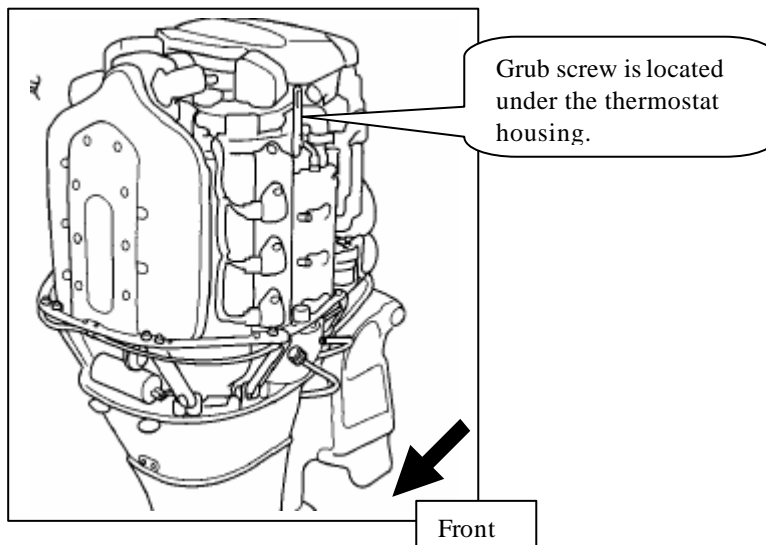
It has come to our attention that some dealers are finding it hard to find a pick up point for a water pressure gauge.

The 175/200/225 outboard engines are fitted with a grub screw that can be easily removed and a fitting screwed into it to fit up the gauge. The grub screw can be found under the starboard side thermostat housing.

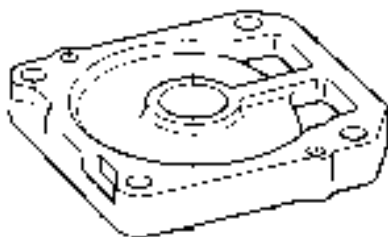
Water pump housing

It has come to our attention that some gear cases may be found to have water entering through the top water seal.

Under normal conditions, the internal pressure will increase when the engine is operating due to friction and heat generated by rotation. However, when engine speed drops or the temperature of gear oil decreases, negative pressure develops in the case causing water to enter through the water pump seals.

To prevent water entry fit the improved water pump housing and water seal. Change gear oil and refill with 0.95 lt of oil.

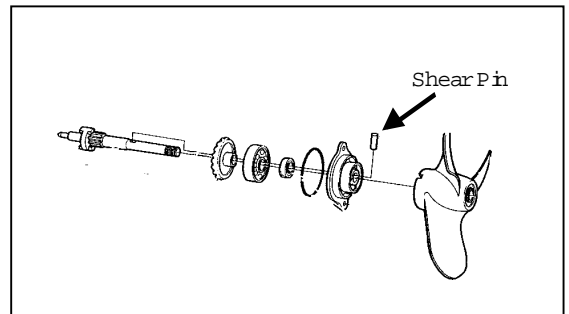
It has come to our attention that the shear pin in the BF5A propeller shaft can break when shifting from reverse to forward. The cause of this is insufficient strength of the material when hard shifting is encountered.

A new stainless steel shear pin with improved strength has made and is now available.

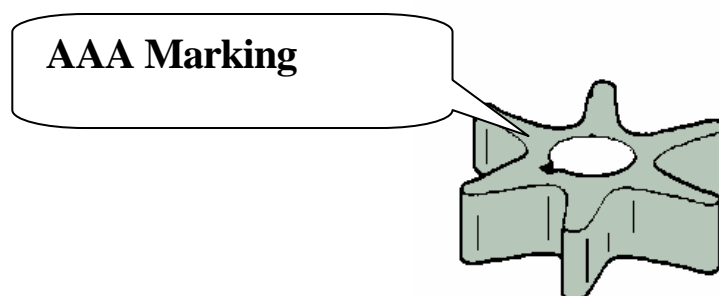
BULLETIN NO : SBMA200215  
 BULLETIN TO : Marine Dealers  
 ATTENTION : DEALER PRINCIPAL, SERVICE MANAGER, SALES MANAGER & ALL RELEVANT STAFF  
 FROM : Marine Service Department  
 DATE : March 2002  
 SUBJECT : BF 75A/90A/115A/130A water pump impeller failure

All new stock from Japan will have the new impeller fitted as standard as the chart below shows.

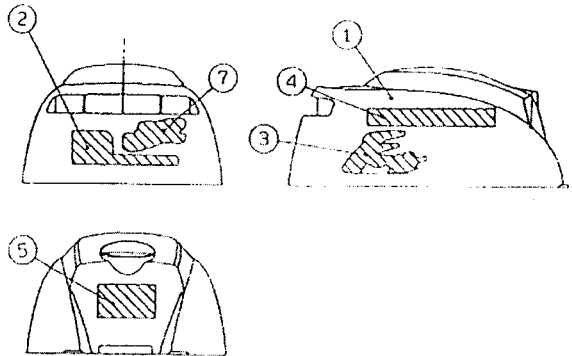
### Decal location and part number.

This occurs when the alcohol and other fuel additives contained in the fuel causes the paint finish to lift, mainly occurring when fuel is left sitting on the cover.

Please order the replacement cowl and the replacement decals **only** if the problem exists. The new cowl has an improved paint primer that is more resistant to fuels.

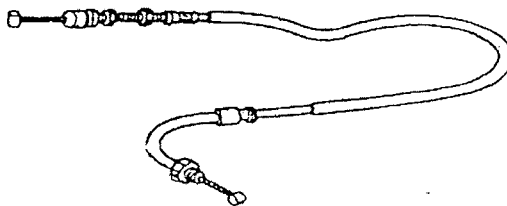
THROTTLE CABLE

Ladies and Gentlemen,  
It has come to our attention corrosion of the BF2D throttle cable may occur in some conditions.

An improved replacement throttle cable kit is available should corrosion be apparent.

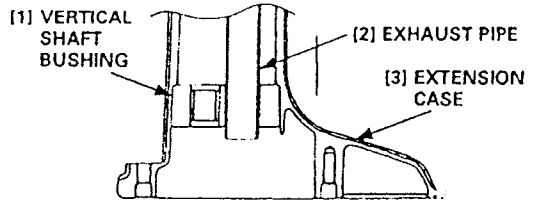
The cause of this is the engine momentarily reversing as it stops, creating negative pressure in the exhaust pipe; water droplets are then introduced into the engine bridging the spark plug electrodes.

2/. Insert the valve comp all the way between the exhaust pipe and the vertical shaft bushing.
