SECTION 3 POWER TRAIN SYSTEM

GROUP 1 STRUCTURE AND FUNCTION

1. POWER TRAIN COMPONENT OVERVIEW

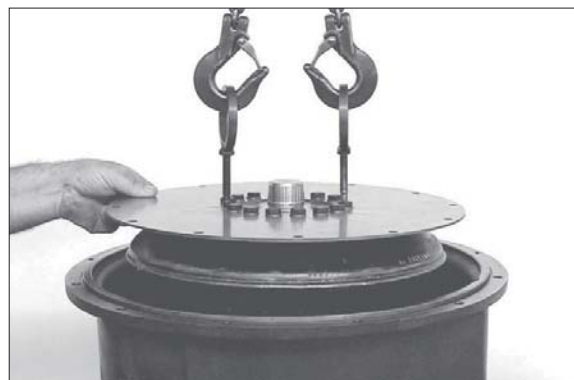
Figure 4

(2) Loosen the bolt connection and by means of the forcing screws (3EA) separate the cover from the converter bell.

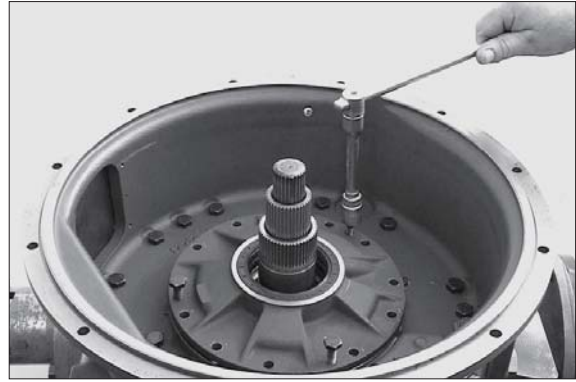
Figure 5

(3) By means of the extractor pull the oil supply flange out of the converter bell.

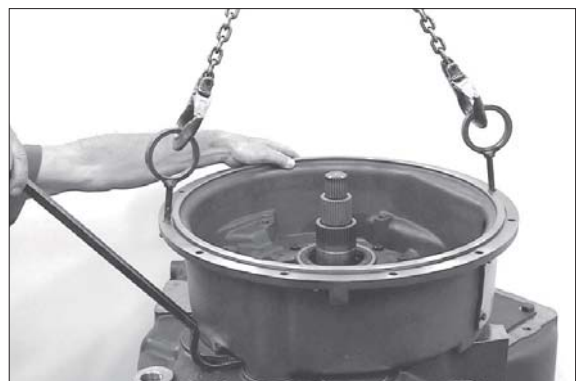
Figure 8

(6) Remove the rectangular ring (arrow).

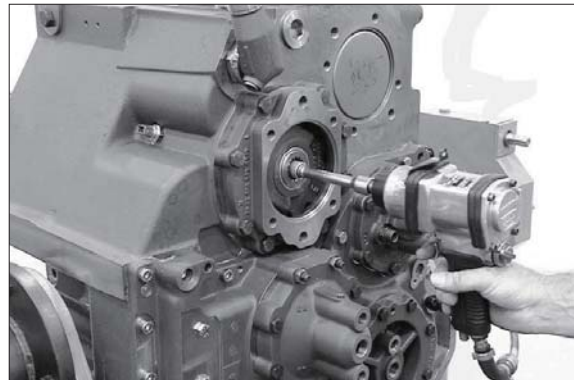
Figure 21

- (2) Remove the cap screw and clamping plate.

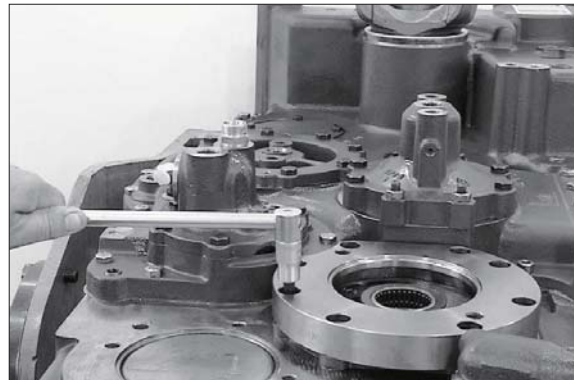
Figure 25

- (2) Loosen the cap screws (4EA / M8).
Position the extractor on the transmission pump and fasten it by means of screws (M8 × 65) to the transmission pump. Then pull out the pump from the housing bore.

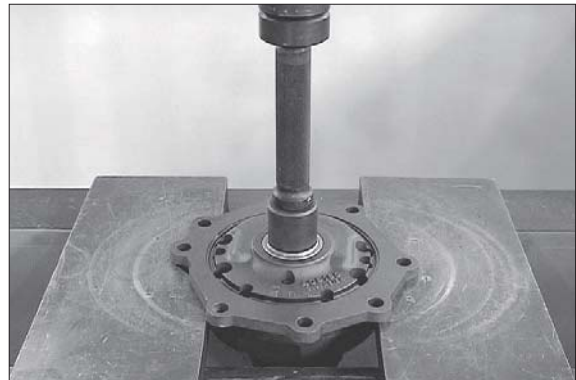
Figure 29

(6) Loosen the cap screws, take off the pump cover and remove the rotor set.

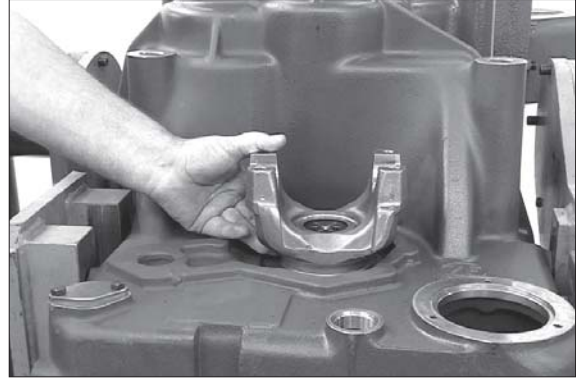
Figure 42

Transmission rear side

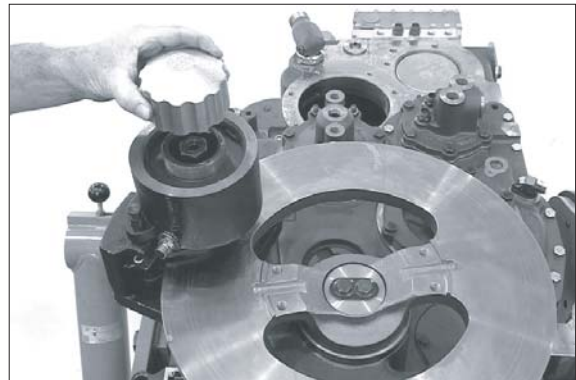
Figure 43

(2) Loosen the counternut and unscrew the adjusting screw in counterclockwise direction until the brake disc is released.

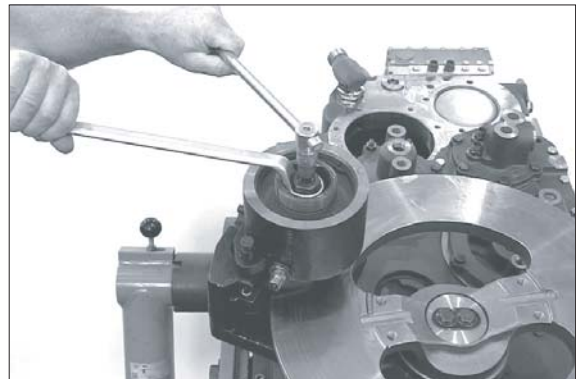
Figure 44

(3) Loosen the cap screws and separate the complete brake from the transmission housing.

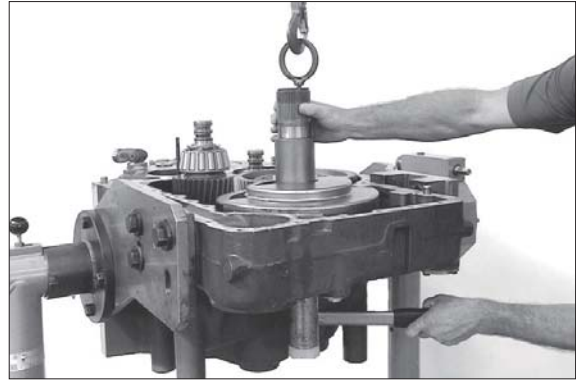
Figure 50

- (6) Loosen the hexagon screws and remove the oil baffle.
Lift the output gear out of the transmission housing (figure).

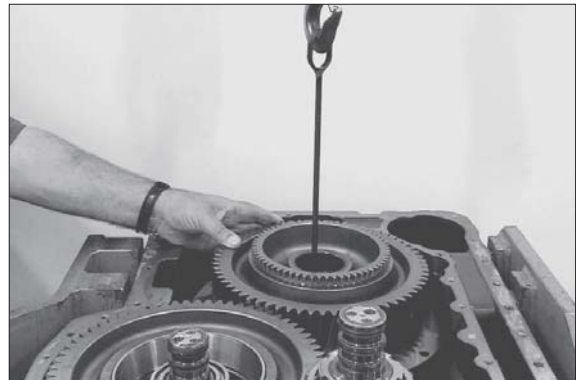
Figure 51

- (7) Remove the bearing inner ring from the output gear.

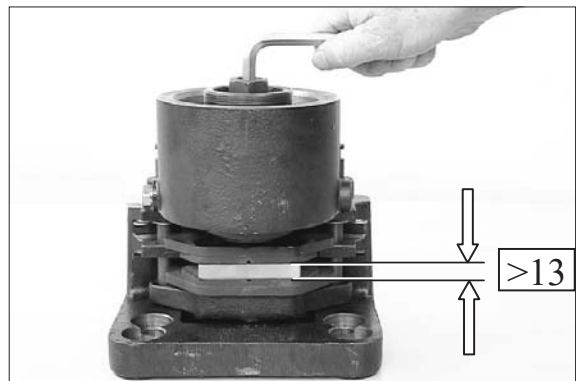
Figure 297

Unscrew the adjusting screw in counterclockwise direction until a dimension > 13.0 mm (brake disc shim) results (figure 297).

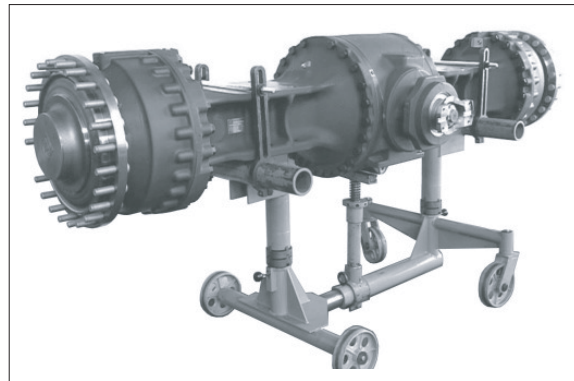
7809AX01

Position axle first onto the two fixtures, secure with clamping brackets and then unbolt the support until contact with the axle is obtained.

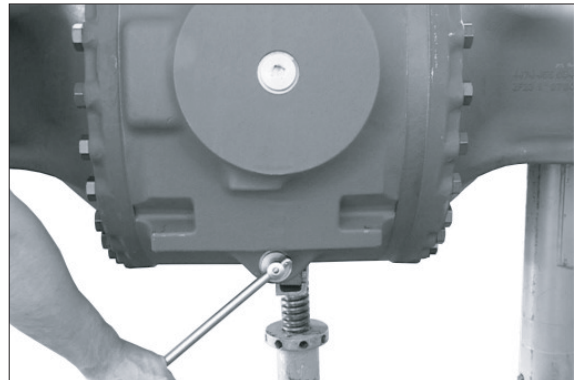
7809AX02

② Loosen screw plugs (3EA, see figure AX02 and AX03) and drain oil from the axle.
