# SHOP MANUAL

## **GUIDANCE FOR REUSABLE PARTS**

# TURBOCHARGER

GUIDANCE FOR REUSABLE PARTS  
**KOMATSU**

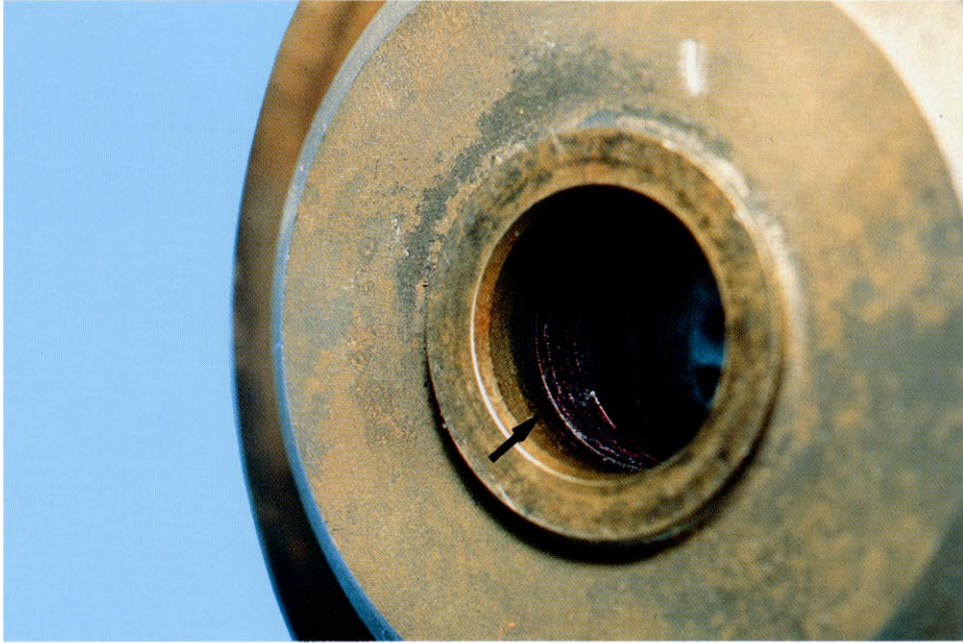
7

**DO NOT USE AGAIN**

- Unsatisfactory lubrication.

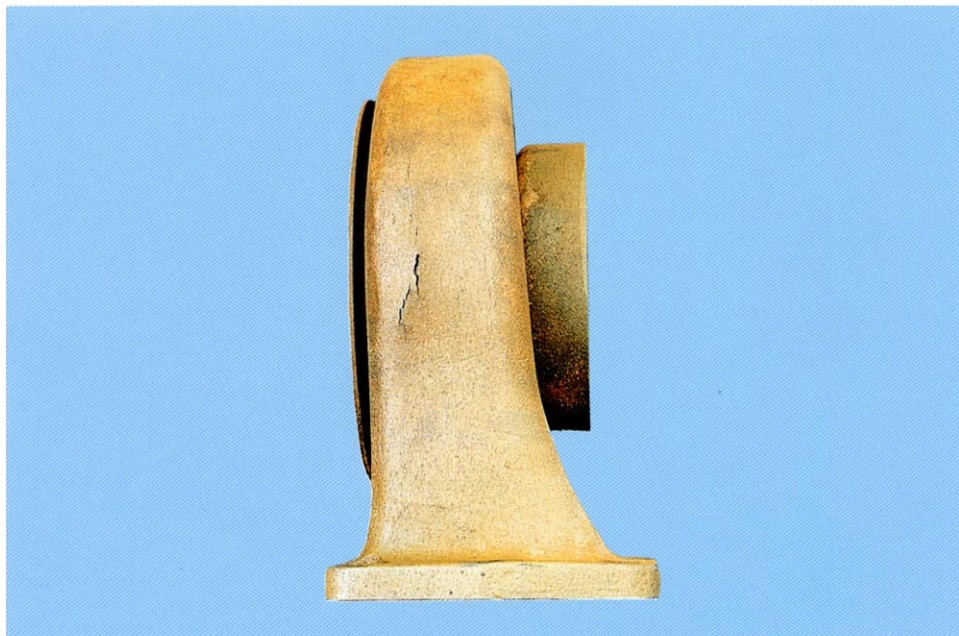
10

- This turbine housing has heat cracks.

- Excessive rise in exhaust temperature (The housing may sometimes crack due to entrance of foreign matter.)

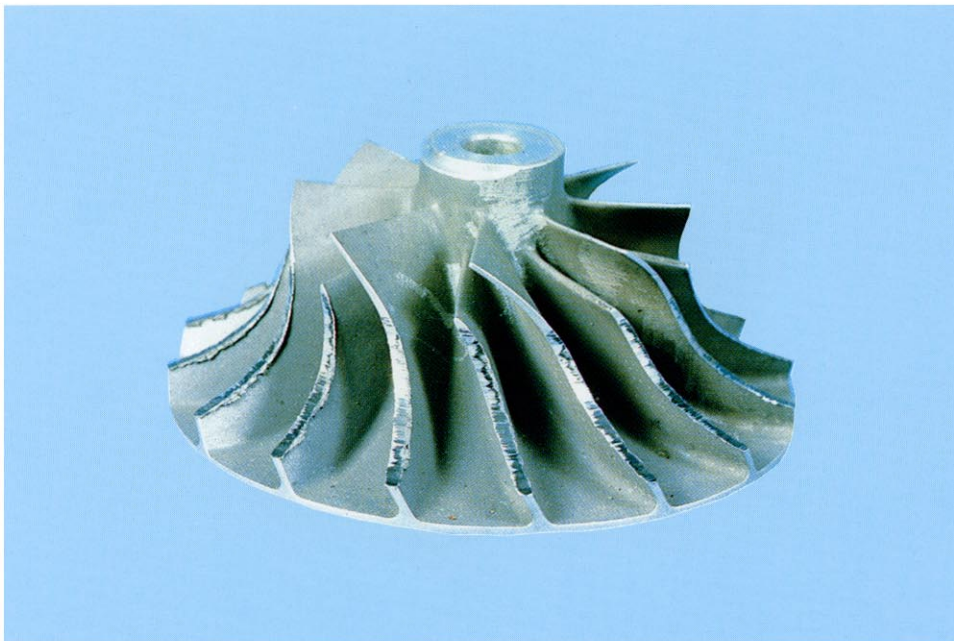
24

- This blower impeller has broken due to contact with the blower impeller.

- The runout of the impeller shaft increased because insufficient lubrication caused the bearing to wear out.

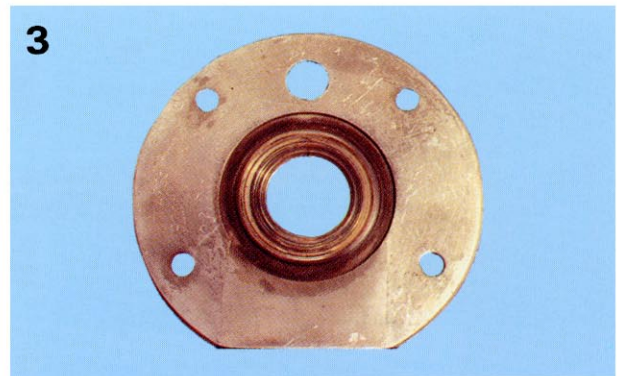
Thrust bearing excessively worn or scuffed due to the lack of lubricating oil.

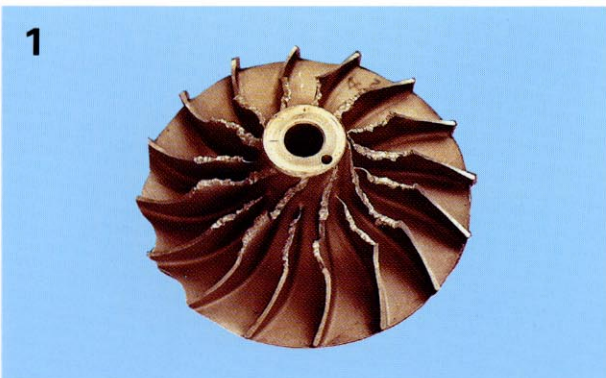
Blower impeller damaged with foreign matter like stones, nuts, washers, etc.

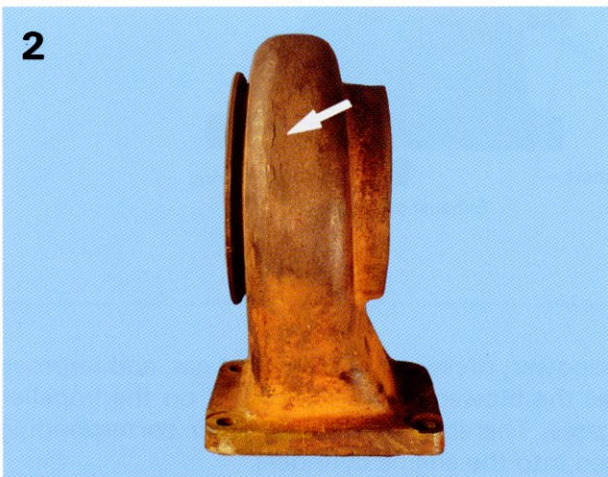
Turbine housing with heat cracks.

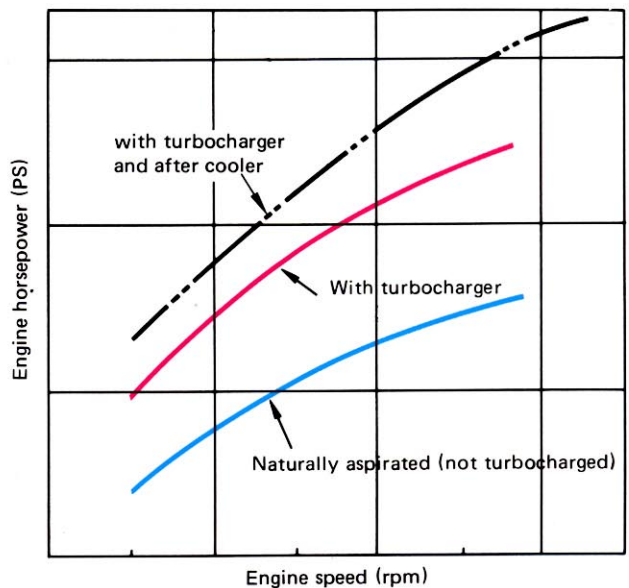
Comparison of horsepower between turbocharged and naturally aspirated engine (NTA 855 engine).

In a turbocharged engine, a quantity of air corresponding to the fuel injection quantity is compressed and supercharged. In an engine of the same cylinder capacity, the horsepower can be increased as indicated in the graph at right. If an after-cooler is used with the turbocharger, the horsepower can be further improved.

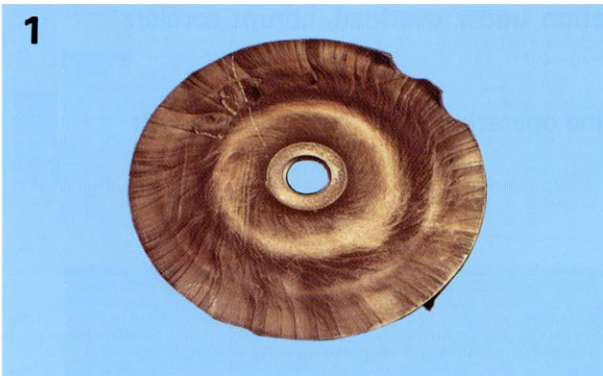
1  
Oil adhering to back face of blower impeller.

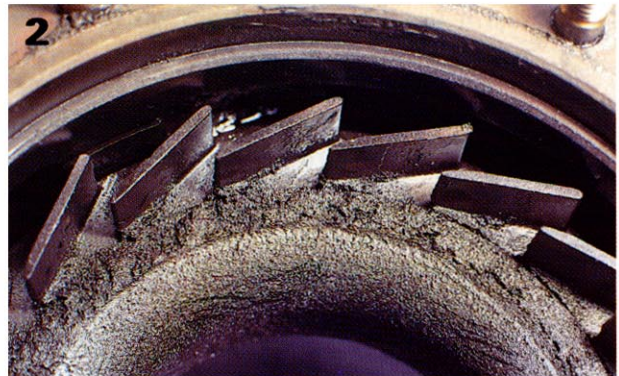
2  
Stains caused by oil which leaked to turbine side.
