SECTION 3 POWER TRAIN SYSTEM

GROUP 1 STRUCTURE AND FUNCTION

1. POWER TRAIN COMPONENT OVERVIEW

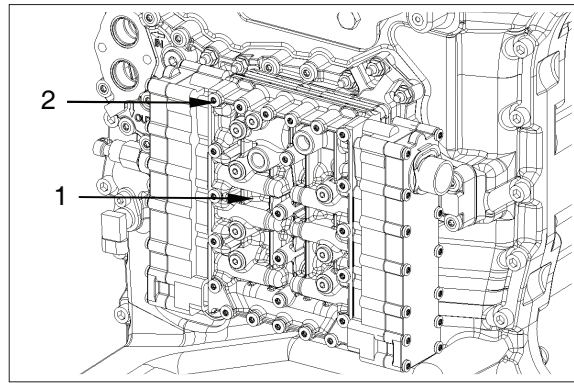
HL940TM003

Loosen Torx screws (2) and separate gear-shift control housing from intermediate plate.

Socket wrench TX-27 5873 042 002
Adjusting screws M6 5870 204 063

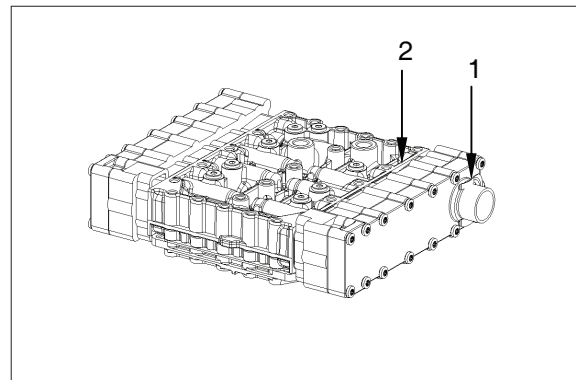
HL940TM008

- ⑥ Mark installation position of wiring harness (1) towards valve block (2).

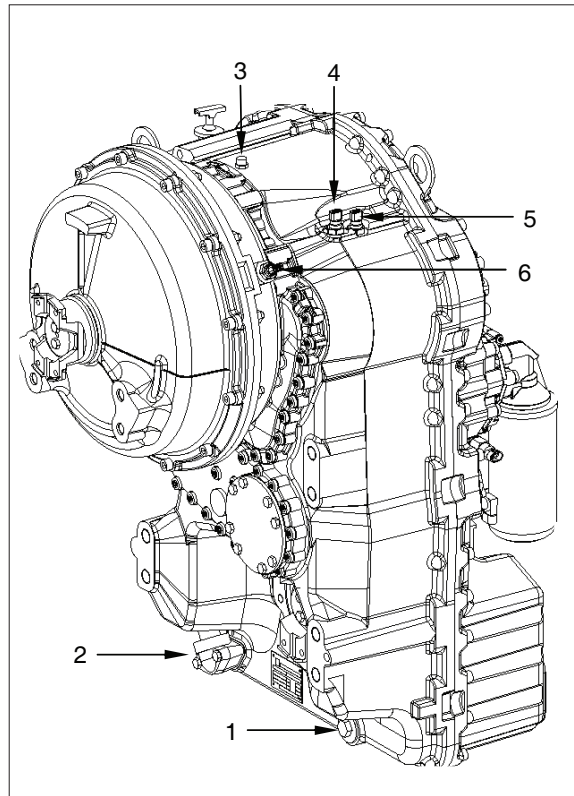
HL940TM019

- 1 Screw plug (oil drain hole)
- 2 Oil filler tube with oil dipstick
- 3 Breather
- 4 Inductive sensor - n central gear chain
- 5 Inductive sensor - n turbine
- 6 Inductive sensor - n engine

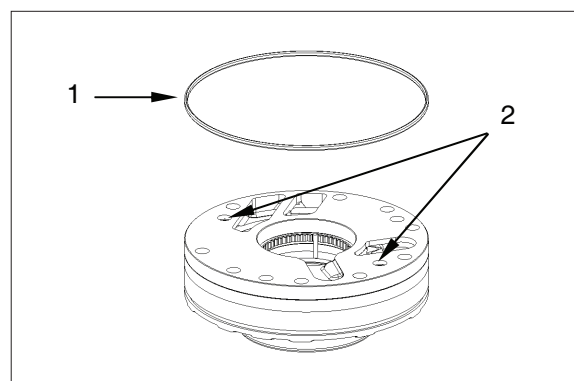
HL940TM033

- ⑤ Check oil gear pump :
In case of wear marks in the pump housing, cover or on the inner and outer rotor, the complete oil pressure pump is to be replaced.

- 1 Cover
- 2 Inner rotor
- 3 Outer rotor
- 4 Pump housing

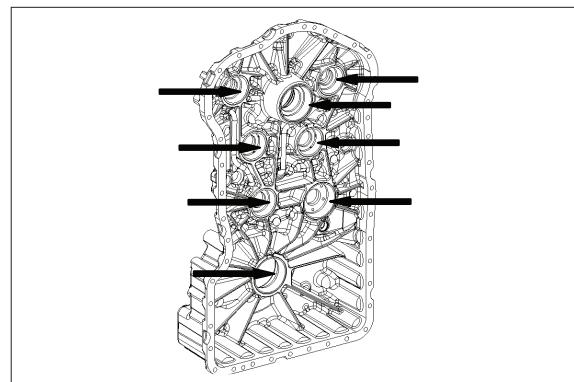
HL940TM087

(13) The lubrication lines are rolled in (1 and 2) and are highly difficult to remove. In case of damage, use of the appropriate special tool is imperative for fitting or replacing these components.

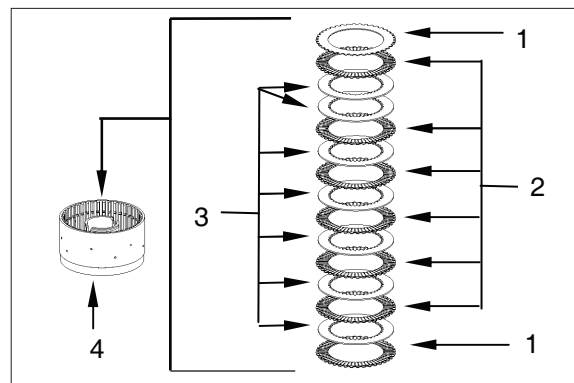
HL940TM193

⑮ Mount end plate (1) and fix disk package by means of snap ring (2) (e.g. thickness = 2.65 mm / recommended value).

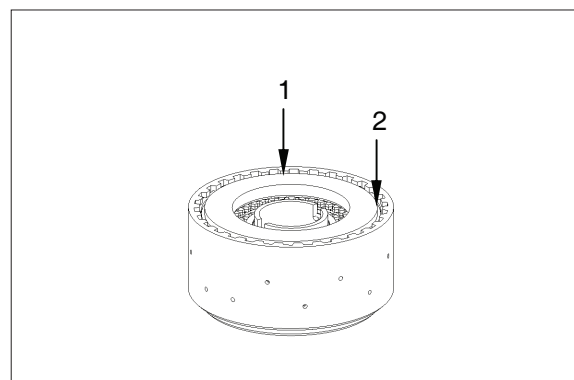
HL940TM194

- ⑩ Press on end plate with F (approx. 100 N = 10 kg) and set dial indicator to "zero".

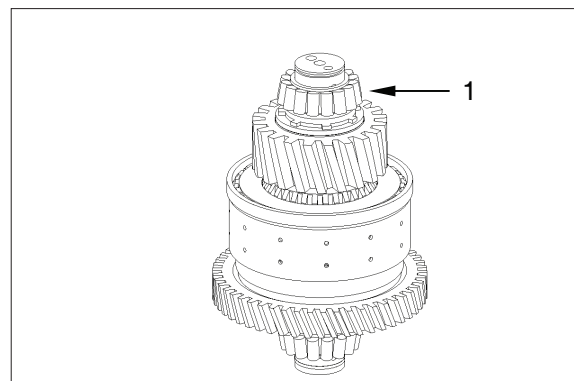
② Mount stud bolt (1).

- Tightening torque (M10 /8.8 × 16) :
1.73 kgf · m (12.6 lbf · ft)

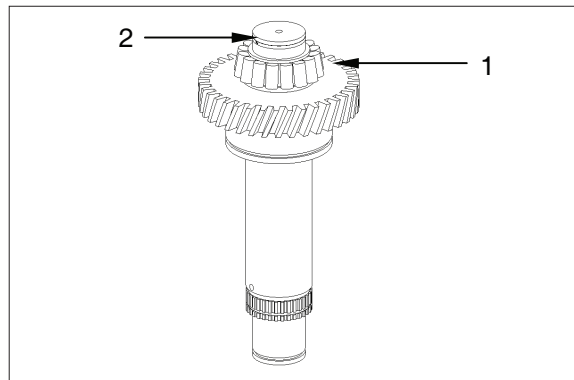
- ③ Undercool shaft (1) (approx. -80°C), heat up gear (2) (approx. +120°C) and mount until contact is obtained.

- ※ Wear protective gloves.
